**Theft Deterrent <RHD, Before Oct. 2015 Production>**

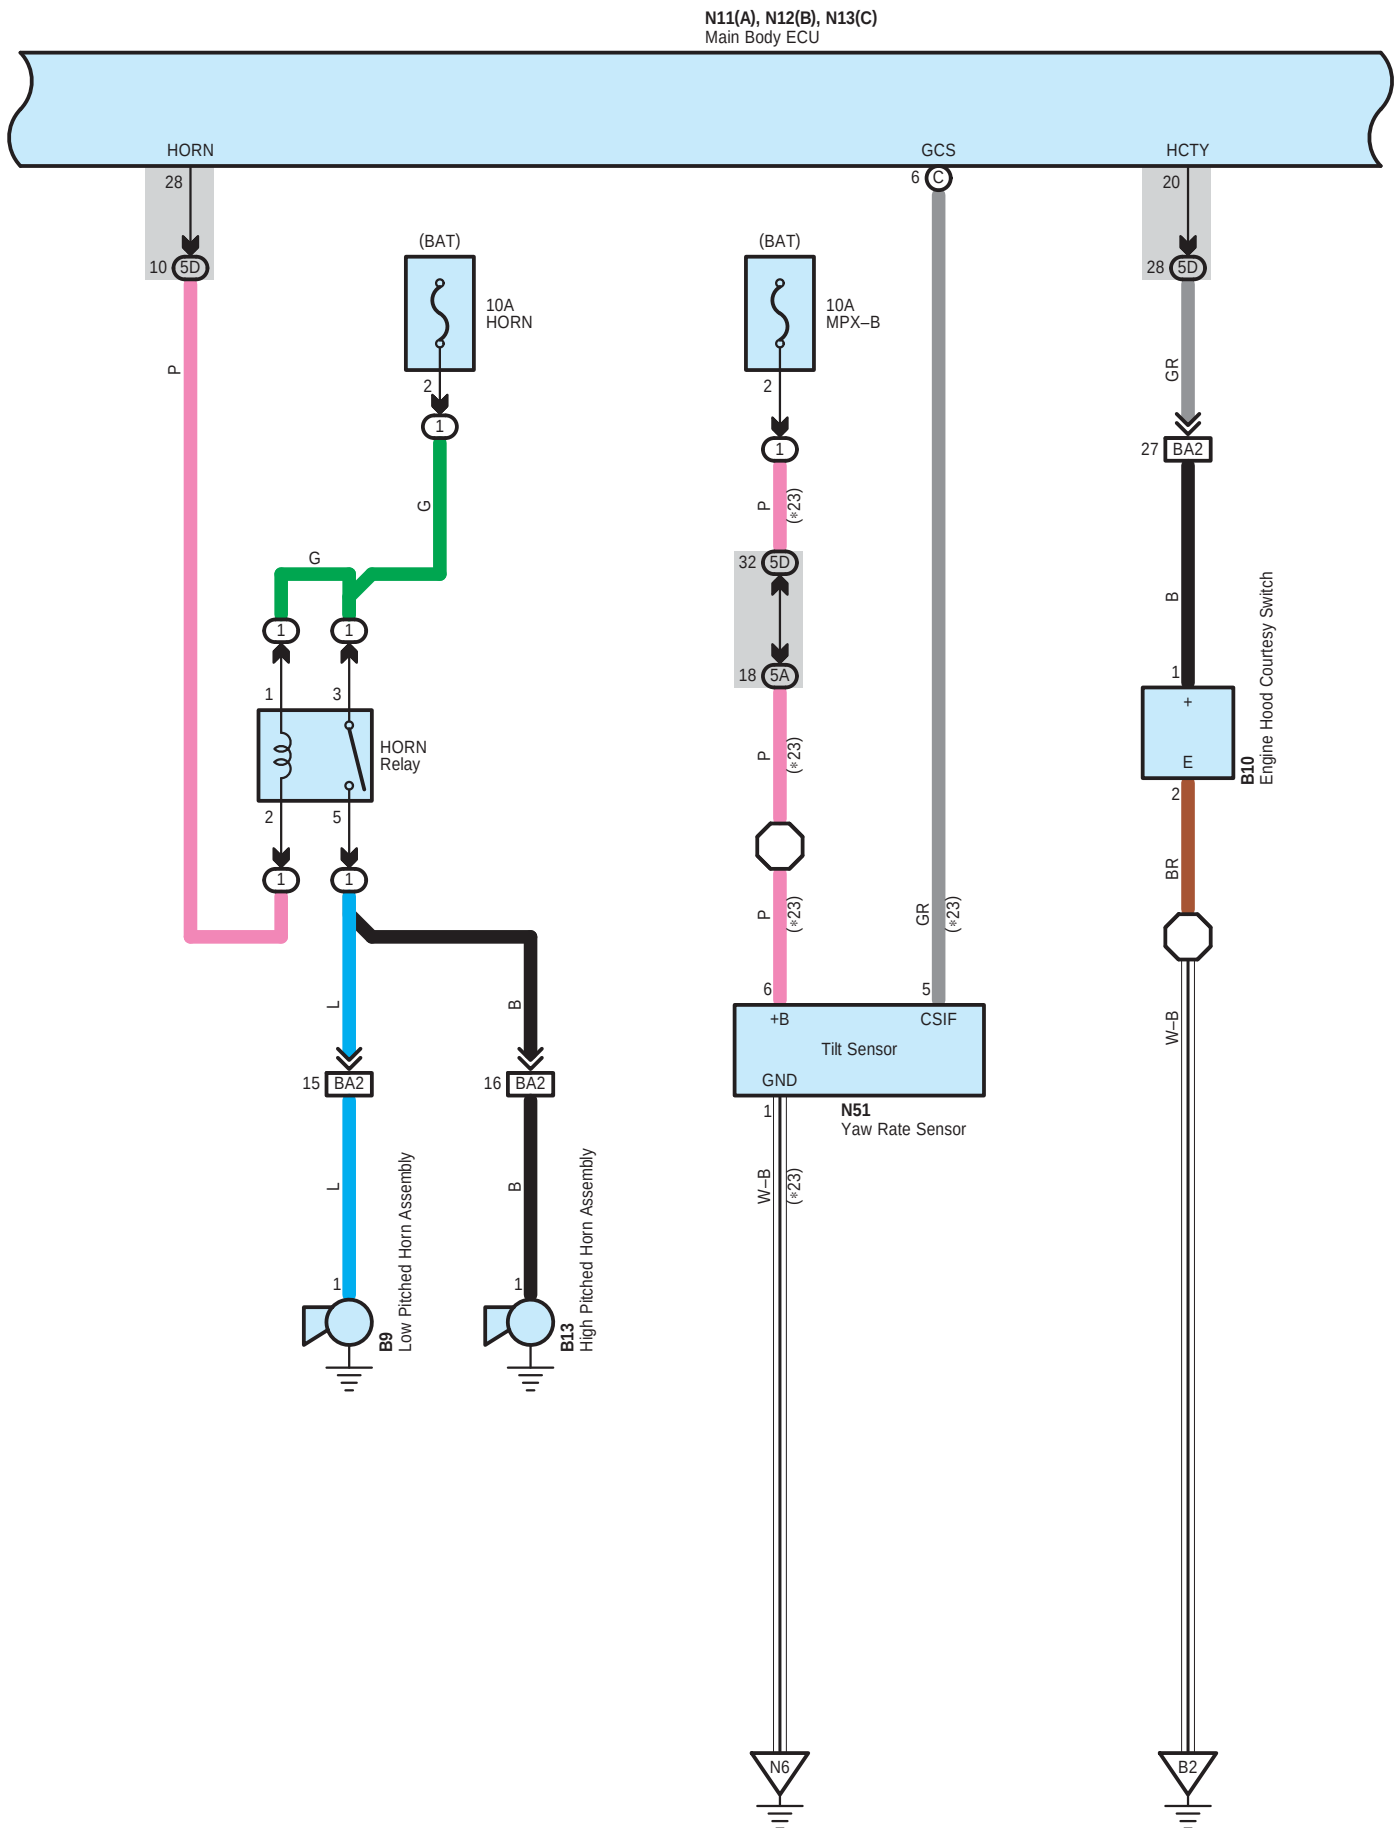
N11(A), N12(B), N13(C)  
Main Body ECU

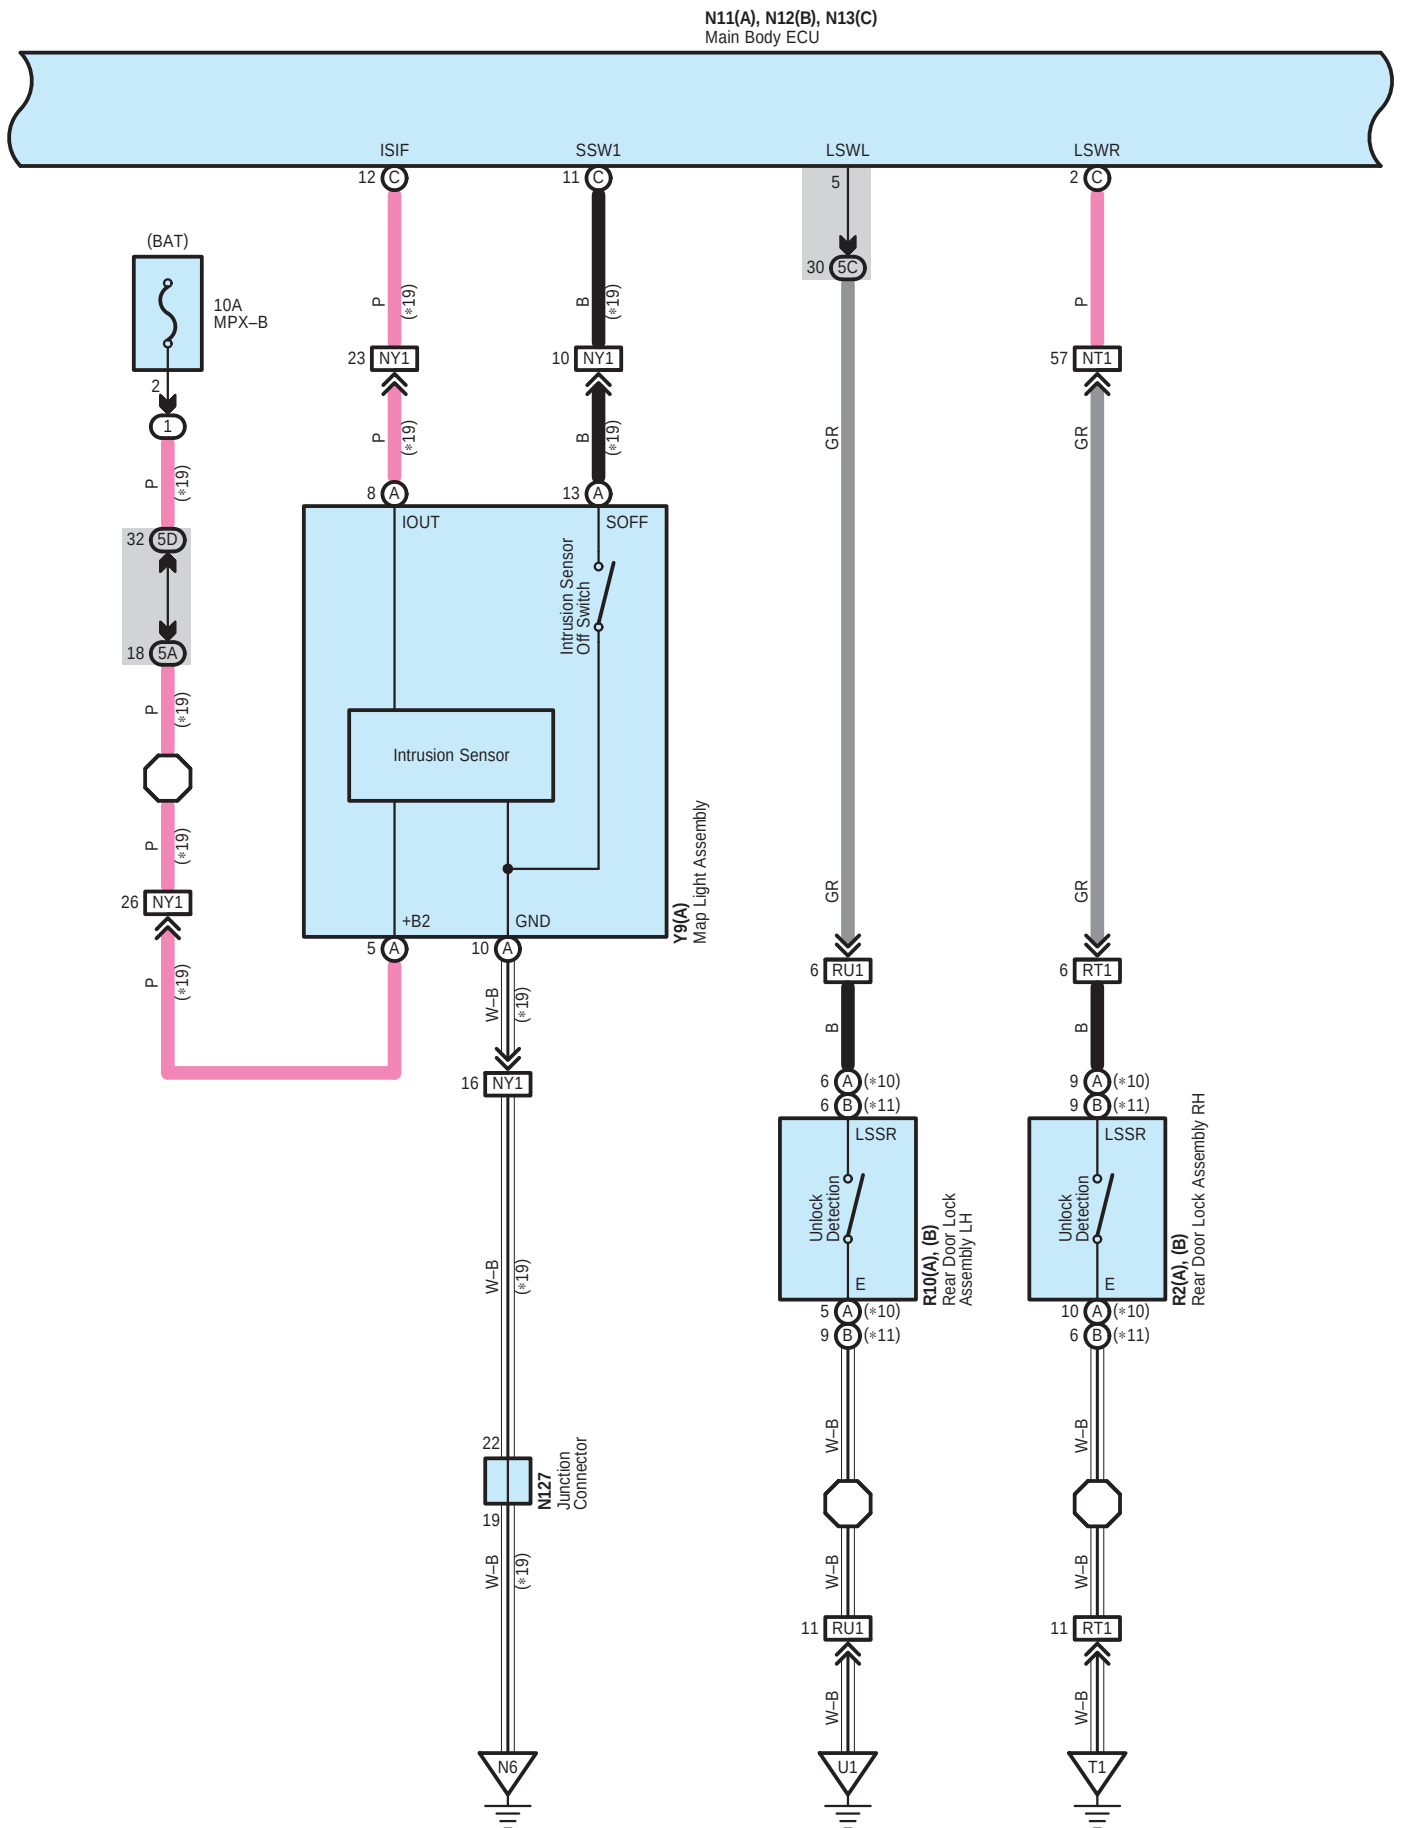
N11(A), N12(B), N13(C)  
Main Body ECU
