Position of Parts in Instrument Panel (From Aug. 2013 Production)

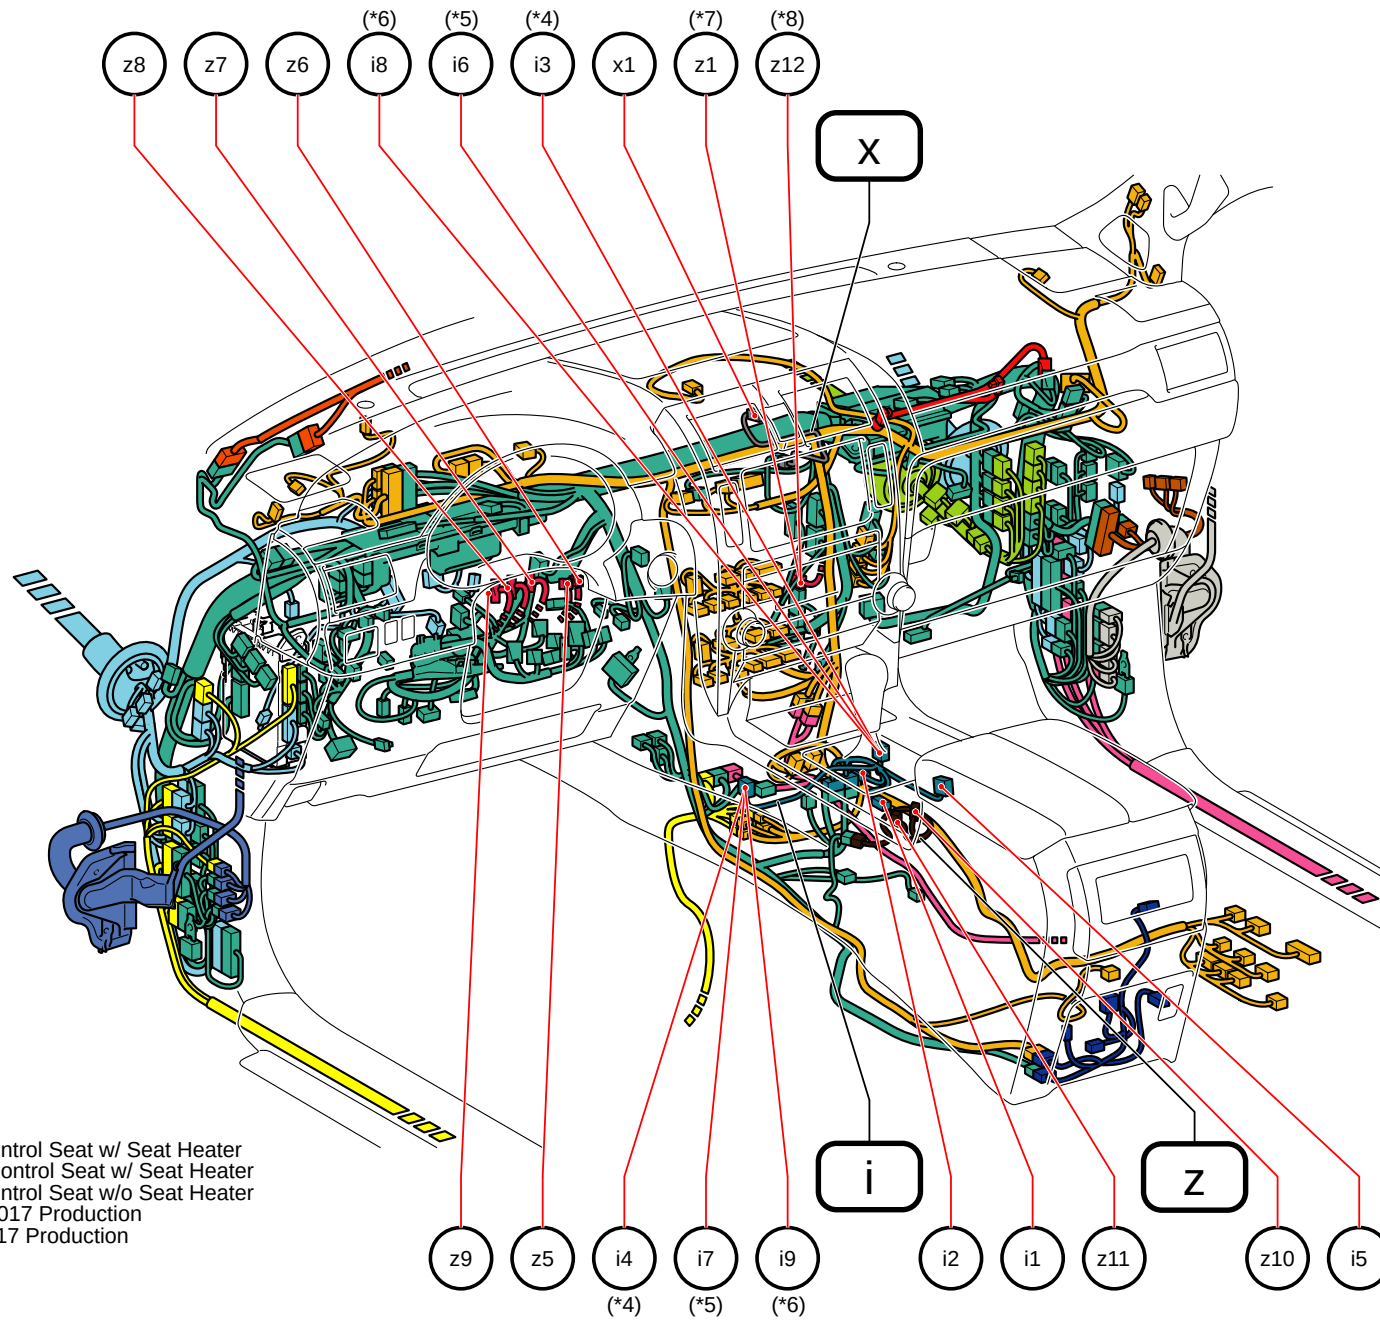
\*4:w/ Climate Control Seat w/ Seat Heater  
 \*5:w/o Climate Control Seat w/ Seat Heater  
 \*6:w/ Climate Control Seat w/o Seat Heater  
 \*7:Before Nov. 2017 Production  
 \*8:From Nov. 2017 Production

| i1 | No. 1 Indoor Electrical Key Antenna Assembly |
| i2 | Power Point Socket Assembly |
| i3 | Refreshing Seat Switch RH |
| i4 | Refreshing Seat Switch LH |
| i5 | Combination Switch Assembly |
| i6 | Refreshing Seat Switch RH |
| i7 | Refreshing Seat Switch LH |
| i8 | Refreshing Seat Switch RH |
| i9 | Refreshing Seat Switch LH |
| x1 | Hazard Warning Signal Switch Assembly |
| z1 | A/C Amplifier Assembly , A/C Blower Assembly |
| z5 | Driver Side Squib Circuit , Spiral Cable Sub-Assembly |
| z6 | Driver Side Squib 2nd Step Circuit , Spiral Cable Sub-Assembly |
| z7 | Cruise Control Main Switch , Spiral Cable Sub-Assembly |
| z8 | Spiral Cable Sub-Assembly , Steering Pad Switch Assembly |
| z9 | Spiral Cable Sub-Assembly , Steering Wheel Heater Control Assembly |
| z10 | Cup Holder Illumination RH (No. 1 Interior Illumination Light Assembly) |
| z11 | Cup Holder Illumination LH (No. 1 Interior Illumination Light Assembly) |
| z12 | A/C Amplifier Assembly , A/C Blower Assembly |
