Position of Parts in Engine Compartment <LHD 3UR-FE From Sep. 2015 Production>

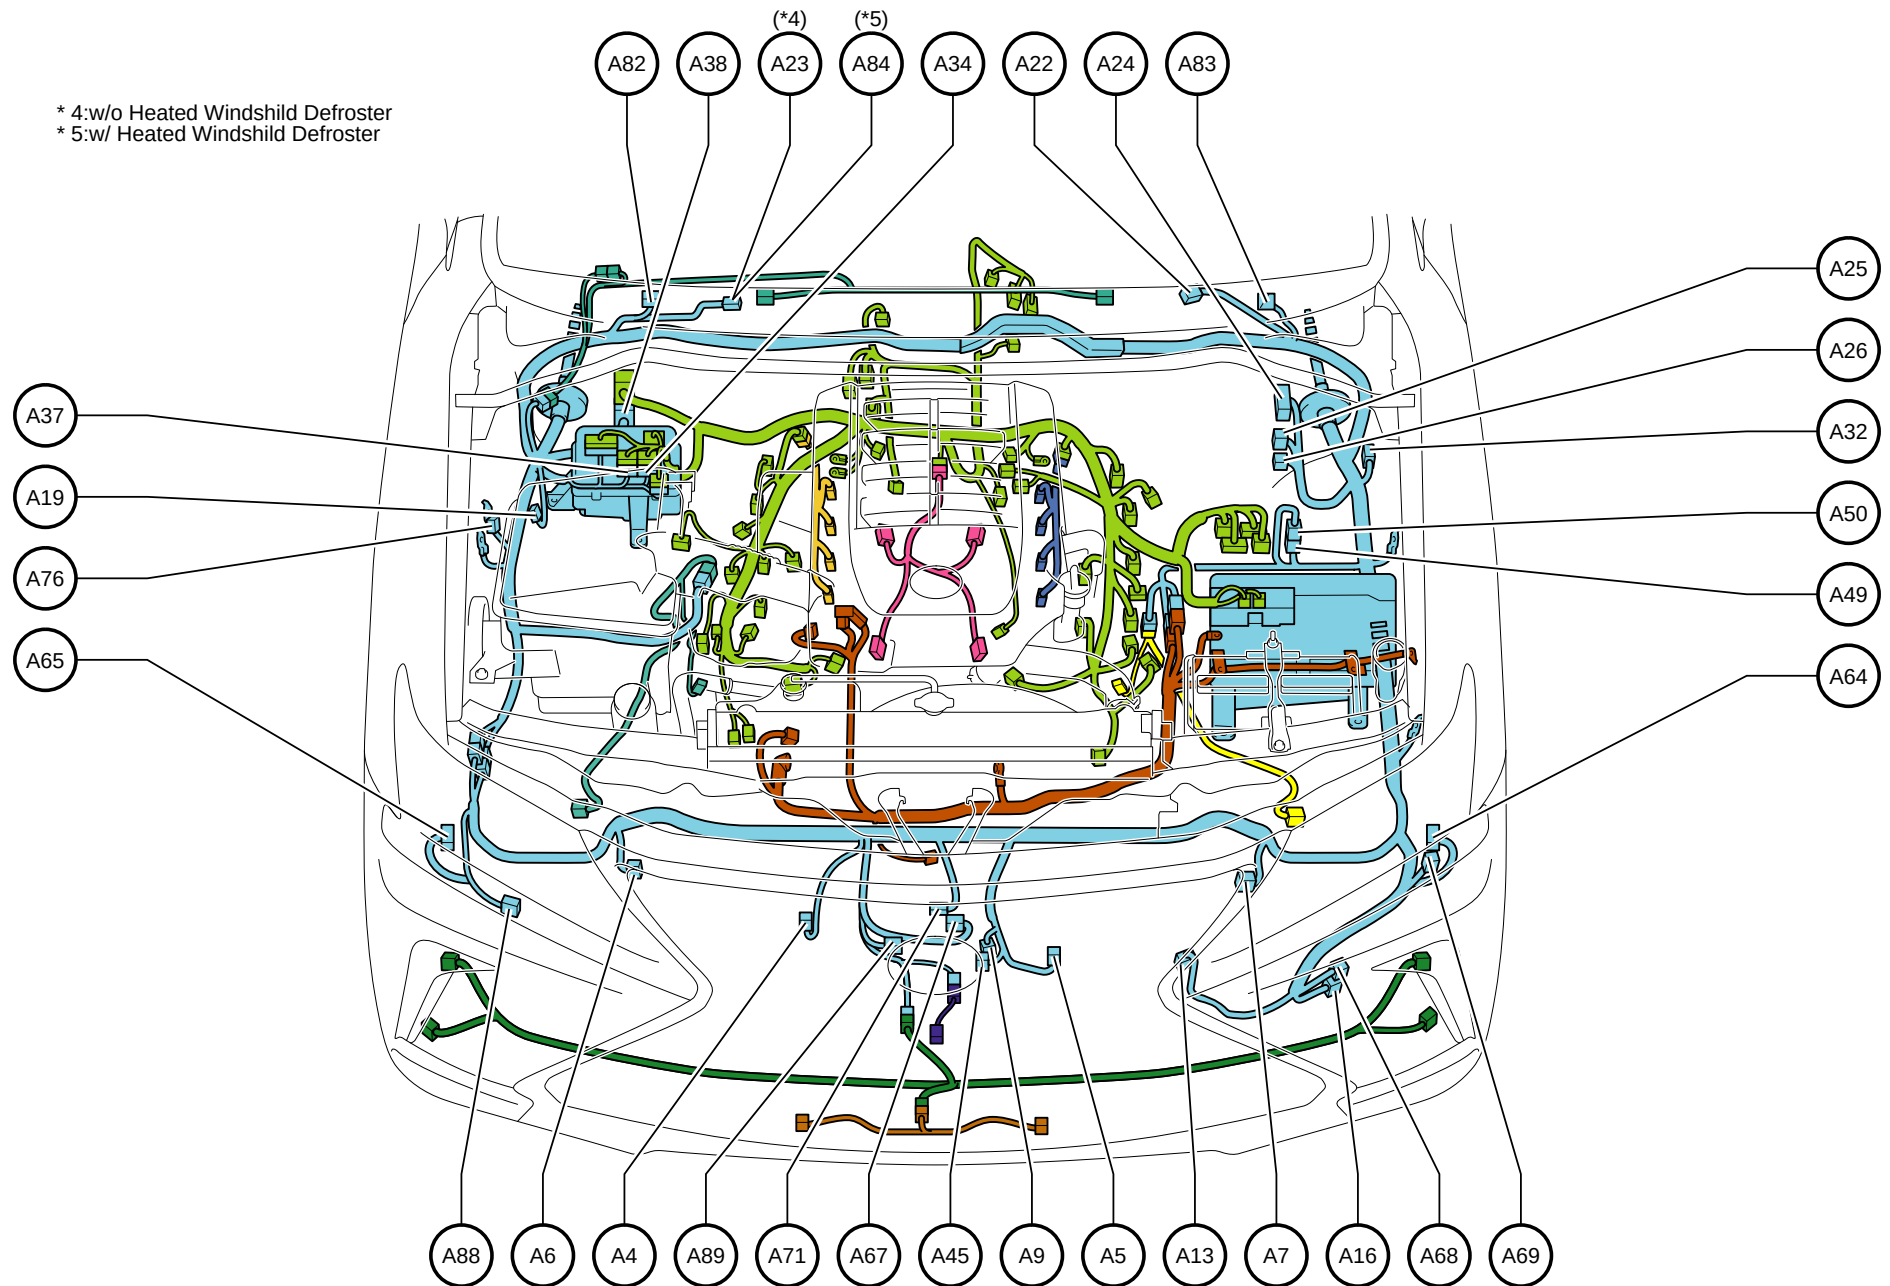
- A 4 High Pitched Horn Assembly
- A 5 Low Pitched Horn Assembly
- A 6 Front Airbag Sensor RH
- A 7 Front Airbag Sensor LH
- A 9 Condenser Blower Motor Assembly

- A 13 A/C Pressure Sensor
- A 16 Windshield Washer Motor and Pump Assembly
- A 19 Security Horn Assembly
- A 22 Windshield Wiper Motor Assembly
- A 23 Front Wiper Deicer (Windshield Glass)

- A 24 Skid Control ECU with Actuator Assembly
- A 25 Skid Control ECU with Actuator Assembly
- A 26 Brake Fluid Level Warning Switch (Brake Master Cylinder Reservoir Assembly)

- A 32 Noise Filter
- A 34 Junction Connector
- A 37 Junction Connector
- A 38 ECM
- A 45 Exhaust Gas Sensor
- A 49 Short Connector
- A 50 Short Connector
- A 64 Headlight ECU Sub-Assembly LH

- A 65 Headlight ECU Sub-Assembly RH
- A 67 Millimeter Wave Radar Sensor Assembly
- A 68 Headlight Cleaner Motor and Pump Assembly
- A 69 Wireless Door Lock Buzzer

- A 71 Hood Lock Assembly
- A 76 Junction Connector
- A 82 Heated Windshield Defroster (Windshield Glass)
- A 83 Heated Windshield Defroster (Windshield Glass)

- A 84 Heated Windshield Defroster (Windshield Glass)
- A 88 Front Tire Pressure Warning Antenna
- A 89 Cooler (Ambient Temperature Sensor) Thermistor
