| <b>DTC</b> | <b>B0138/72</b> | <b>Short in P/T Squib LH Circuit (to B+)</b> |

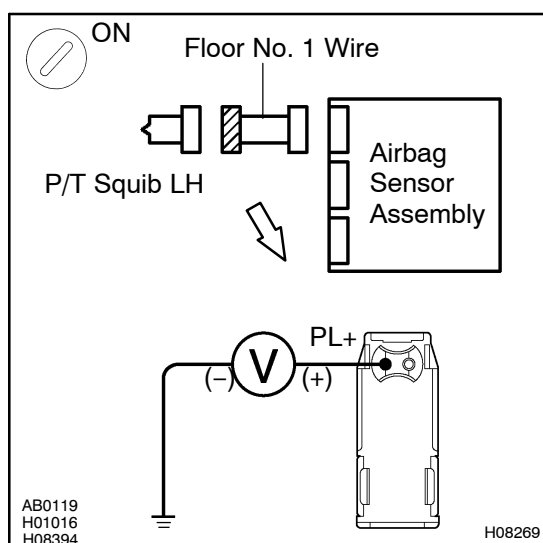
| <b>2</b> | <b>Check floor No. 1 wire (P/T squib LH circuit).</b> |

- Deactivate the LEXUS link system (See page DI-706).
- Connect the negative (-) terminal cable to the battery, and wait at least for 2 seconds.

- Turn the ignition switch to ON.
- Measure the voltage between the body ground and PL+ of the floor No. 1 wire connector on the seat belt pretensioner LH (P/T squib LH) side.

**Voltage: Below 1 V**

| <b>NG</b> | <b>Replace floor No. 1 wire.</b> |

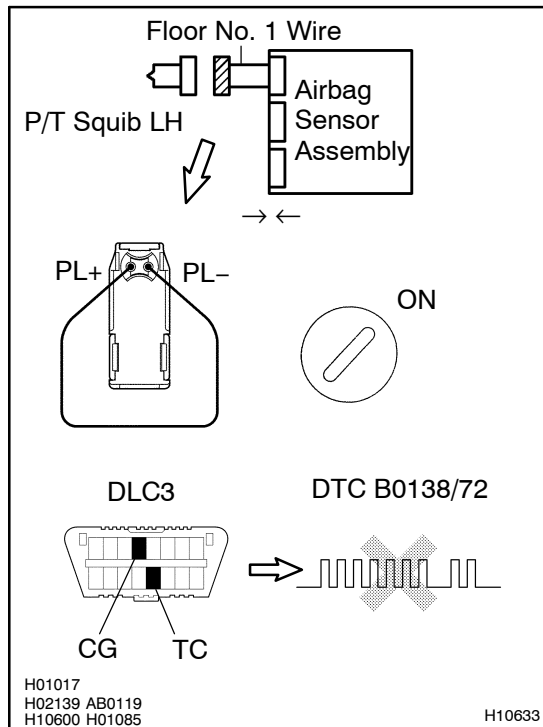
### 3 Check airbag sensor assembly.

- Connect the connector to the airbag sensor assembly.
- Using a service wire, connect PL+ and PL- of the floor No. 1 wire connector on the seat belt pretensioner LH (P/T squib LH) side.
- Connect the negative (-) terminal cable to the battery, and wait at least for 2 seconds.

- Turn the ignition switch to ON, and wait at least for 10 seconds.
- Clear the DTC stored in memory (See page [DI-706](#)).
- Turn the ignition switch to LOCK, and wait at least for 10 seconds.
- Turn the ignition switch to ON, and wait at least for 10 seconds.
- Check the DTC (See page [DI-706](#)).

**DTC B0138/72 is not output.**

**Replace airbag sensor assembly.**

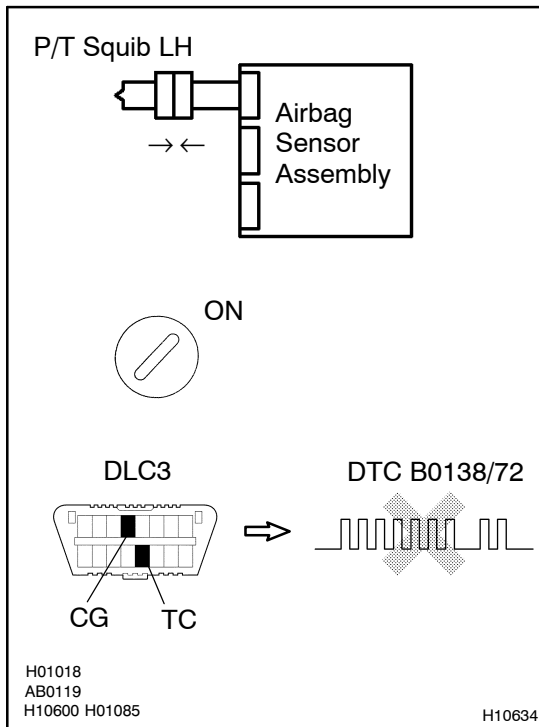
## 4 Check P/T squib LH.

- Turn the ignition switch to LOCK.
- Disconnect the negative (-) terminal cable from the battery, and wait at least for 90 seconds.
- Connect the seat belt pretensioner LH (P/T squib LH) connector.
- Connect the negative (-) terminal cable to the battery, and wait at least for 2 seconds.

- Turn the ignition switch to ON, and wait at least for 10 seconds.
- Clear the DTC stored in memory (See page [DI-706](#)).
- Turn the ignition switch to LOCK, and wait at least for 10 seconds.
- Turn the ignition switch to ON, and wait at least for 10 seconds.
- Check the DTC (See page [DI-706](#)).

**DTC B0138/72 is not output.**

**Replace seat belt pretensioner LH (P/T squib LH).**
