# REAR HEATER RELAY INSPECTION

AC3PG-01

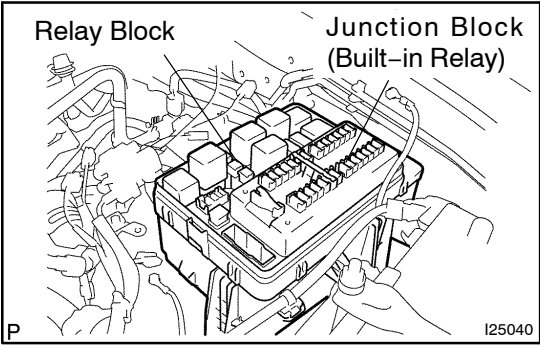
**HINT:**  
The rear heater relay is built in the engine room junction block. Since the relay is constructed with a relay block that is in the junction block as a unit, it is impossible to disconnect the wire harness connecting with the relay block.  
If the relay has a malfunction, replace it with the junction block assembly wireharness together.

- 1. REMOVE ENGINE ROOM J/B
- 2. INSPECT REAR HEATER RELAY CONTINUITY

| Condition | Tester connection | Specified condition |
| Constant | 29 – 31 | Continuity |
| Apply B+ between terminals 29 and 31. | 2 – 3 | Continuity |

If continuity is not as specified, replace the engine room J/B.
