| <b>DTC</b> | <b>B0135/73</b> | <b>Short in P/T Squib LH Circuit</b> |

## CIRCUIT DESCRIPTION

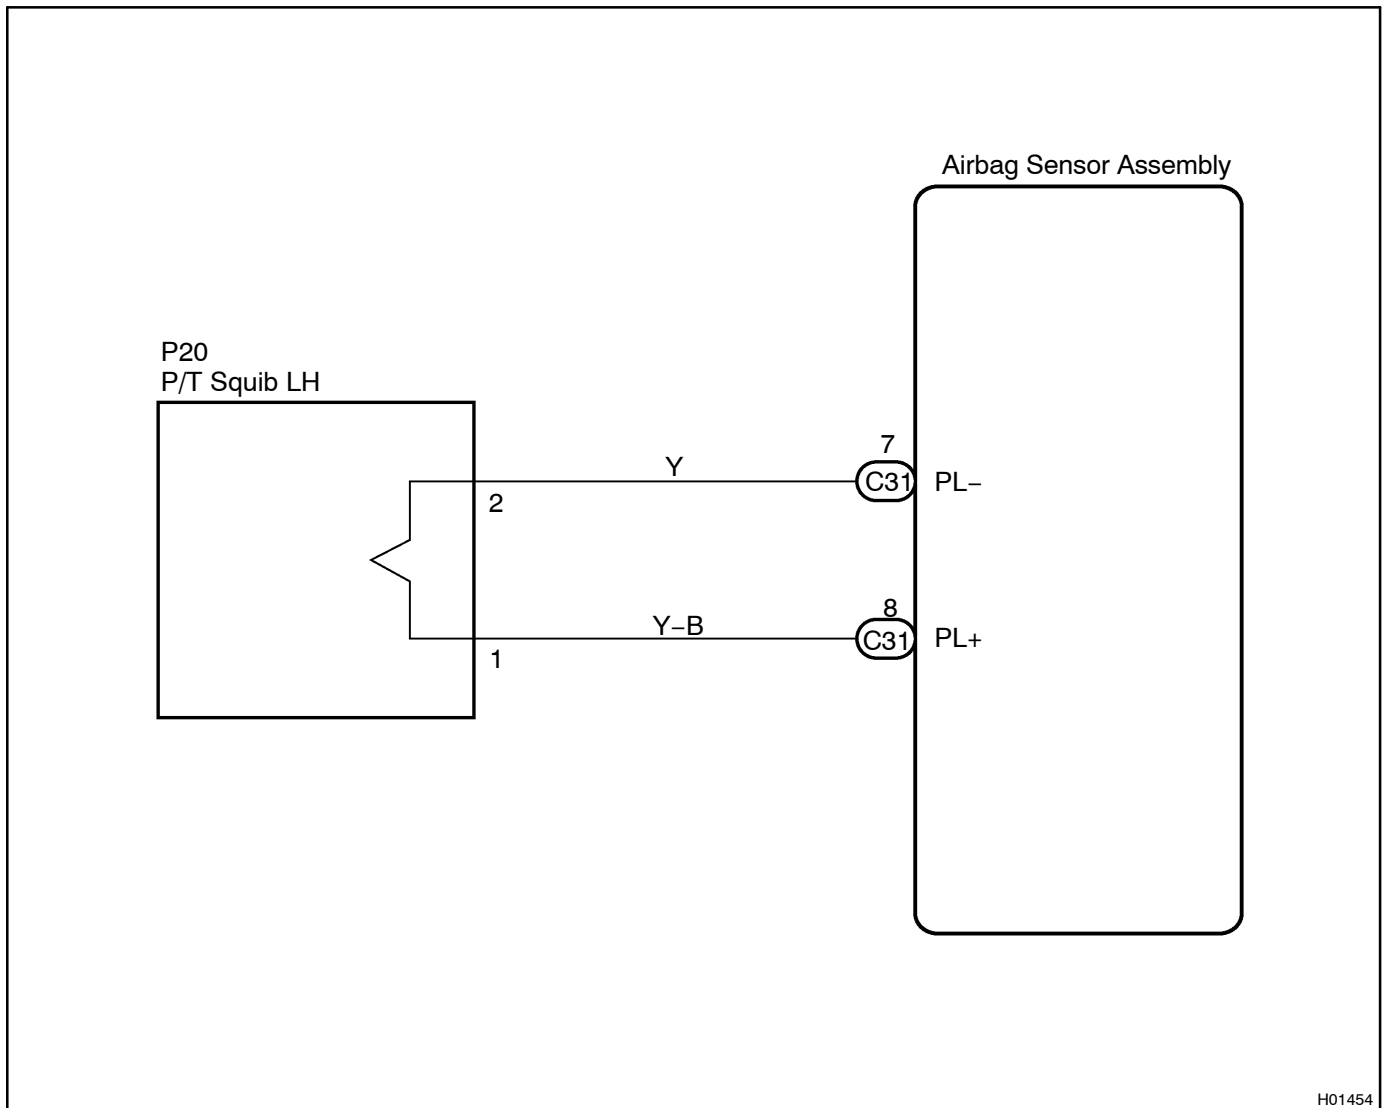
H01454

The P/T squib LH circuit consists of the airbag sensor assembly and the seat belt pretensioner LH. It causes the SRS to deploy when the SRS deployment conditions are satisfied. For details of the function of each component, see OPERATION on page [RS-3](#). DTC B0135/73 is recorded when a short is detected in the P/T squib LH circuit.

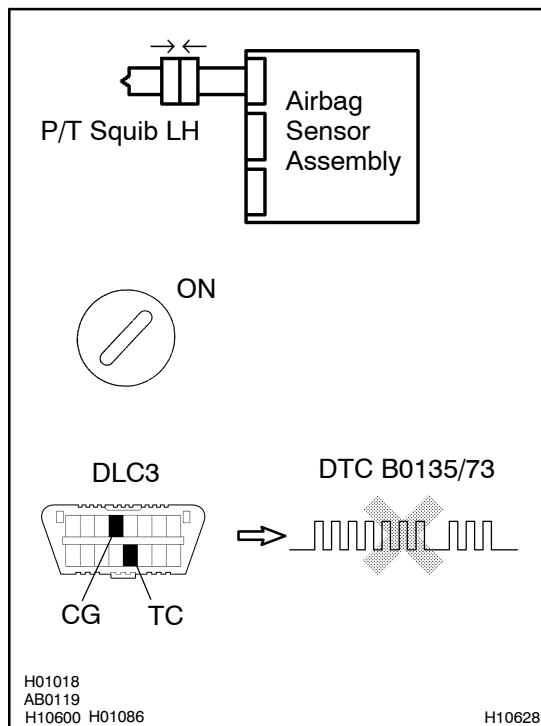
- Turn the ignition switch to LOCK.
- Disconnect the negative (-) terminal cable from the battery, and wait at least for 90 seconds.
- Connect the seat belt pretensioner LH (P/T squib LH) connector.
- Connect the negative (-) terminal cable to the battery, and wait at least for 2 seconds.

- Turn the ignition switch to ON, and wait at least for 10 seconds.
- Clear the DTC stored in memory (See page [DI-876](#)).
- Turn the ignition switch to LOCK, and wait at least for 10 seconds.
- Turn the ignition switch to ON, and wait at least for 10 seconds.
- Check the DTC (See page [DI-876](#)).

**DTC B0135/73 is not output.**

**Replace seat belt pretensioner LH (P/T squib LH).**
