| <b>DTC</b> | <b>B0138/72</b> | <b>Short in P/T Squib LH Circuit (to B+)</b> |

## CIRCUIT DESCRIPTION

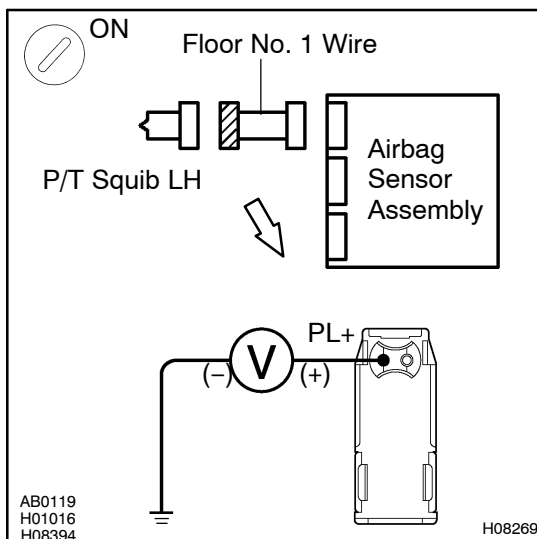
| <b>2</b> | <b>Check floor No. 1 wire (P/T squib LH circuit).</b> |

- Turn the ignition switch to ON.
- Measure the voltage between the body ground and PL+ of the floor No. 1 wire connector on the seat belt pretensioner LH (P/T squib LH) side.

**Voltage: Below 1 V**

**Replace floor No. 1 wire.**

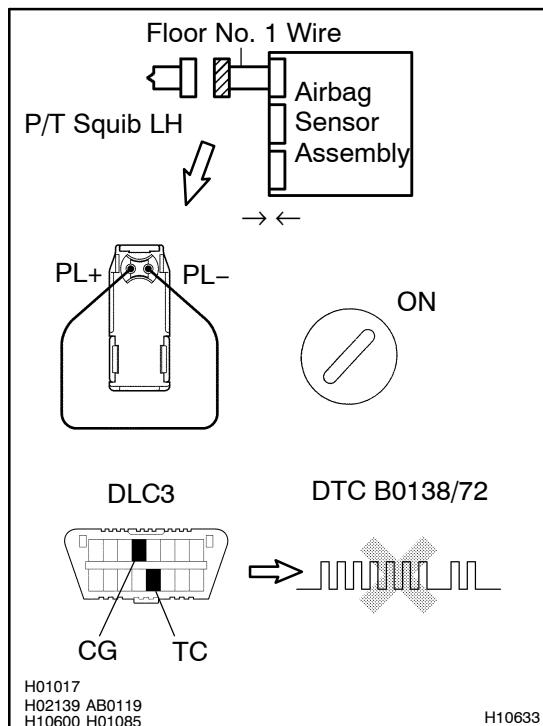
### 3 Check airbag sensor assembly.

- Connect the connector to the airbag sensor assembly.
- Using a service wire, connect PL+ and PL- of the floor No. 1 wire connector on the seat belt pretensioner LH (P/T squib LH) side.
- Connect the negative (-) terminal cable to the battery, and wait at least for 2 seconds.

- Turn the ignition switch to ON, and wait at least for 10 seconds.
- Clear the DTC stored in memory (See page [DI-876](#)).
- Turn the ignition switch to LOCK, and wait at least for 10 seconds.
- Turn the ignition switch to ON, and wait at least for 10 seconds.
- Check the DTC (See page [DI-876](#)).

**DTC B0138/72 is not output.**

**Replace airbag sensor assembly.**

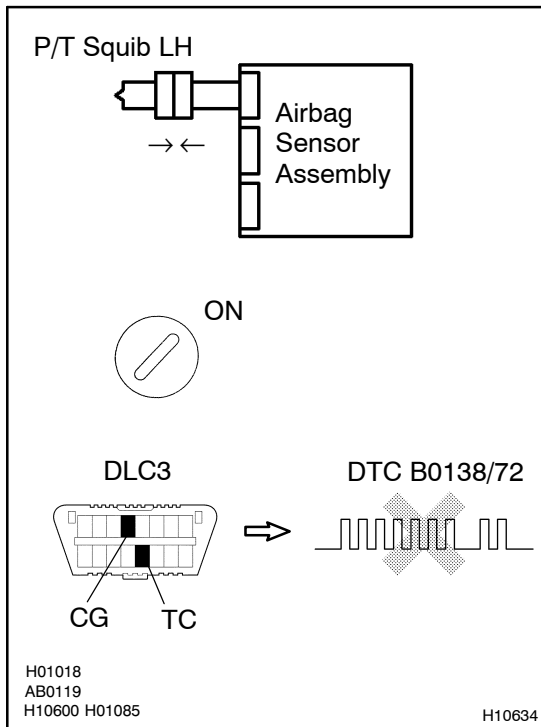
**Check P/T squib LH.**

- Turn the ignition switch to LOCK.
- Disconnect the negative (-) terminal cable from the battery, and wait at least for 90 seconds.
- Connect the seat belt pretensioner LH (P/T squib LH) connector.
- Connect the negative (-) terminal cable to the battery, and wait at least for 2 seconds.

- Turn the ignition switch to ON, and wait at least for 10 seconds.
- Clear the DTC stored in memory (See page [DI-876](#)).
- Turn the ignition switch to LOCK, and wait at least for 10 seconds.
- Turn the ignition switch to ON, and wait at least for 10 seconds.
- Check the DTC (See page [DI-876](#)).

**OK:****DTC B0138/72 is not output.****HINT:**

**NG****Replace seat belt pretensioner LH (P/T squib LH).****OK**
