| <b>DTC</b> | <b>B0135/73</b> | <b>Short in P/T Squib LH Circuit</b> |

## CIRCUIT DESCRIPTION

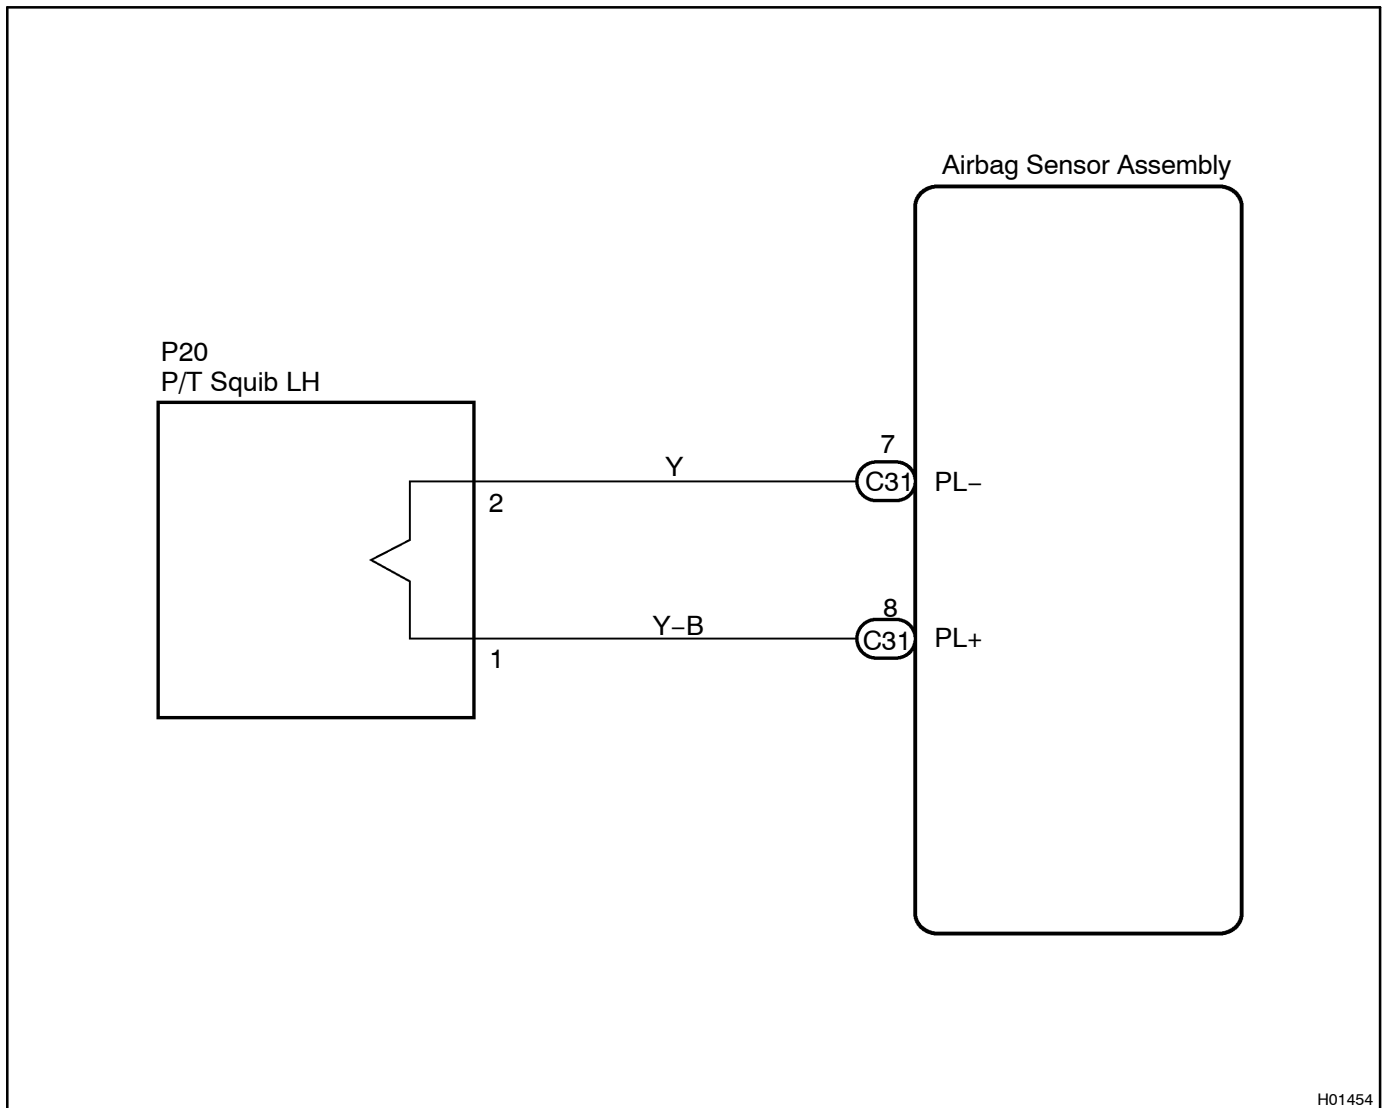
H01454

The P/T squib LH circuit consists of the airbag sensor assembly and the seat belt pretensioner LH. It causes the SRS to deploy when the SRS deployment conditions are satisfied. For details of the function of each component, see OPERATION on page [RS-3](#). DTC B0135/73 is recorded when a short is detected in the P/T squib LH circuit.
