# Position of Parts in Instrument Panel (RHD)

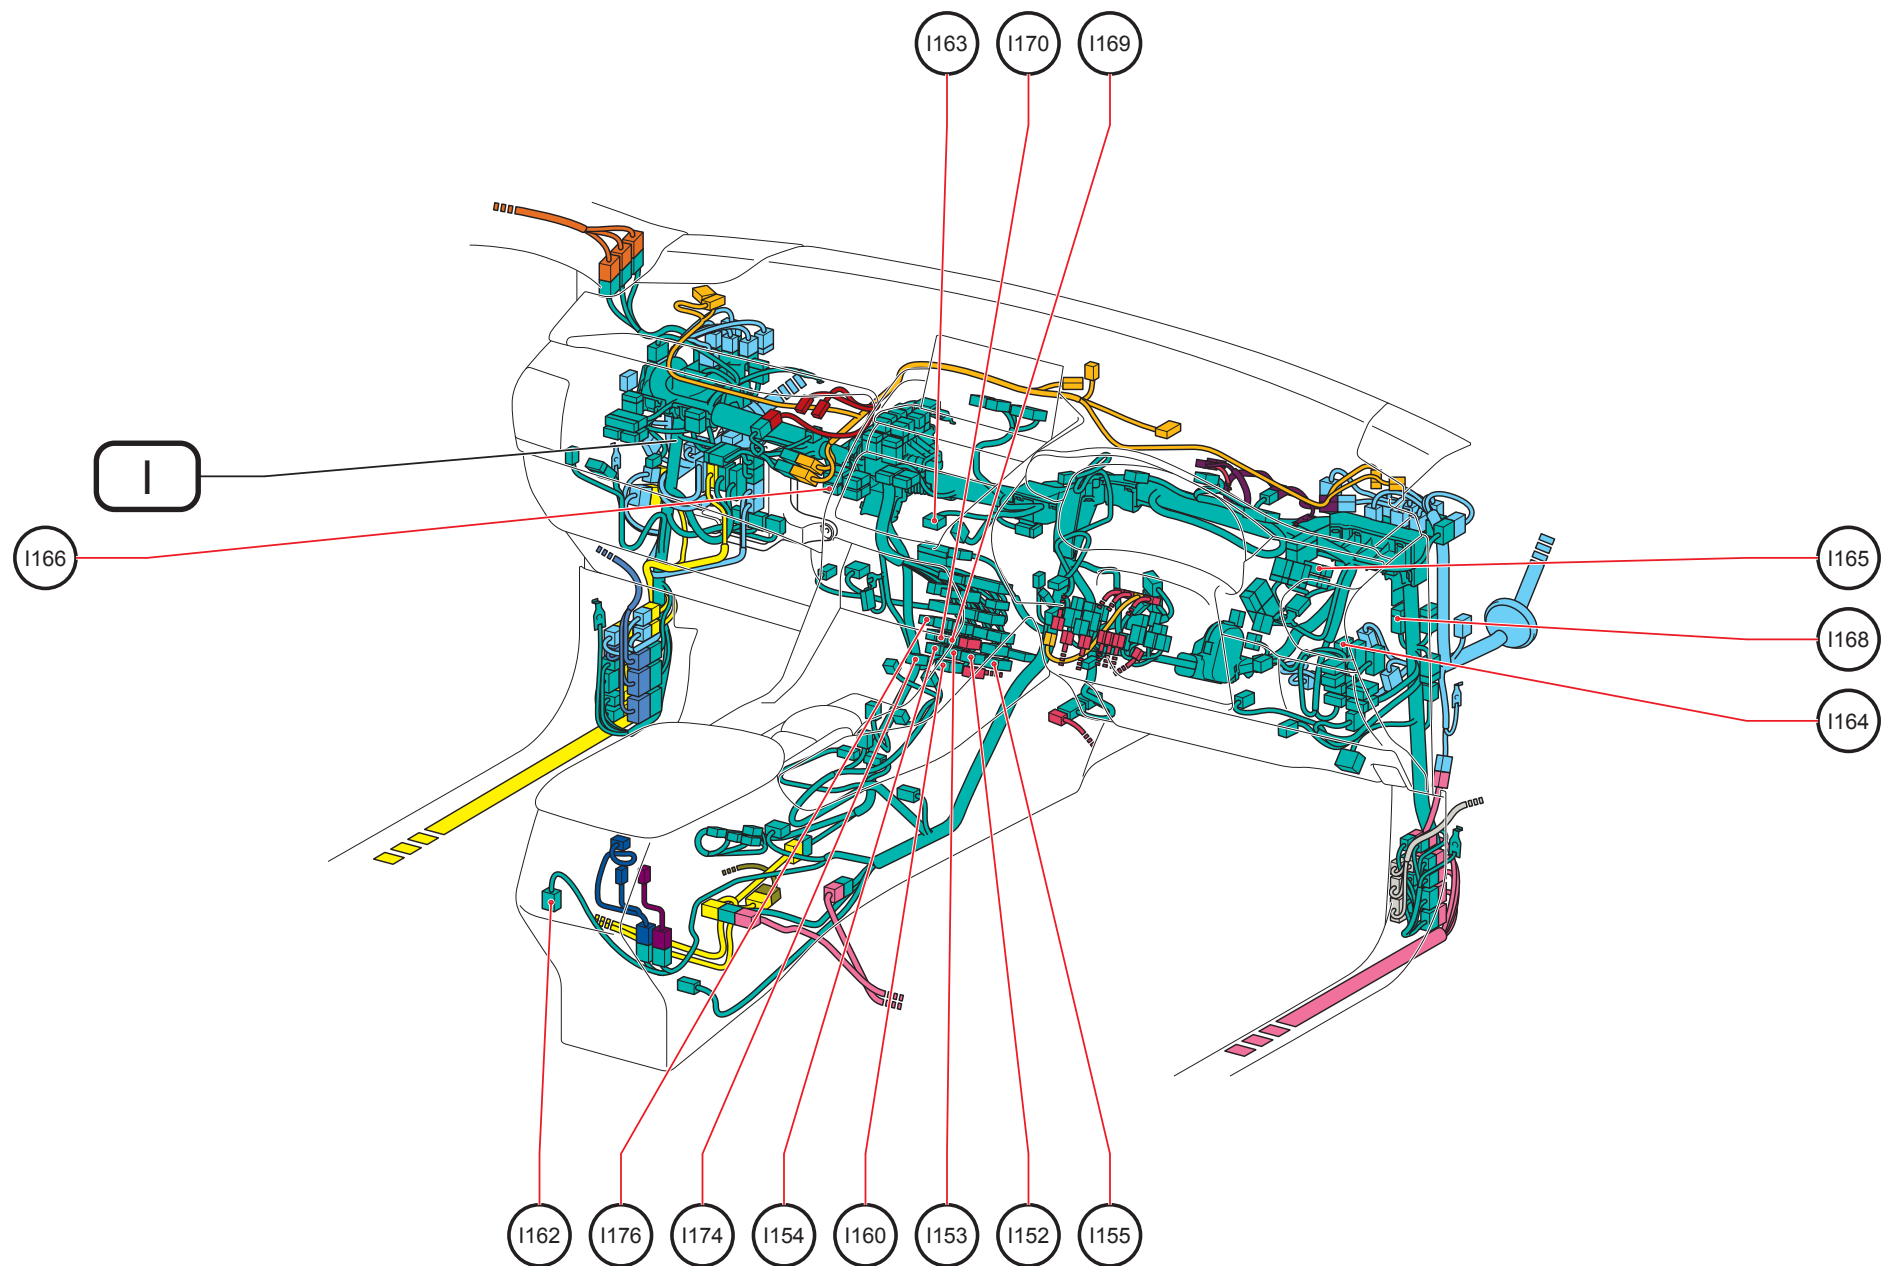
| I152 | Radio Receiver Assembly |
| I153 | Radio Receiver Assembly |
| I154 | Radio Receiver Assembly |
| I155 | Radio Receiver Assembly |
| I160 | Navigation ECU |
| I162 | Refreshing Seat Switch |
| I163 | Clock Assembly (Air Conditioning Control Assembly) |
| I164 | Network Gateway ECU |
| I165 | No. 9 CAN Junction Connector |
| I166 | No. 10 CAN Junction Connector |
| I168 | No. 12 CAN Junction Terminal |
| I169 | Radio Receiver Assembly |
| I170 | Radio Receiver Assembly |
| I174 | Radio Receiver Assembly |
| I176 | Navigation ECU |

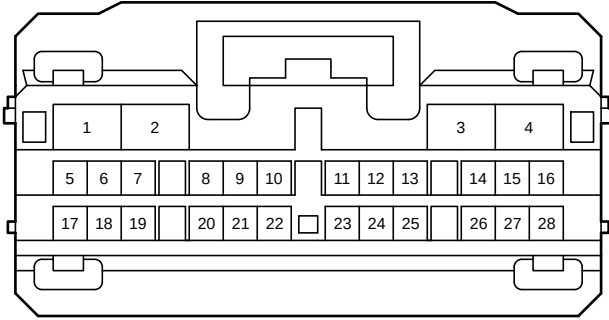
I152  
Gray

82824-52380

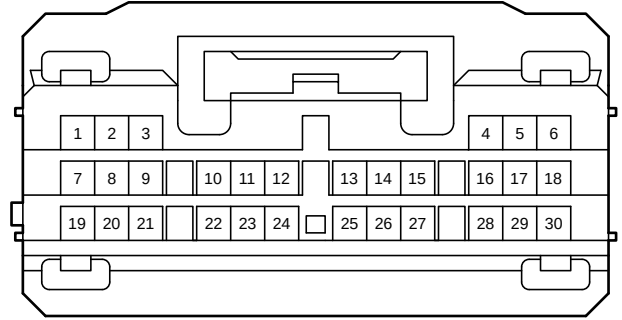
I153  
Black

90980-12761

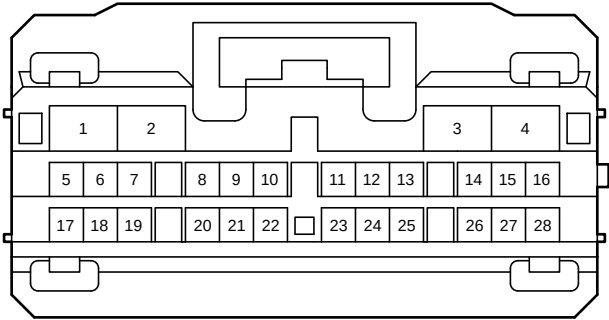
I154  
White

90980-12760

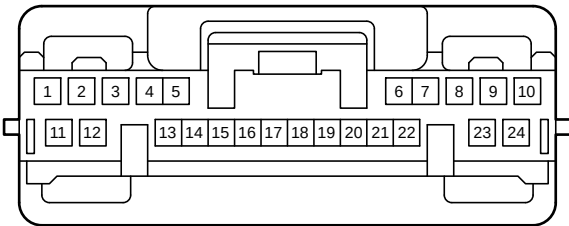
I160  
Black

90980-12912

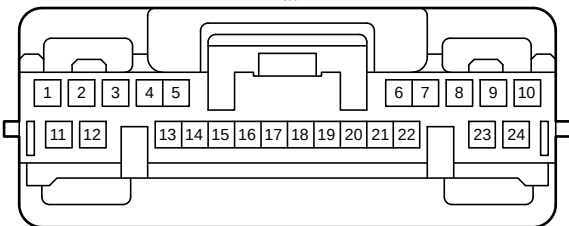
I164  
Black

90980-12912

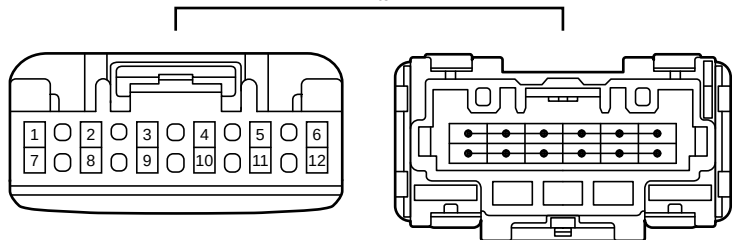
I165  
White

90980-12C68

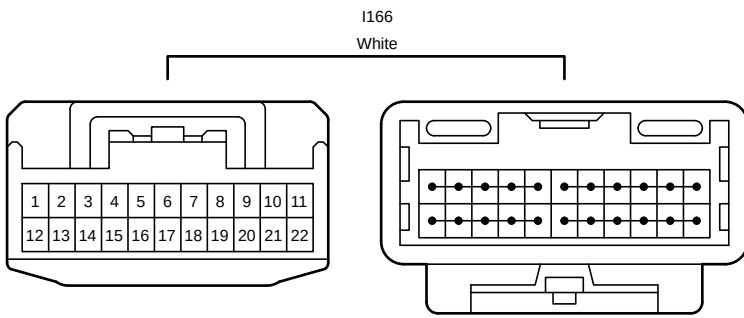
90980-12372  
(Before May 2018 Production, RHD From May 2018 Production)

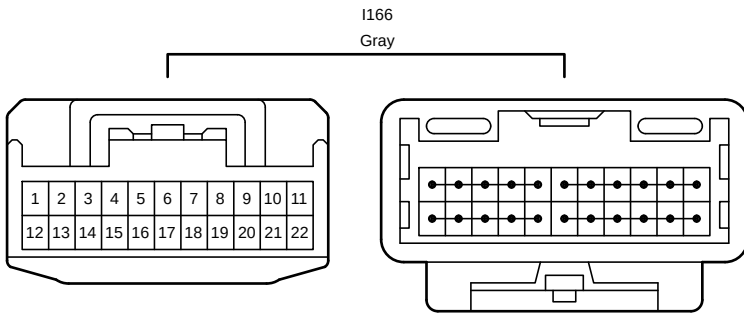
90980-12372  
(LHD From May 2018 Production)
