SERVICE BULLETIN

SERVICE BULLETIN		No.: MSB-97E26-001 REV	
		Date: 1997-12-05	<Model> <M/Y>
Subject:	CHANGE OF FRONT ROTOR FOR ABS EQUIPPED VEHICLES (REVICED)	(EC,EXP) L400 (PA0V)	97-10 97-10
Group:	FRONT AXLE	Draftno: 96-SY-18	(EC,EXP) PAJERO (V10,V20,V30,V40)
INFORMATION	OVERSEAS SERVICE DEPT

1. Description:

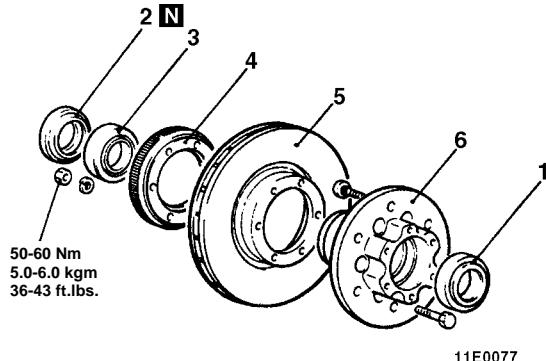
11E0077

<Vehicles built up to May, 1994>

<Deleted>

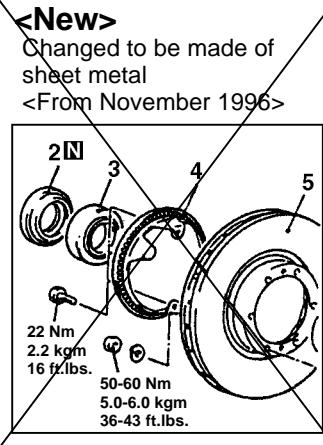
Changed to be made of sheet metal
<From November 1996>

- (1) The front rotor has been changed to that made of sheet metal. Accordingly, bearing surface has been added to the brake disc.
- (2) The number of bolts used for mounting the front rotor has been changed from 2 to 4. Accordingly, the bolt holes have been added to the bearing surface of the brake disc.

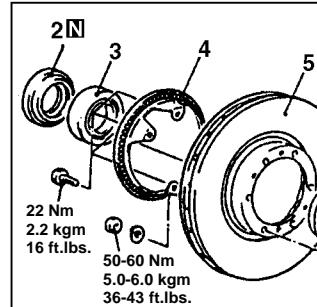
Two bolts changed to four bolts
<From November 1996>

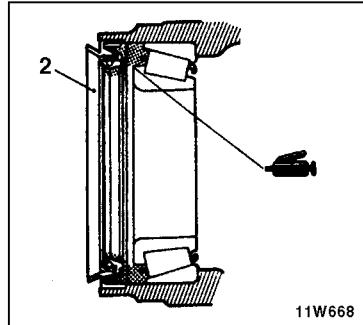
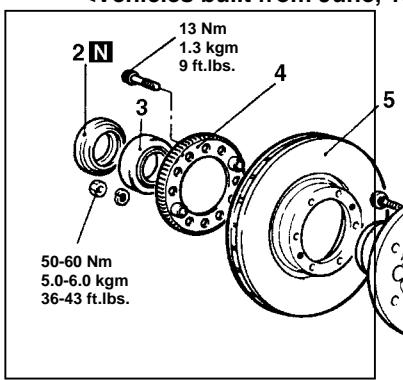
<Added>

Up to October 1996

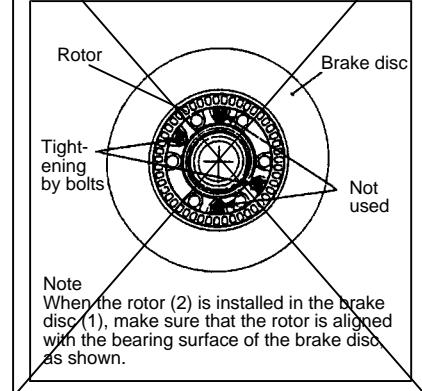
<From November 1996>
