# SERVICE BULLETIN

| Classification:<br>EM94-007 | Section:<br>Engine | Models:<br>Various |

## VG30 ENGINE OIL DIP STICK CAUTION

**APPLIED MODELS:** All VG30i/E or VG30DE equipped models

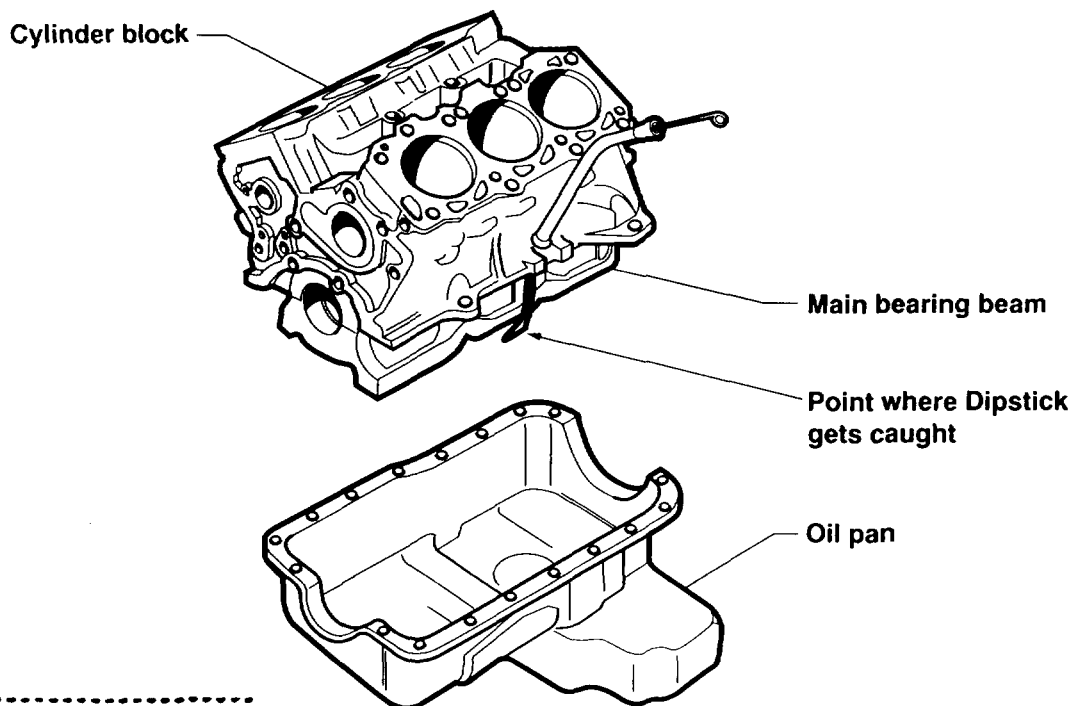
When performing any service that requires removal of the oil pan, always remove the dip stick before replacing the oil pan. If the dip stick is left in the engine the end of it may become caught between the main bearing beam and the windage tray of the oil pan. The only way to remove the dip stick after it has been caught is to remove the oil pan.
