**SUBARU**

## SERVICE BULLETIN

**APPLICABILITY:** All Models  
**SUBJECT:** Cylinder Head Gasket (residual carbon deposits and rubber coating removal)

**NUMBER:** 02-100-06R  
**DATE:** 10/31/06

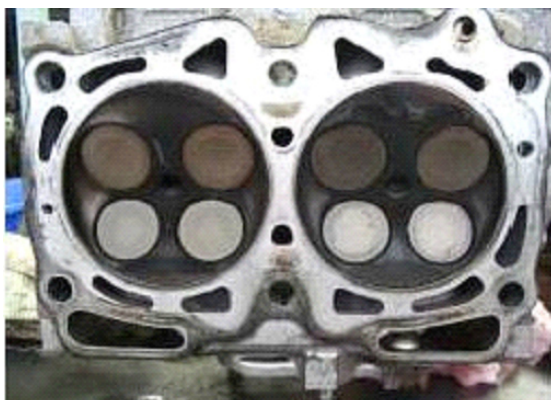
Removed Cylinder Head

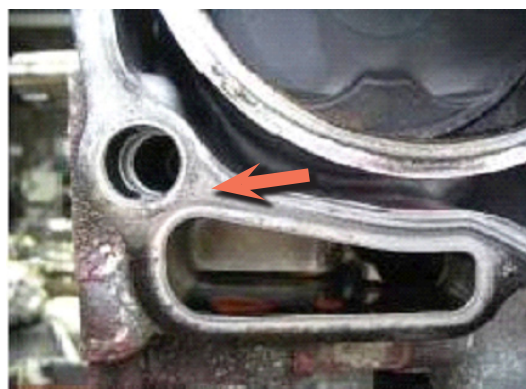
Using a gasket scraper, carefully clean any carbon deposits and rubber coating found on the surface of cylinder block and cylinder head.

**CAUTION:** Keep the scraper as flush as possible to the surface to avoid damage to the mating surface of cylinder block and cylinder head.

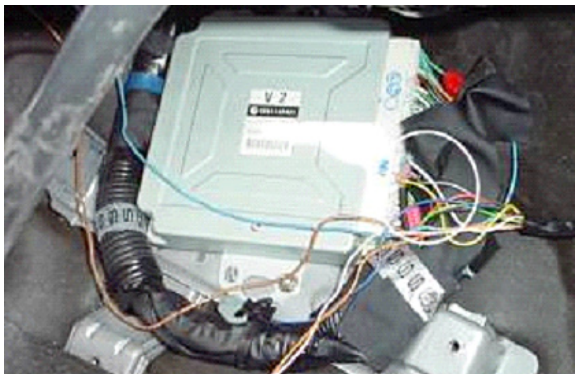
Aftermarket Air Fuel Controller wired to ECM

Modifying the engine tuning of a Subaru to increase horse power by Engine Control Unit (ECU) replacement or reprogramming can lead to engine failures. Other external engine modifications, such as intake or exhaust systems, can also lead to failures. Any modifications can reduce engine durability and cause reliability deterioration.

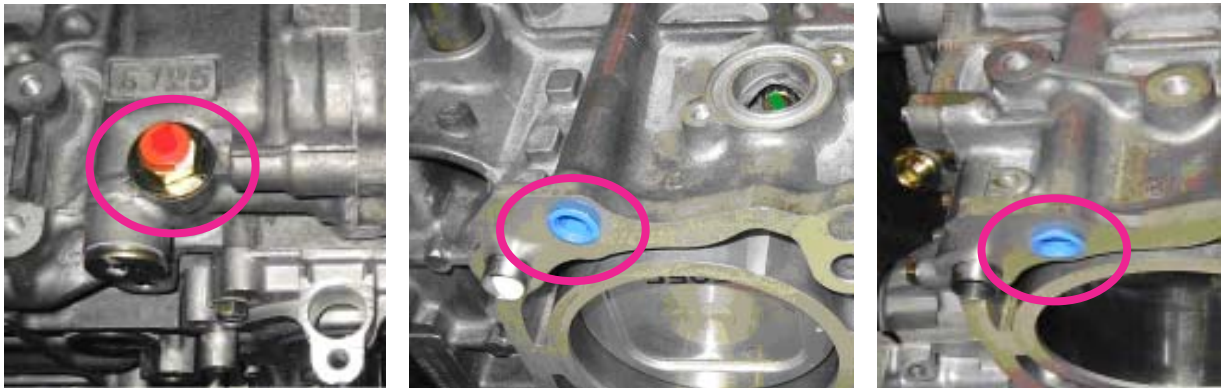
Be sure to remove the three plastic transit plugs (shown below) prior to installation. One is located in the oil pressure switch plug. The others are in the main oil gallery ports that feed each head.

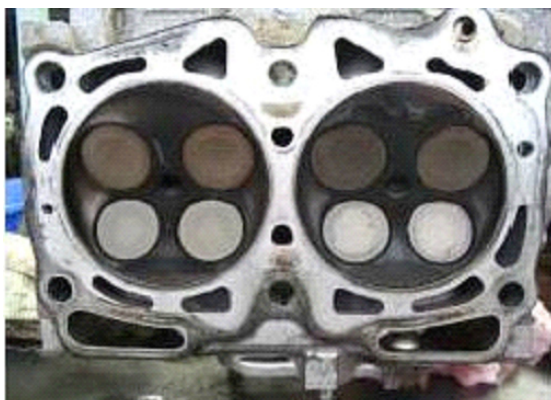
Removed Cylinder Head

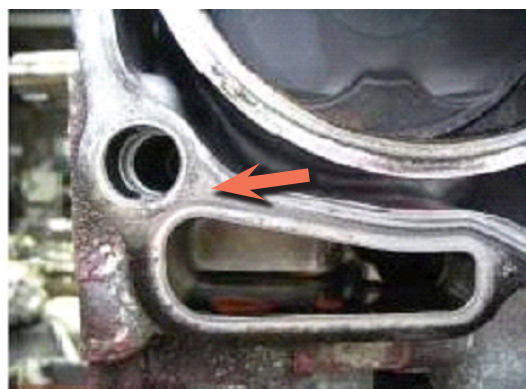
Using a gasket scraper, carefully clean any carbon deposits and rubber coating found on the surface of cylinder block and cylinder head.

**CAUTION:** Keep the scraper as flush as possible to the surface to avoid damage to the mating surface of cylinder block and cylinder head.
