SERVICE BULLETIN

APPLICABILITY: 2005MY and later Legacy / Outback
2006MY and later Tribeca

NUMBER: 10-77-08
DATE: 11/24/08

SUBJECT: Water Leak from A/C Evaporator
Drain Hose

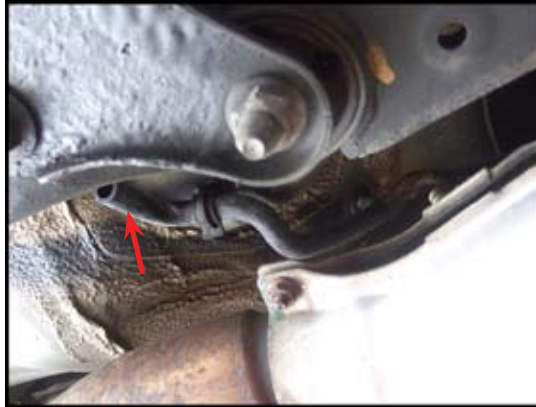
Evaporator Hose

Hose Modification

By cutting the hose to a shorter length, it helps prevent spiders from crawling from the control arm to the hose end.

- Cut off the end of the hose (engine compartment side) to the following specification:
 - Legacy / Outback – 10mm
 - Tribeca – 25mm

Note: For Tribeca models, if an orifice was installed following Service Bulletin #10-76-06, remove the orifice, cut the hose, and reinstall the orifice.
