## 5. Body Sealing

# Body Sealing

## BODY STRUCTURE

- Common for wagon and sedan model

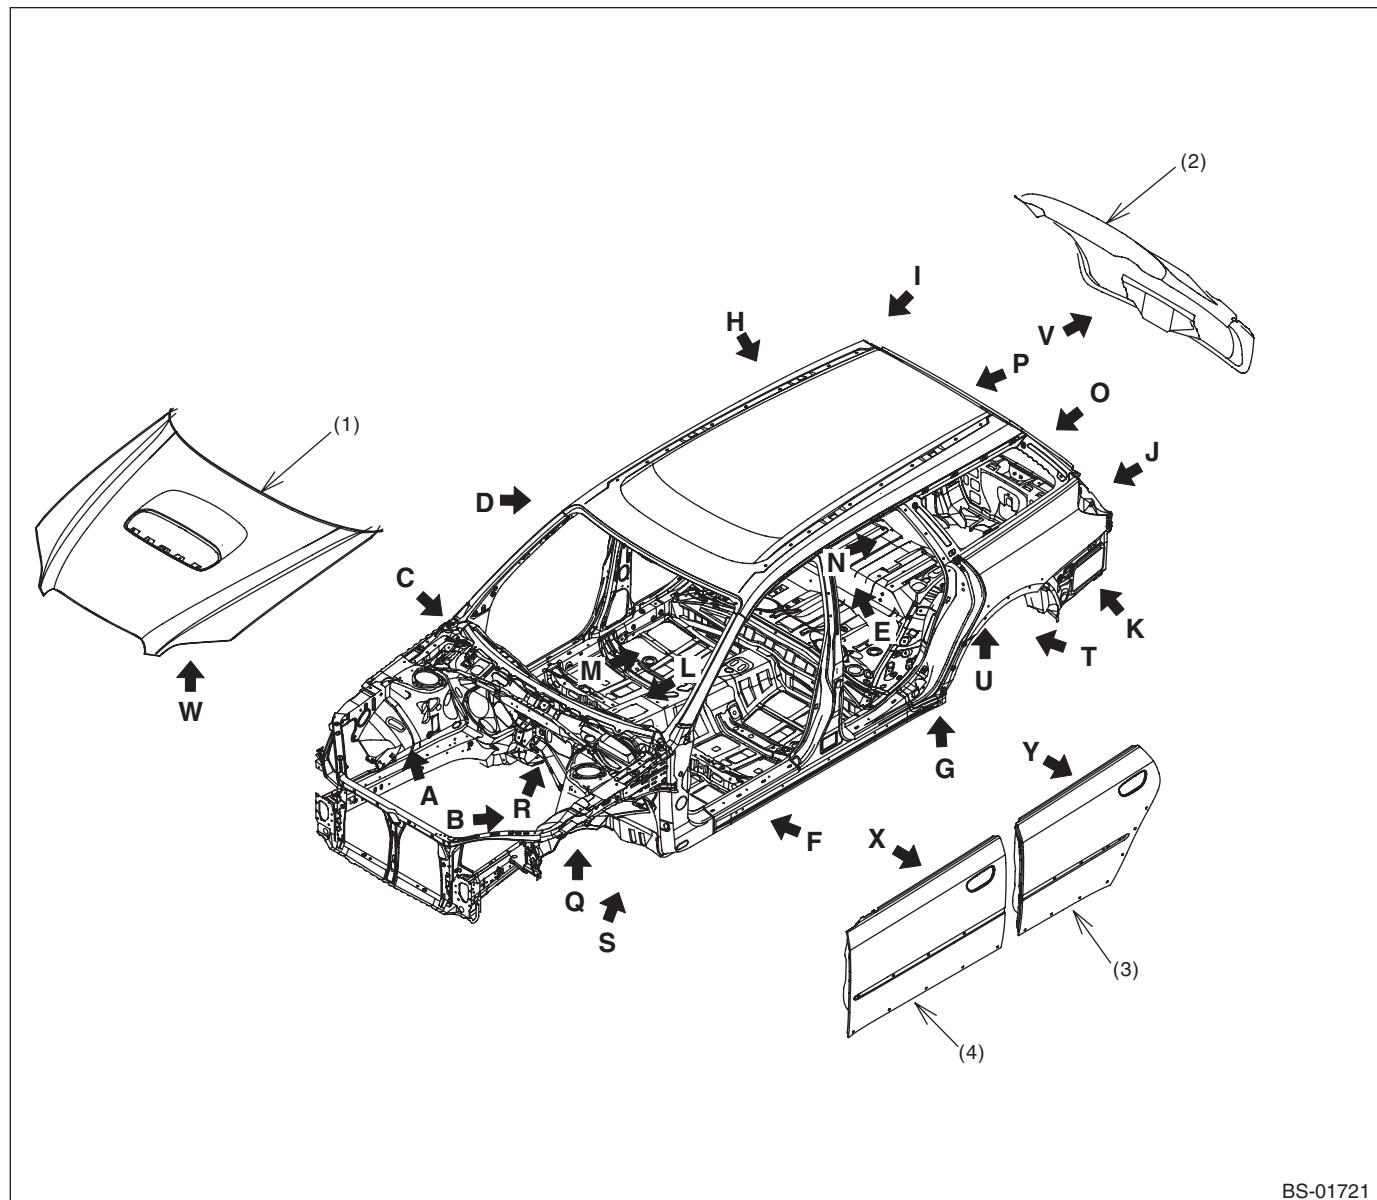
BS-01721

(1) Front hood  
(2) Rear gate

(3) Rear door

(4) Front door

Sealer already has been applied to hood, door, and rear gate in replacement condition.

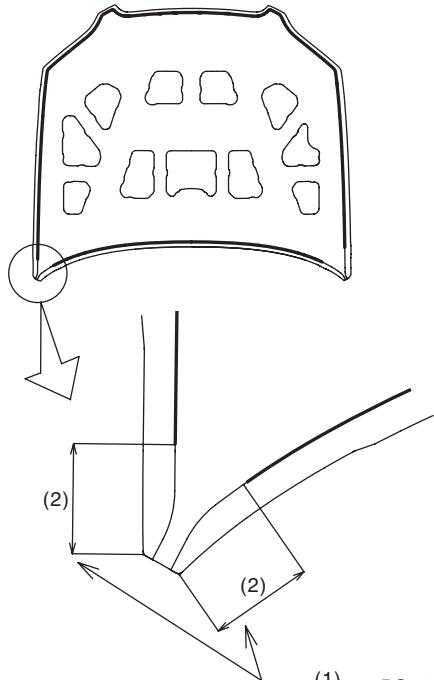
View W

BS-01436

(1) Application not required.

(2) 50 mm (1.97 in)

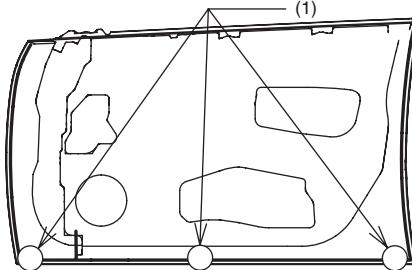
View X

BS-00754

(1) Do not block the water drain holes.

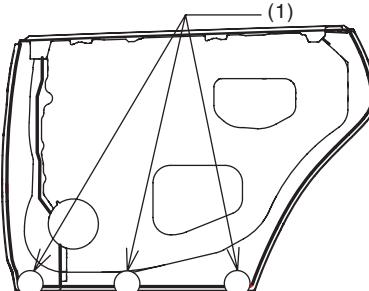
View Y

BS-00755

(1) Do not block the water drain holes.

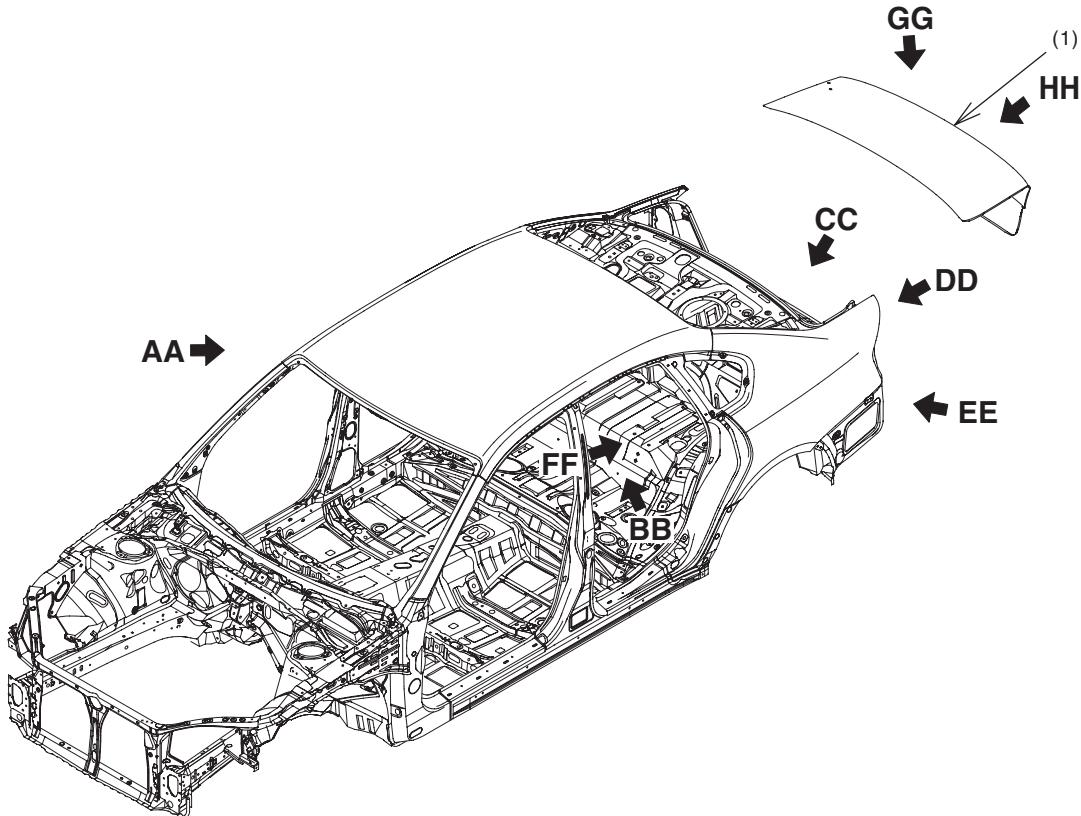
BS-00757

- Sedan model

(1) Trunk

**CAUTION:**  
Sealer already has been applied to the trunk in replacement condition.
