## 6. Pipe Assembly

## POWER ASSISTED SYSTEM (POWER STEERING)

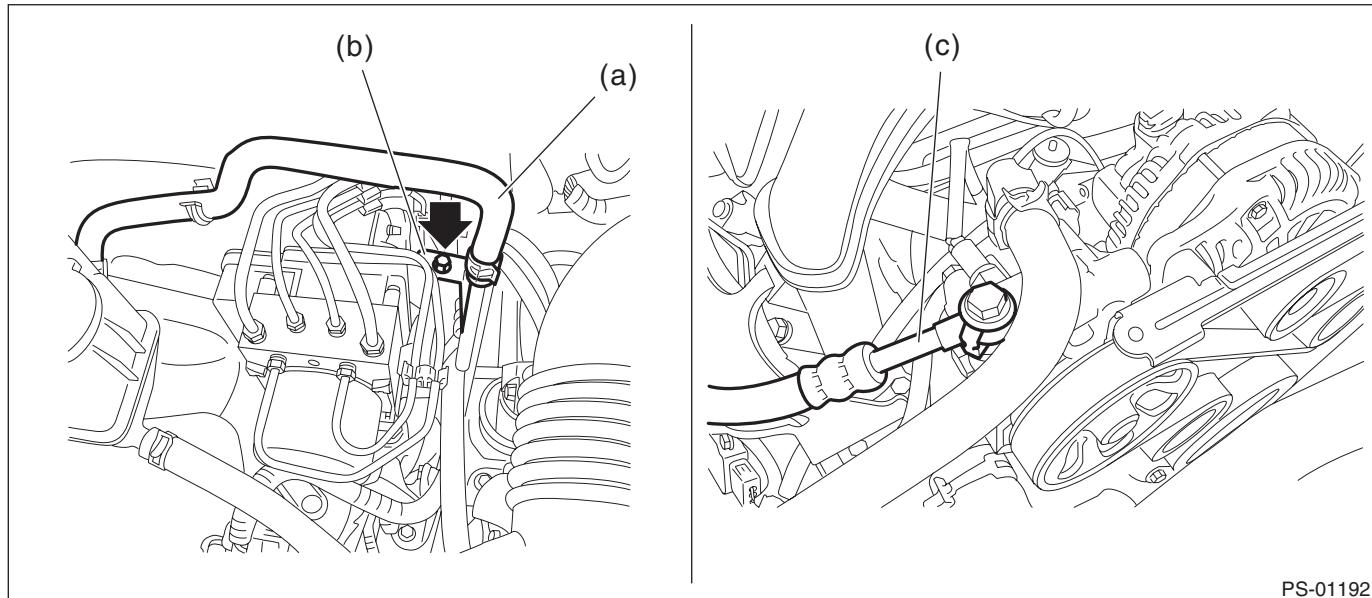
- (1) Remove the clip and disconnect the hose (a) from the pipe.
- (2) Remove the power steering hose bracket (b).
- (3) Remove the hose (c) from power steering pump.

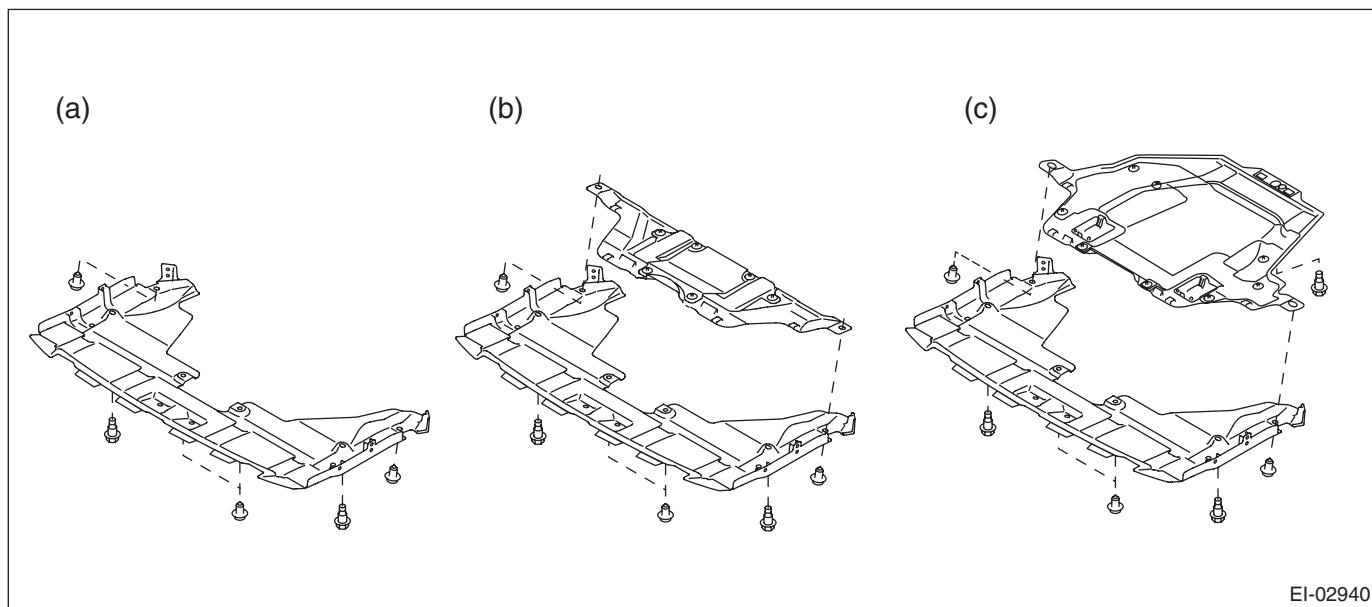
- 3) Lift up the vehicle, and then remove the under cover.

(a) Small type

(b) Medium type

(c) Large type

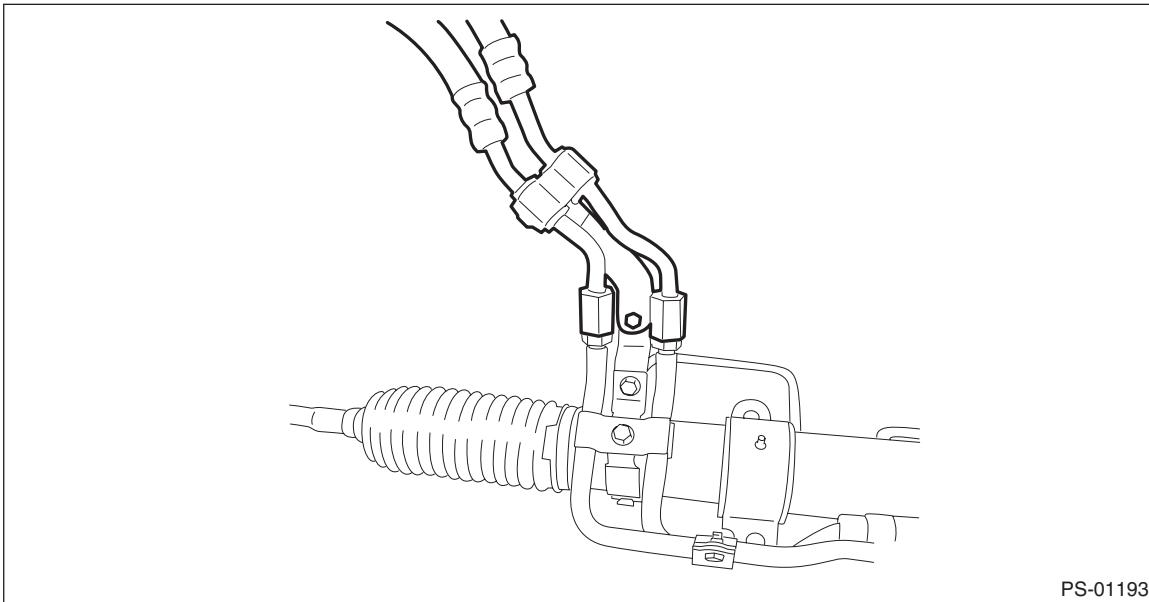
- 4) Disconnect the hose assembly from the steering gearbox.

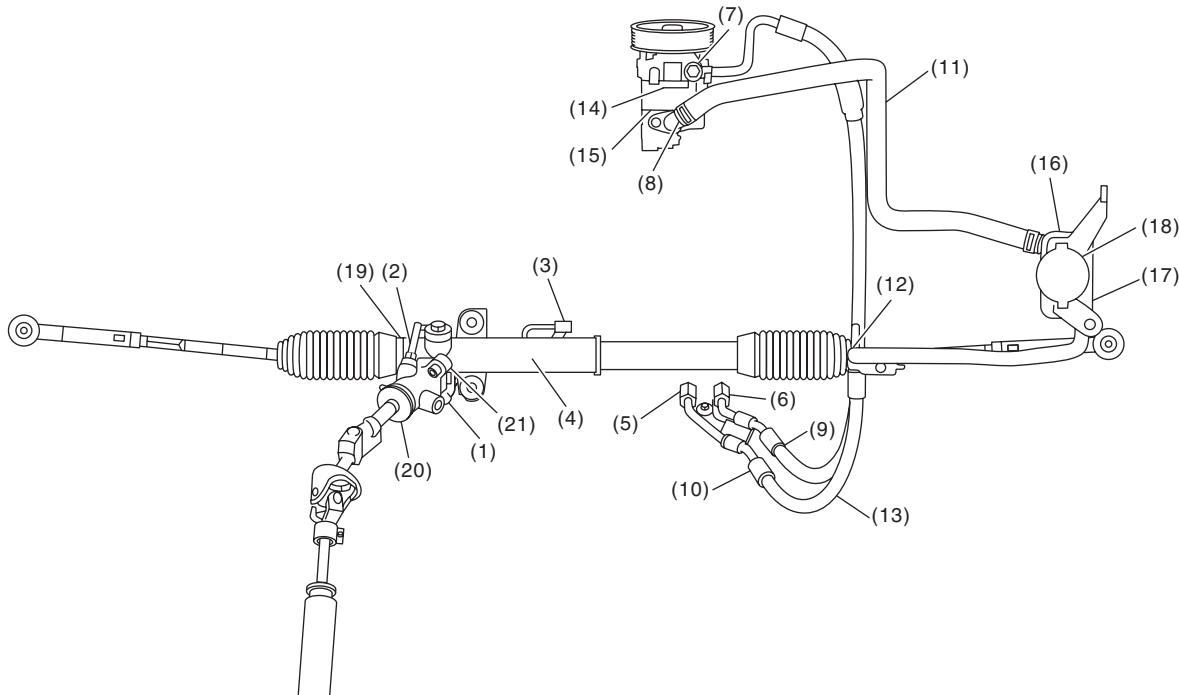
PS-01069

Fluid leaking area	Possible cause	Corrective action
Leakage from the connections of pipes and hoses, numbered (1) through (8) in the figure	Insufficient tightening of flare nut, adhesion of dirt, damage to flare or flare nut or eye bolt	Loosen and retighten. Replace if ineffective.
	Improper installation of hose or clamp	Retighten or replace the clamp.
	Damaged O-ring or gasket	Replace the O-ring, gasket pipe or hose with new part, if still no improvement, replace the gearbox or oil pump as well.
Leakage from hose (9) through (13) in the figure	Crack or damage in hose	Replace with a new part.
	Crack or damage in hose hardware	Replace with a new part.
Leakage from surrounding of aluminum portion of oil pump, (14) and (15) in the figure	Damaged O-ring	Replace the oil pump.
	Damaged gasket	Replace the oil pump.
Leakage from oil tank, (16) and (17) in the figure	Crack in oil tank	Replace the oil tank.

Leakage from filler neck of (18)	Damaged cap gasket	Replace the cap.
	Crack in root of filler neck	Replace the oil tank.
	Fluid level too high	Adjust the fluid level.
Leakage from power cylinder of gearbox area (19) in the figure	Damaged oil seal	Replace the oil seal.
Leakage from (20), (21) in the figure and control valve of gearbox	Damaged gasket or oil seal	Replace the faulty parts.
	Damage in control valve	Replace the control valve.

There are conditions in which a fluid leak is diagnosed, but is not actually leaking. This is because the fluid spilt during the last maintenance was not completely wiped off. Be sure to wipe off spilt fluid thoroughly after maintenance.
