24. Extension Case

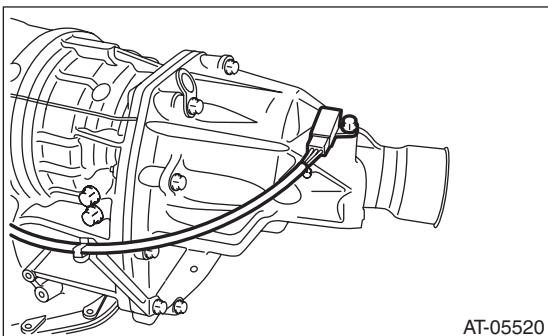
- 1) Remove the transmission assembly. <Ref. to 5AT-36, REMOVAL, Automatic Transmission Assembly.>
- 2) Disconnect the rear vehicle speed sensor connector.

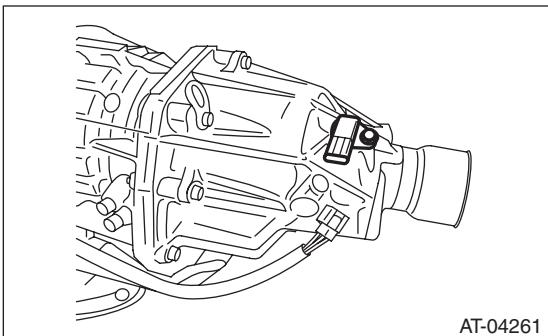
- 3) Remove the rear vehicle speed sensor.

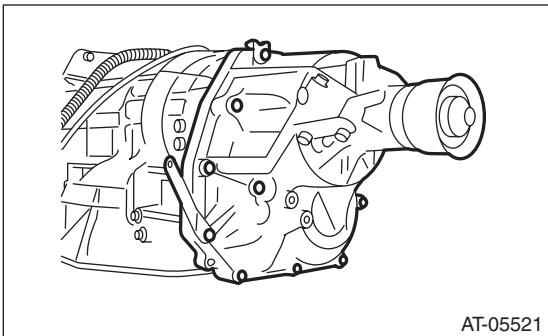
- 4) Remove the extension case.

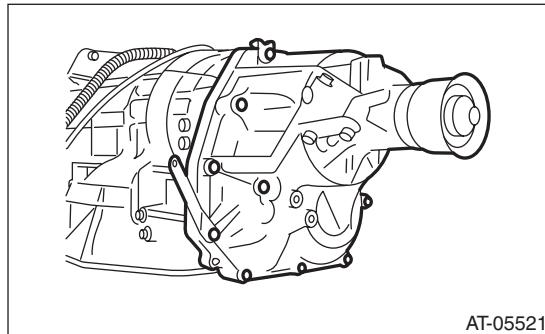
- 2) Install the extension case.

Use a new gasket.

Tightening torque:

25 N·m (2.5 kgf-m, 18.4 ft-lb)

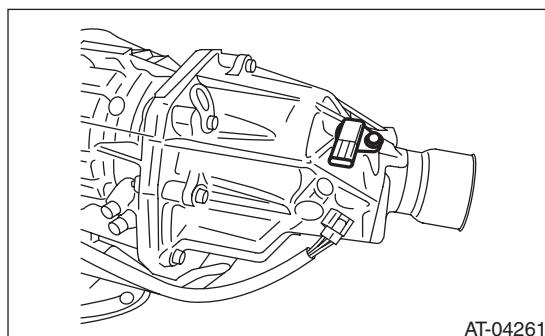
- 3) Install the rear vehicle speed sensor.

Use new O-rings.

Tightening torque:

7 N·m (0.7 kgf-m, 5.2 ft-lb)

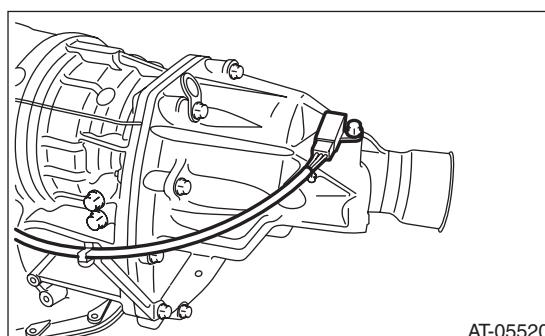
- 4) Connect the rear vehicle speed sensor connector.

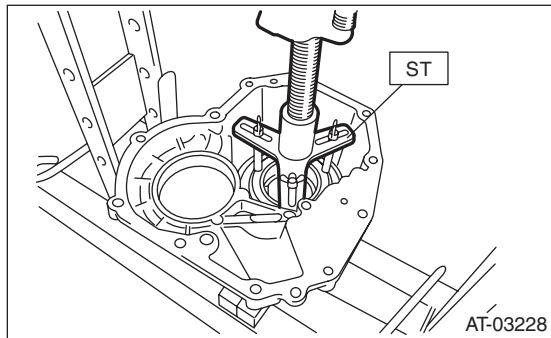
2) Remove the snap ring using the ST and press.
ST 18762AA000 COMPRESSOR SPECIAL TOOL

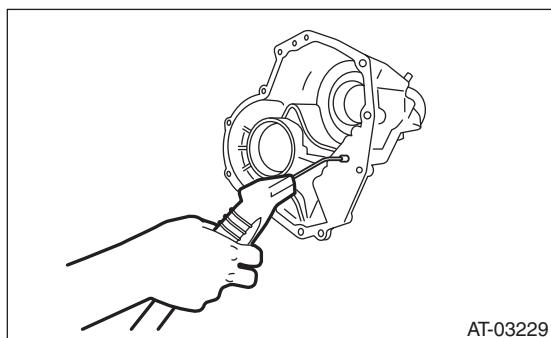
3) Supply compressed air to remove the clutch piston.

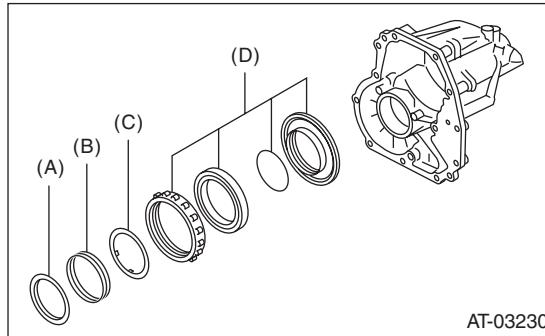
3) Insert the transfer clutch assembly, spring retainer, return spring and clutch spring retainer.

(A) Clutch spring retainer
(B) Return spring
(C) Spring retainer
(D) Transfer clutch piston ASSY

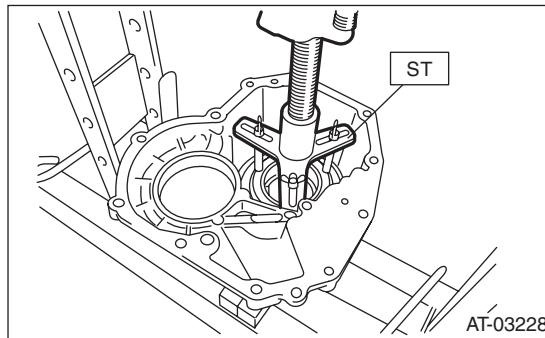
4) Using the ST and compressor, install the snap ring.

ST 18762AA000 COMPRESSOR SPECIAL TOOL
