# Position of Parts in Body <LHD>

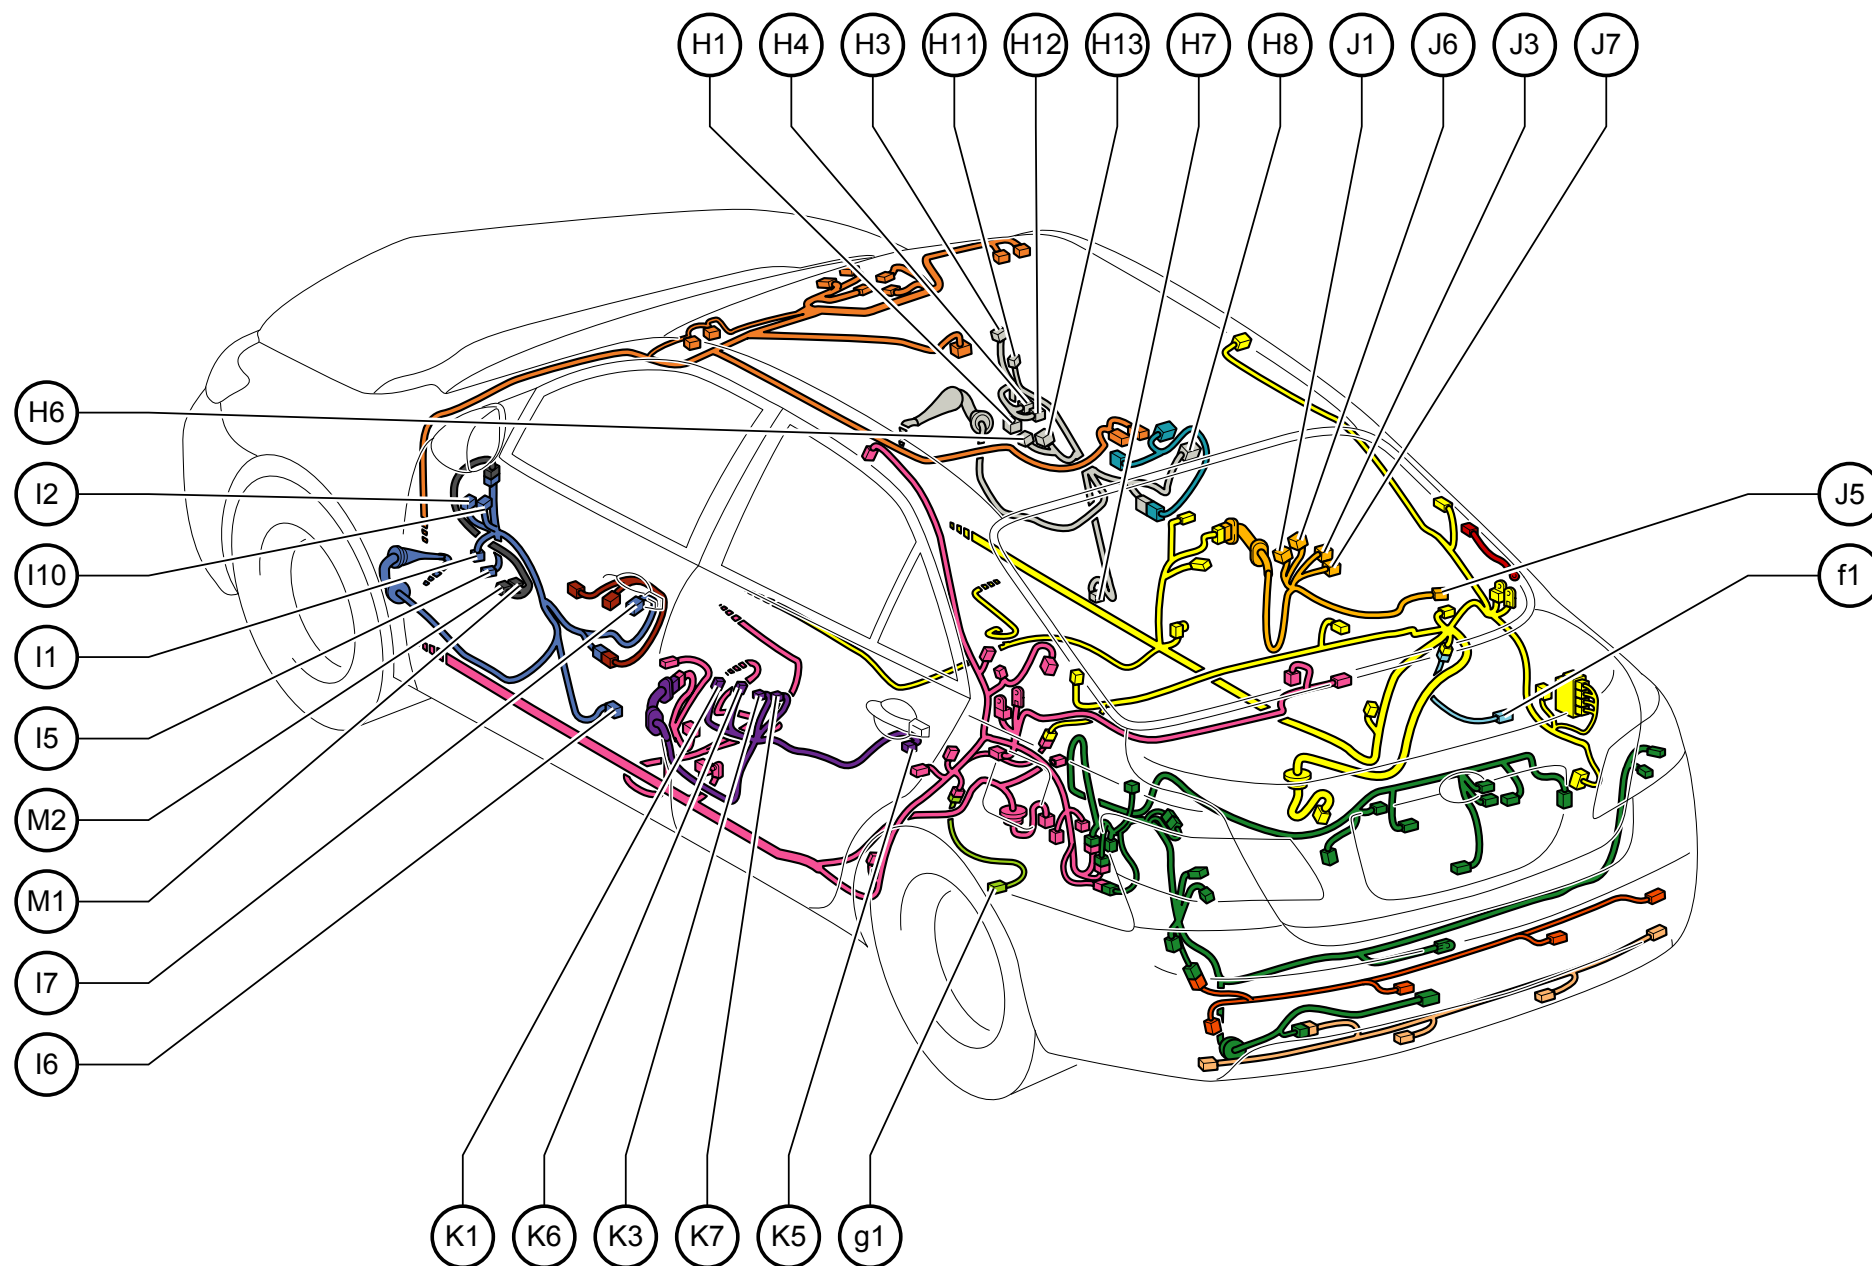
H 1 Speaker (Front Door RH)  
H 3 Outer Rear View Mirror (RH)  
H 4 Power Window Regulator Motor (Front RH)  
H 6 Power Window SW (Front RH)  
H 7 Courtesy Lamp (Front Door RH)  
H 8 Door Lock Assembly (Front RH)  
H 11 Outer Rear View Mirror (RH)  
H 11 Outer Rear View Mirror (RH)  
H 12 Power Window Regulator Motor (Front RH)  
H 13 Power Window SW (Front RH)

I 1 Speaker (Front Door LH)  
I 2 Outer Rear View Mirror (LH)  
I 5 Power Window Regulator Motor (Front LH)  
I 6 Courtesy Lamp (Front Door LH)  
I 7 Door Lock Assembly (Front LH)  
I 10 Outer Rear View Mirror (LH)  
I 10 Outer Rear View Mirror (LH)

J 1 Power Window SW (Rear RH)  
J 3 Power Window Regulator Motor (Rear RH)  
J 5 Door Lock Assembly (Rear RH)  
J 6 Power Window SW (Rear RH)  
J 7 Power Window Regulator Motor (Rear RH)

K 1 Power Window SW (Rear LH)  
K 3 Power Window Regulator Motor (Rear LH)  
K 5 Door Lock Assembly (Rear LH)  
K 6 Power Window SW (Rear LH)  
K 7 Power Window Regulator Motor (Rear LH)

M 1 Power Window Master SW  
M 2 Power Window Master SW

f 1 Speed Sensor (Rear RH)

g 1 Speed Sensor (Rear LH)
