# Mirror Heater , Rear Window Defogger

- \* 1 : Except \*2
- \* 2 : Turkey, Russian
- \* 3 : Before Jan. 2009 Production
- \* 4 : From Jan. 2009 Production until Aug. 2010 Production
- \* 5 : From Aug. 2010 Production

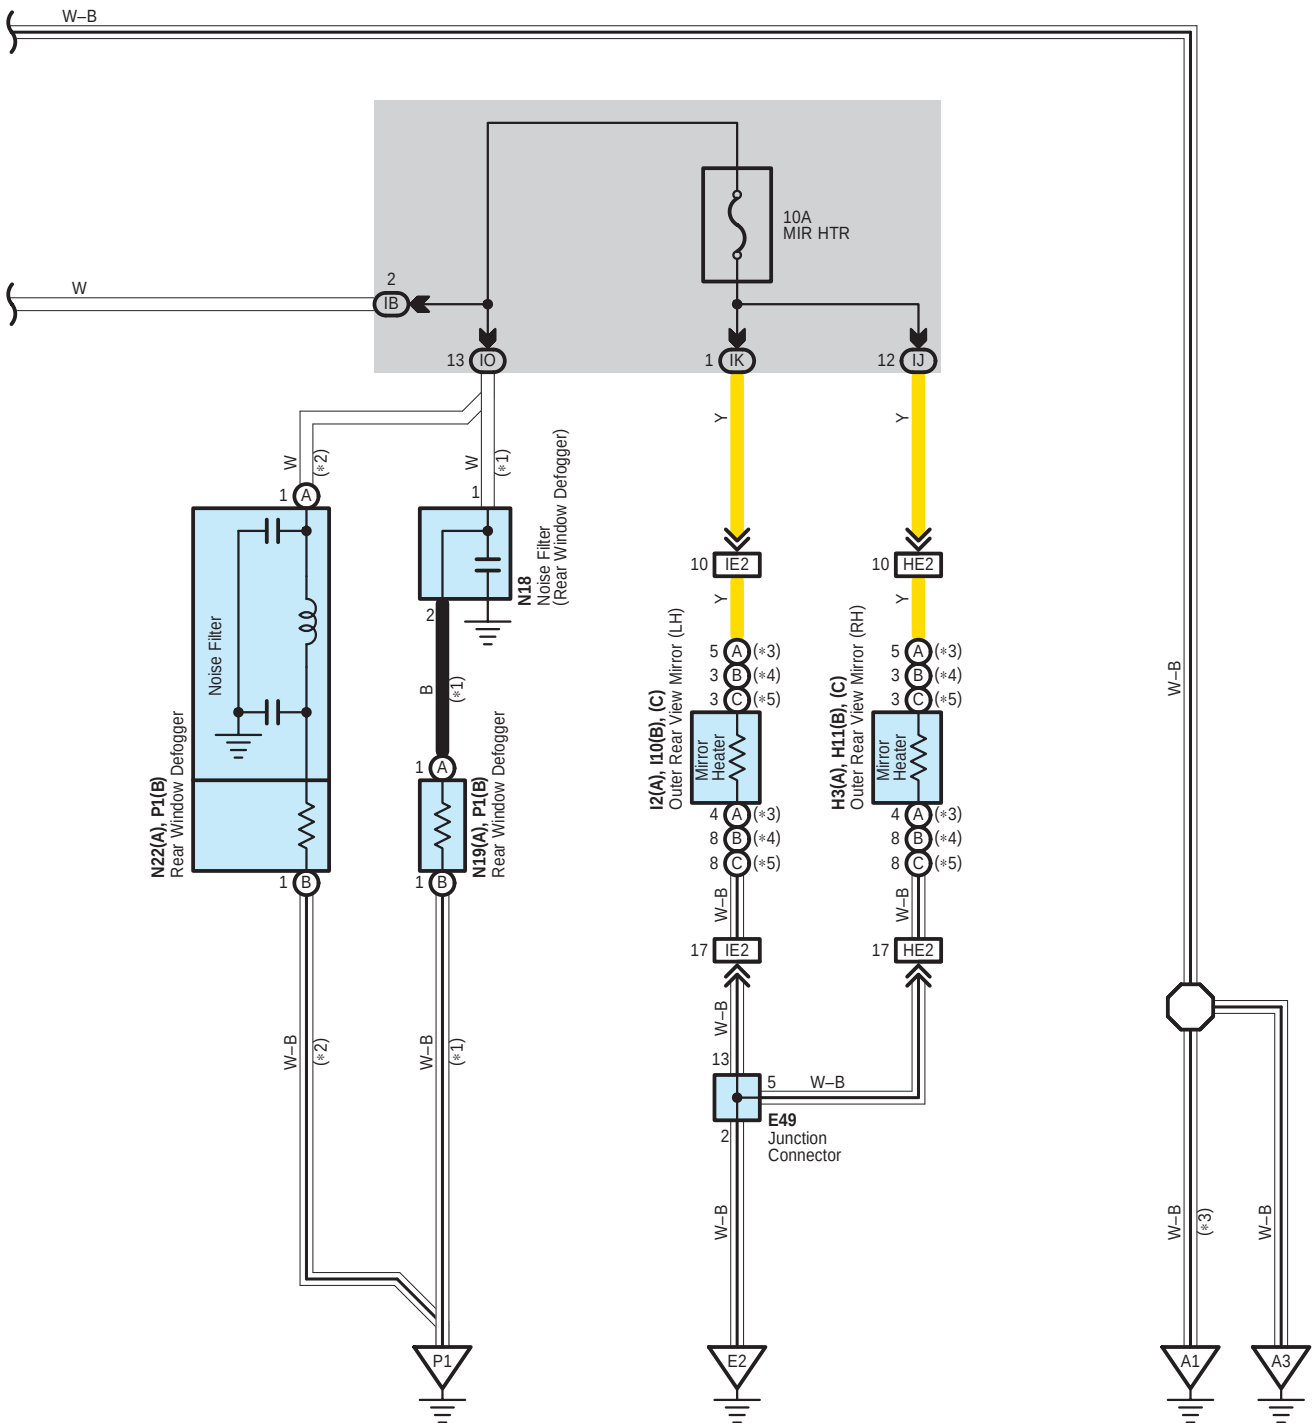
# Mirror Heater , Rear Window Defogger
