# Theft Deterrent

I12(A), I13(B)  
Main Body ECU

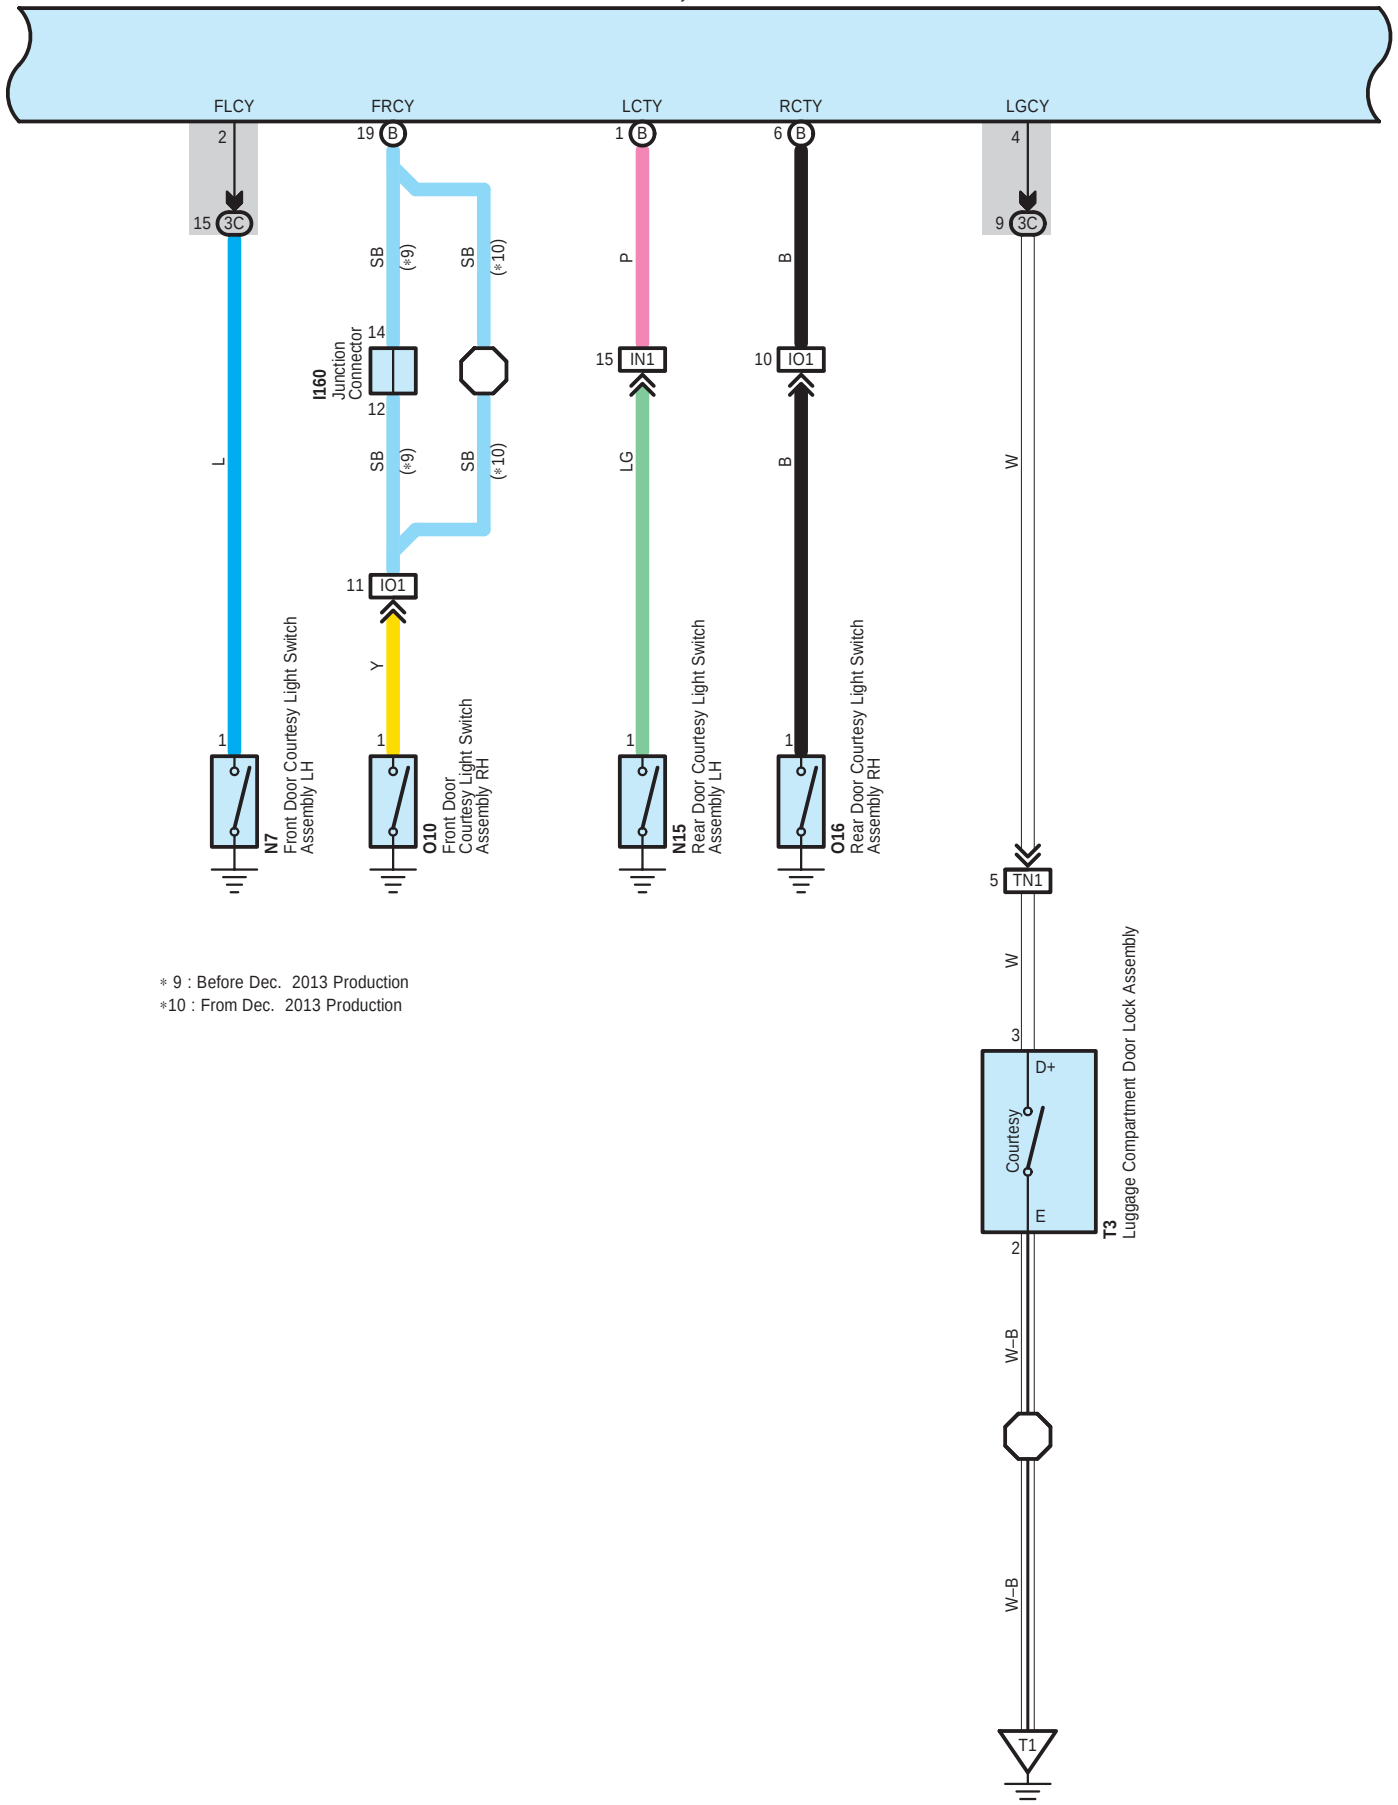
\* 9 : Before Dec. 2013 Production

\*10 : From Dec. 2013 Production
