# Position of Parts in Instrument Panel <RHD>

(Before Jan. 2017 Production)

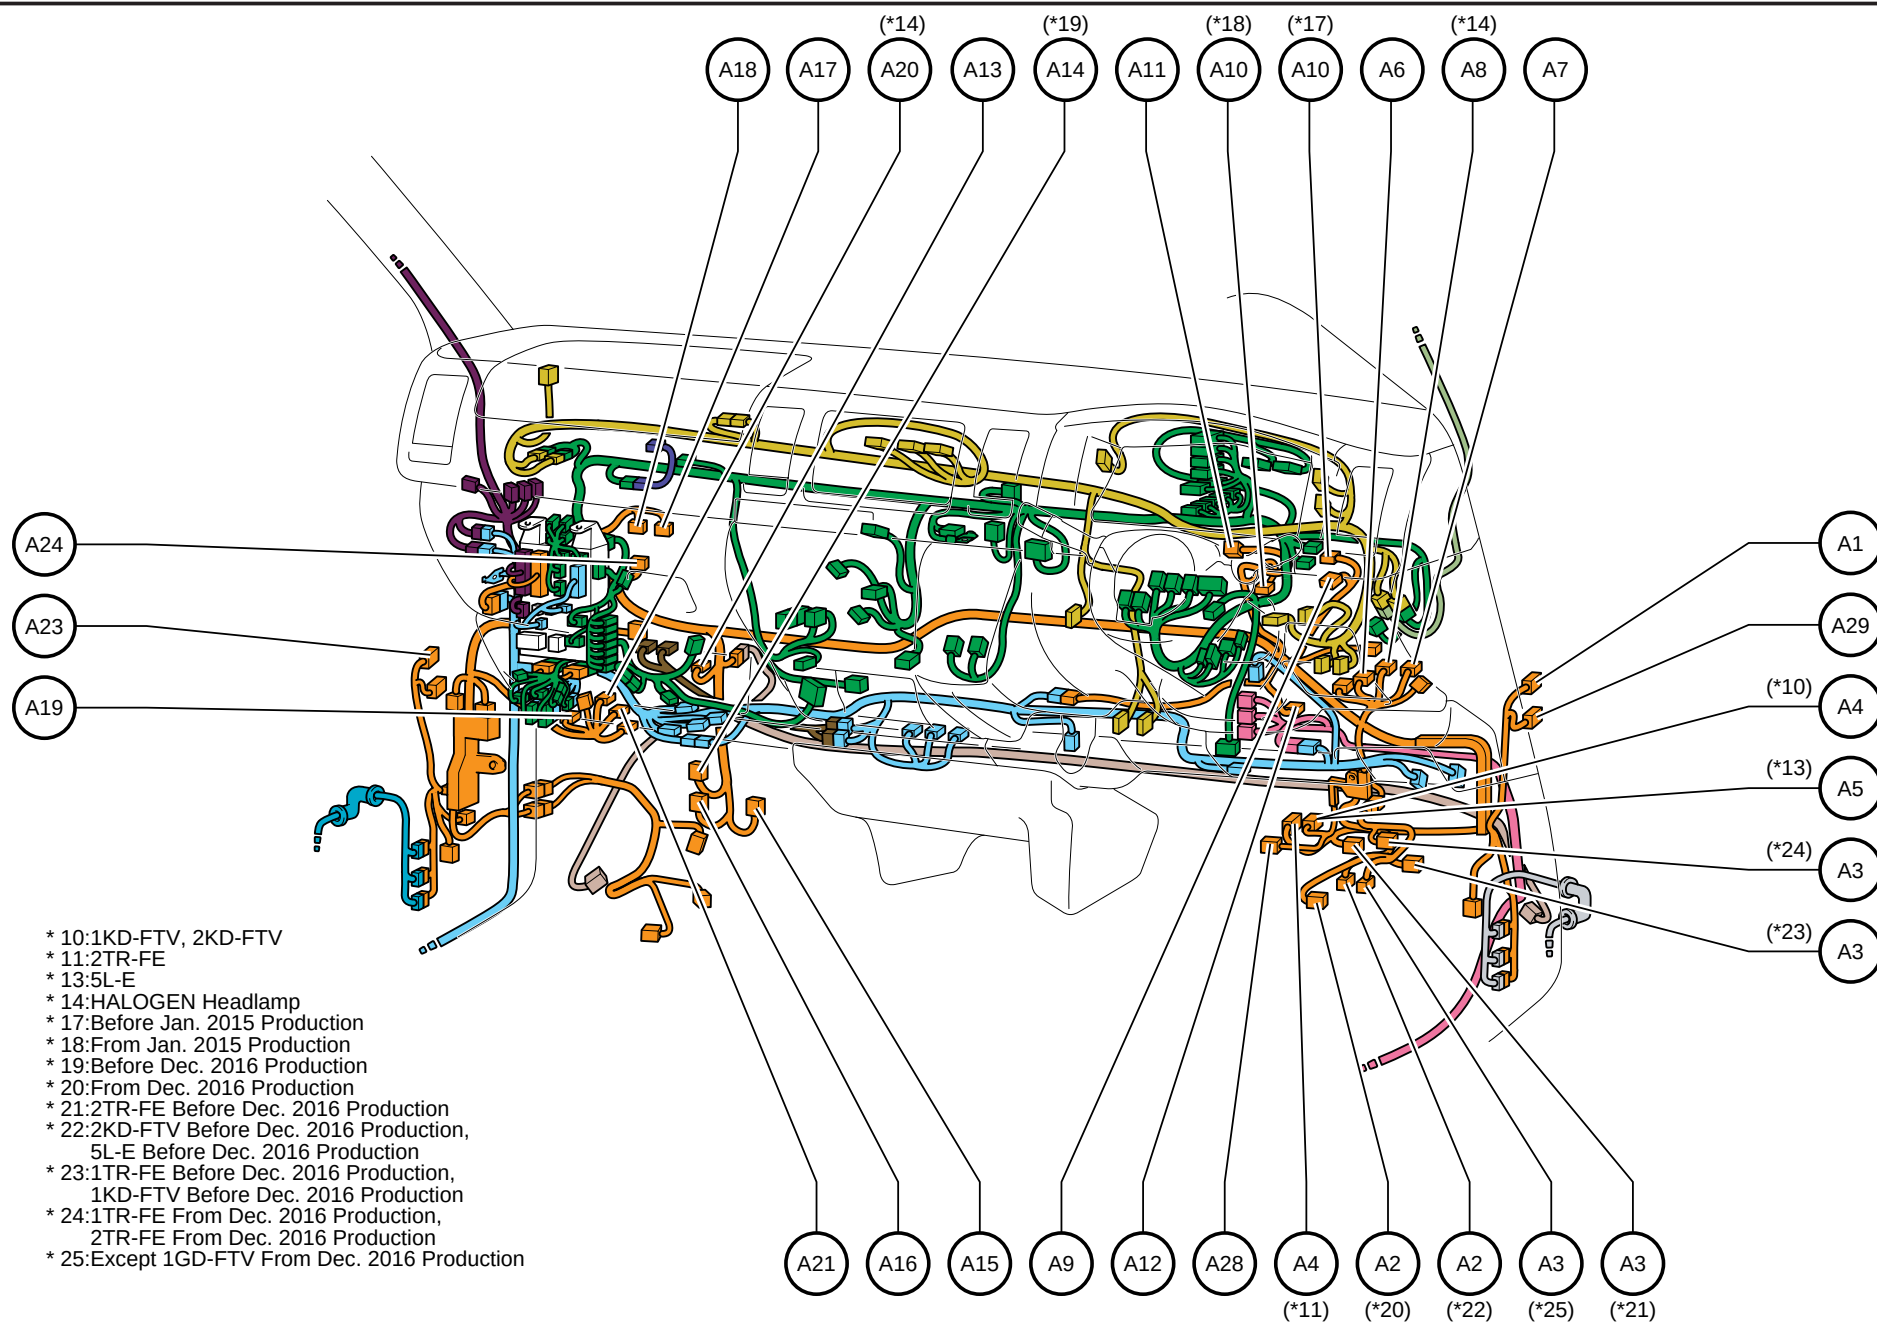
- A 1 Turn Signal Lamp (Front RH)
- A 2 Inlet Air Temp. Sensor (Air Cleaner)
- A 3 Air Flow Meter
- A 4 A/C Pressure Sensor No.1
- A 5 Pressure SW
- A 6 Clearance Lamp (Front RH)
- A 7 Headlamp (RH)
- A 8 Headlamp Leveling Motor (RH)
- A 9 Brake Vacuum Warning SW
- A 10 Brake Fluid Level Warning SW
- A 11 Windshield Wiper Motor
- A 12 Airbag Sensor (Front RH)
- A 13 Airbag Sensor (Front LH)
- A 14 Ambient Temp. Sensor
- A 15 Horn (Low)
- A 16 Horn (High)
- A 17 Windshield Washer Motor
- A 18 Rear Washer Motor
- A 19 Headlamp (LH)
- A 20 Headlamp Leveling Motor (LH)
- A 21 Clearance Lamp (Front LH)
- A 23 Turn Signal Lamp (Front LH)
- A 24 Short Pin (Vacuum)
- A 28 Magnet Valve
- A 29 Daytime Running Light (Headlamp Assembly RH)
