CIRCUIT INSPECTION

| DTC | RrDEF, FACE | Front Room Temperature Sensor Circuit |

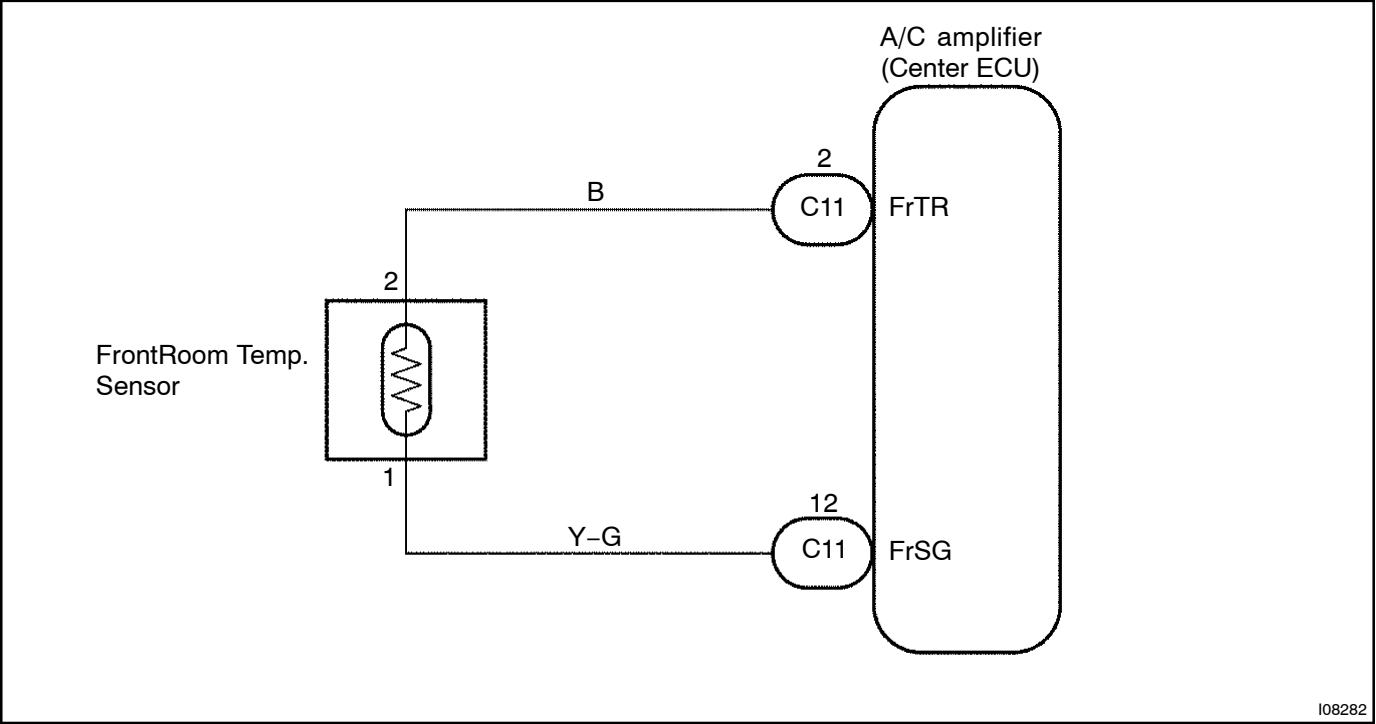
WIRING DIAGRAM

This sensor detects the temperature inside the cabin and sends the appropriate signals to the A/C amplifier.

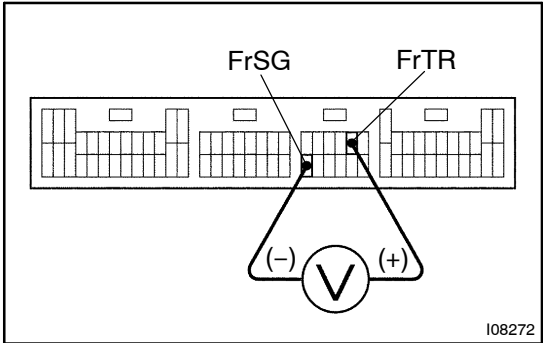
| 1 | Check voltage between terminals FrTR and FrSG of A/C amplifier connector. |

- (a) Turn ignition switch ON.
- (b) Measure voltage between terminals FrTR and FrSG of A/C amplifier connector at each temperature.

**at 25°C (77°F) : 1.8 – 2.2 V**

**at 40°C (104°F) : 1.2 – 1.6 V**

As the temperature increases, the voltage decreases.

Remove A/C amplifier with connectors still connected.

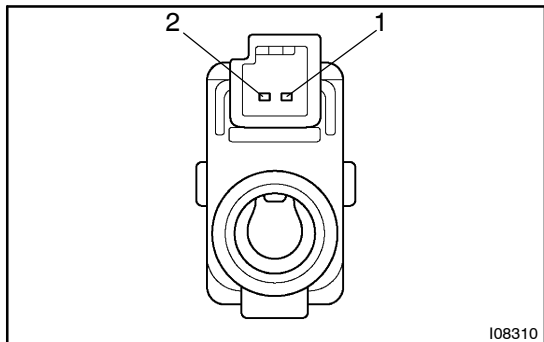
**2 Check front room temperature sensor.**

Measure resistance between terminals 1 and 2 of room temperature sensor connector at each temperature.

at 25°C (77°F) : 1.65 – 1.75 kΩ

at 50°C (122°F) : 0.55 – 0.65 kΩ

As the temperature increases, the resistance decreases.

Disconnect room temperature sensor connector.
