| <b>DTC</b> | <b>19</b> | <b>Rear Room Temperature Sensor Circuit</b> |

## CIRCUIT DESCRIPTION

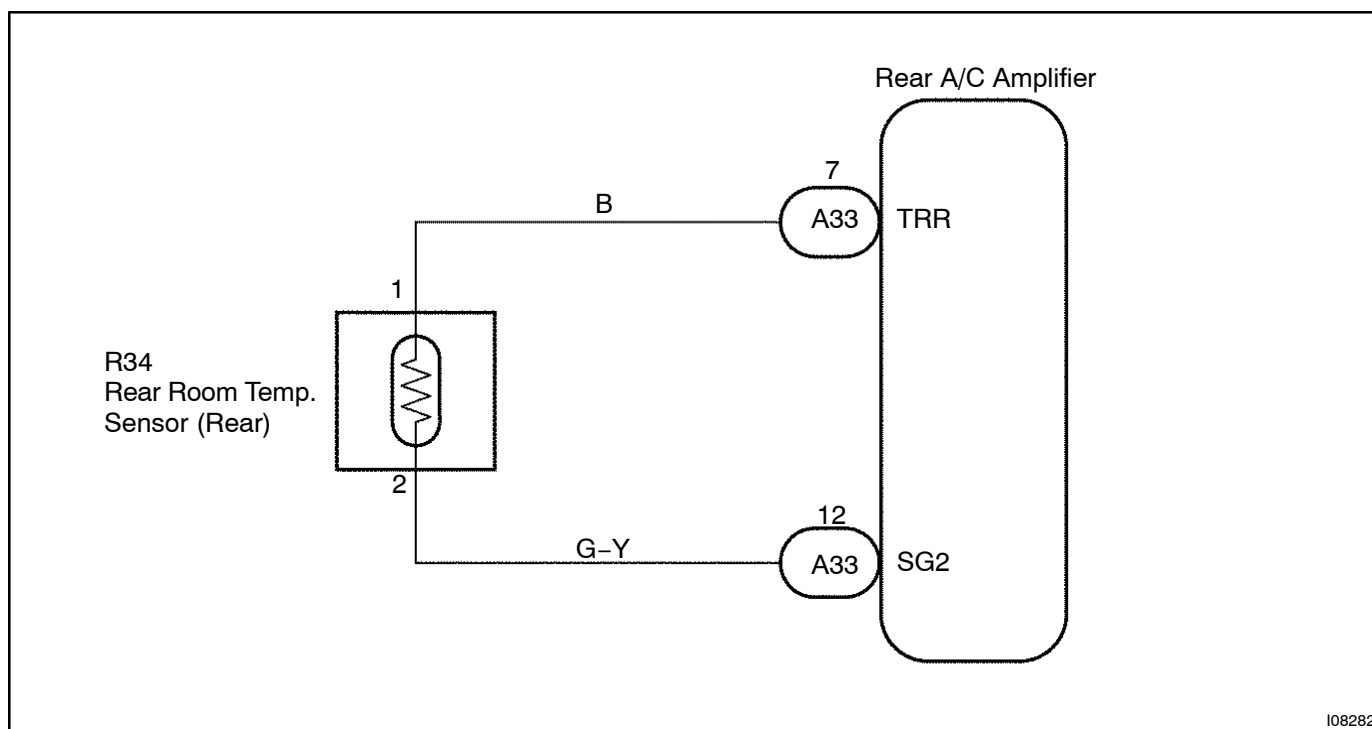
I08282

## WIRING DIAGRAM

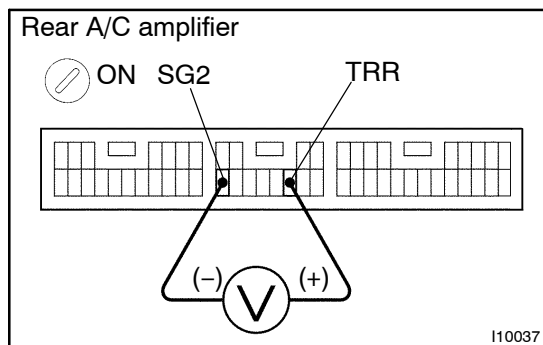
| <b>1</b> | <b>Check voltage between terminals TRR and SG2 of A/C amplifier.</b> |

- (a) Turn ignition switch to ON.
- (b) Measure voltage between terminals TRR and SG2 of rear A/C amplifier connector at each temperature.

**OK:****Voltage :**

at 25°C (77°F) : 1.8 – 2.2 V

at 40°C (104°F) : 1.2 – 1.6 V

As the temperature increases, the voltage decreases.

Proceed to next circuit inspection shown on problem symptoms table (See page [DI-1086](#)). However, if DTC 19 is displayed, check and replace A/C amplifier.

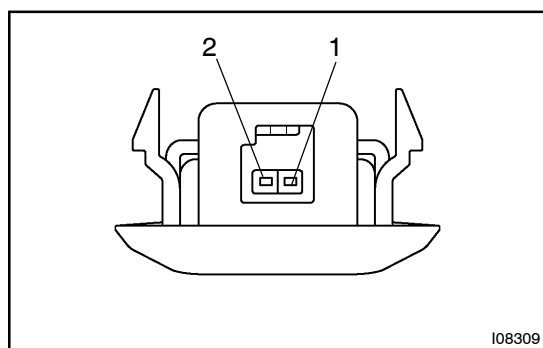
| <b>2</b> | <b>Check rear room temperature sensor.</b> |

Measure resistance between terminals 1 and 2 of room temperature sensor connector at each temperature.

**OK:****Resistance :**

at 25°C (77°F) : 1.65 – 1.75 kΩ

at 50°C (122°F) : 0.55 – 0.65 kΩ

As the temperature increases, the resistance decreases.

**Replace rear room temperature sensor.**
