| <b>DTC</b> | <b>B0135/73</b> | <b>Short in P/T Squib LH Circuit</b> |

## CIRCUIT DESCRIPTION

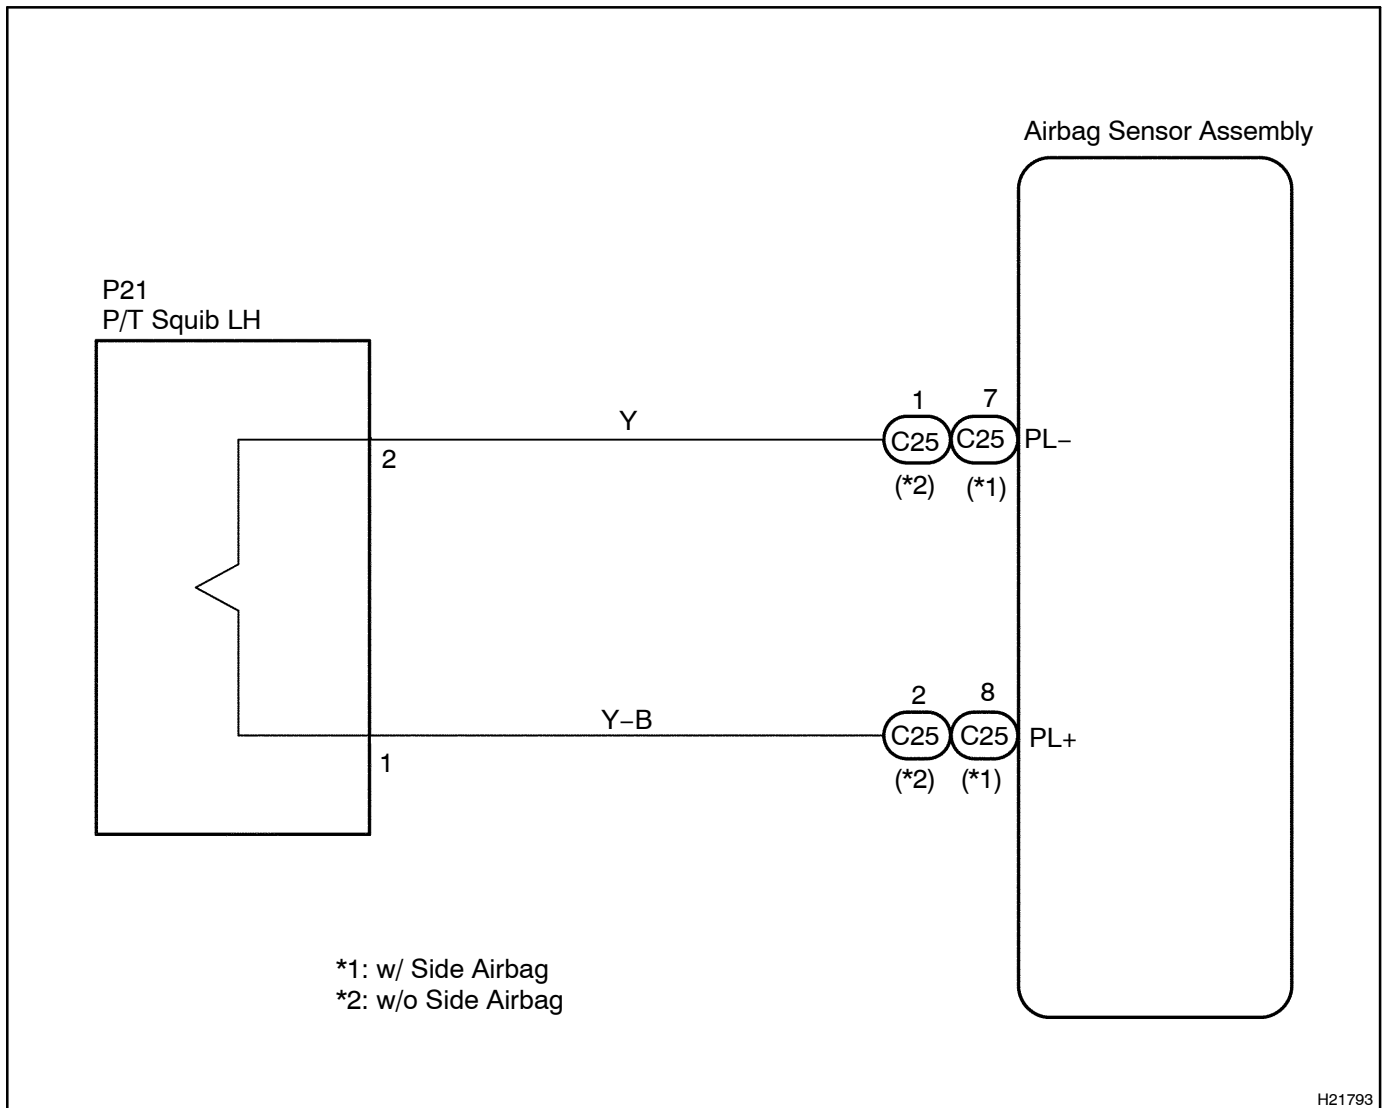
## WIRING DIAGRAM

The P/T squib LH circuit consists of the airbag sensor assembly and the seat belt pretensioner LH. It causes the SRS to deploy when the SRS deployment conditions are satisfied. For details of the function of each component, see OPERATION on page RS-3. DTC B0135/73 is recorded when a short is detected in the P/T squib LH circuit.

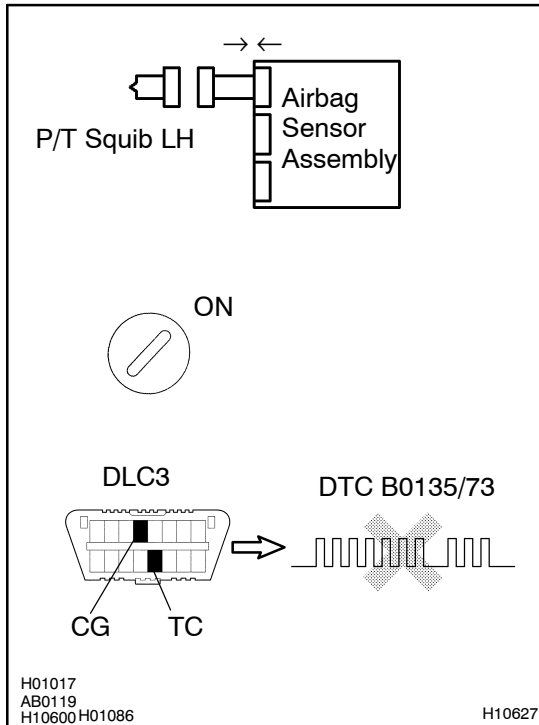
### 3 Check airbag sensor assembly.

- Connect the connector to the airbag sensor assembly.
- Connect the negative (-) terminal cable to the battery, and wait at least for 2 seconds.

- Turn the ignition switch to ON, and wait at least for 10 seconds.
- Clear the DTC stored in memory (See page [DI-523](#)).
- Turn the ignition switch to LOCK, and wait at least for 10 seconds.
- Turn the ignition switch to ON, and wait at least for 10 seconds.
- Check the DTC (See page [DI-523](#)).

**DTC B0135/73 is not output.**

**Replace airbag sensor assembly.**
