| <b>DTC</b> | <b>B0135/73</b> | <b>Short in P/T Squib LH Circuit</b> |

## CIRCUIT DESCRIPTION

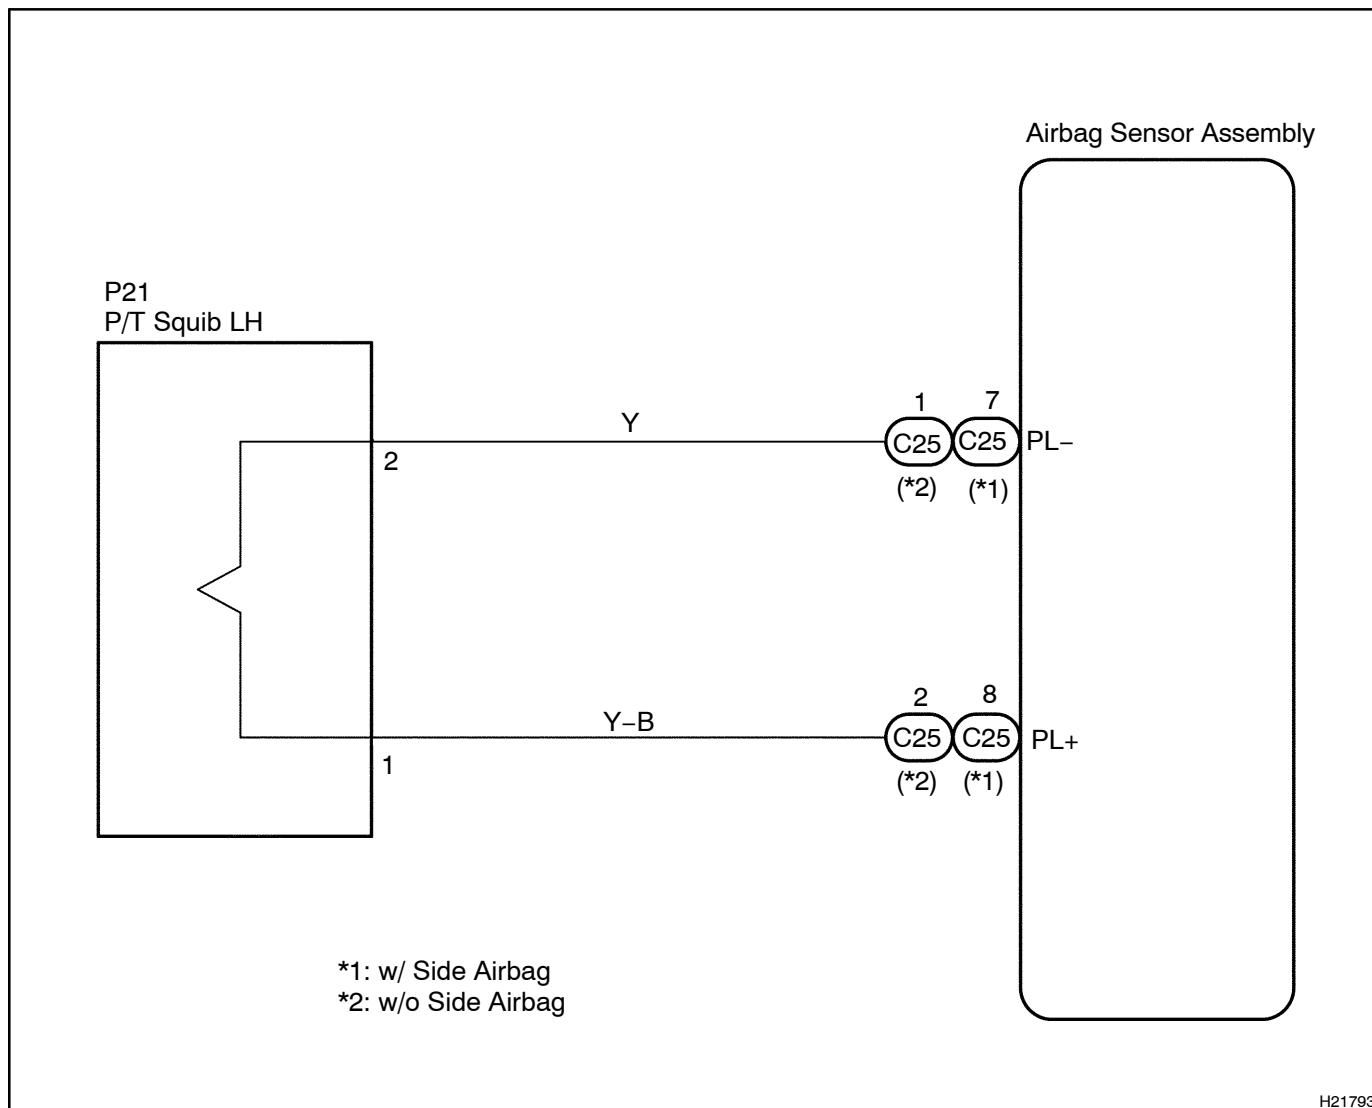
## WIRING DIAGRAM

The P/T squib LH circuit consists of the airbag sensor assembly and the seat belt pretensioner LH. It causes the SRS to deploy when the SRS deployment conditions are satisfied. For details of the function of each component, see OPERATION on page RS-3. DTC B0135/73 is recorded when a short is detected in the P/T squib LH circuit.

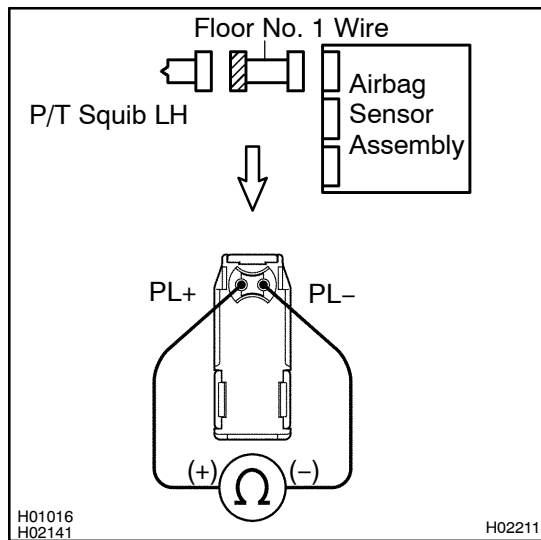
- 2 Check floor No. 1 wire (P/T squib LH circuit).

Release the airbag activation prevention mechanism built in the connector of the floor No. 1 wire on the airbag sensor assembly side (See page [DI-692](#)).

Measure the resistance between PL+ and PL- of the floor No. 1 wire connector on the seat belt pretensioner LH (P/T squib LH) side.

**Resistance: 1 MΩ or Higher**

**Replace floor No. 1 wire.**

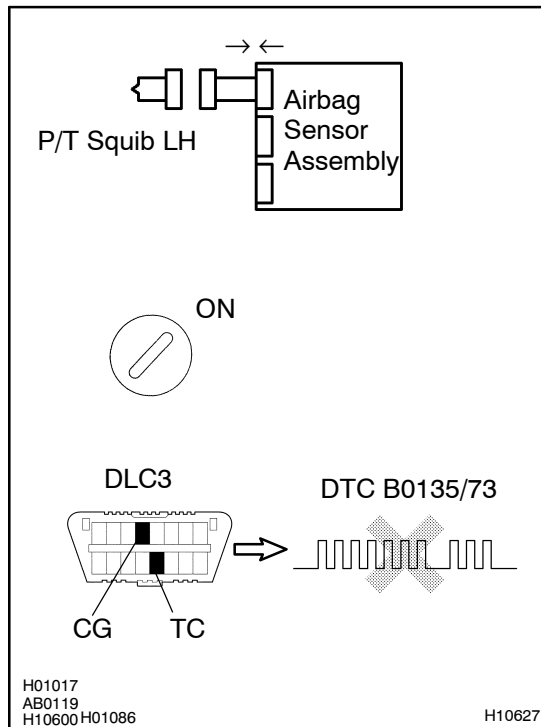
### 3 Check airbag sensor assembly.

- Connect the connector to the airbag sensor assembly.
- Connect the negative (-) terminal cable to the battery, and wait at least for 2 seconds.

- Turn the ignition switch to ON, and wait at least for 10 seconds.
- Clear the DTC stored in memory (See page [DI-692](#)).
- Turn the ignition switch to LOCK, and wait at least for 10 seconds.
- Turn the ignition switch to ON, and wait at least for 10 seconds.
- Check the DTC (See page [DI-692](#)).

**DTC B0135/73 is not output.**

**Replace airbag sensor assembly.**

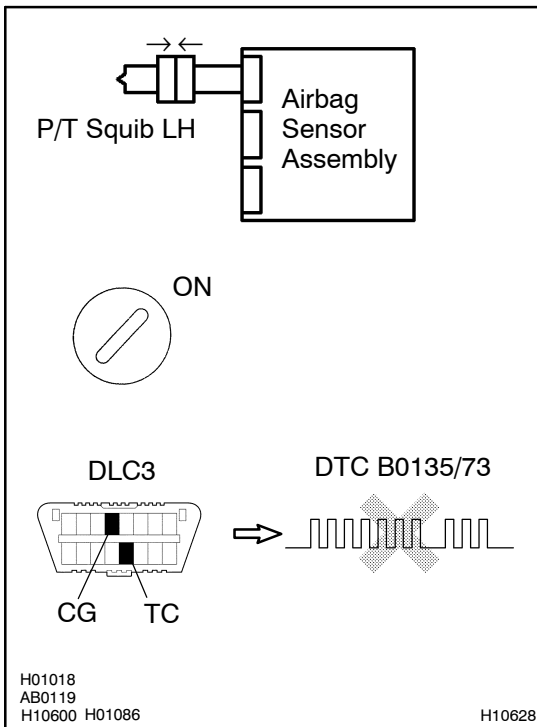
#### 4 Check P/T squib LH.

- Turn the ignition switch to LOCK.
- Disconnect the negative (-) terminal cable from the battery, and wait at least for 90 seconds.
- Connect the seat belt pretensioner LH (P/T squib LH) connector.
- Connect the negative (-) terminal cable to the battery, and wait at least for 2 seconds.

- Turn the ignition switch to ON, and wait at least for 10 seconds.
- Clear the DTC stored in memory (See page [DI-692](#)).
- Turn the ignition switch to LOCK, and wait at least for 10 seconds.
- Turn the ignition switch to ON, and wait at least for 10 seconds.
- Check the DTC (See page [DI-692](#)).

**DTC B0135/73 is not output.**

**Replace seat belt pretensioner LH (P/T squib LH).**
