# REAR HEATER RELAY INSPECTION

AC30Y-01

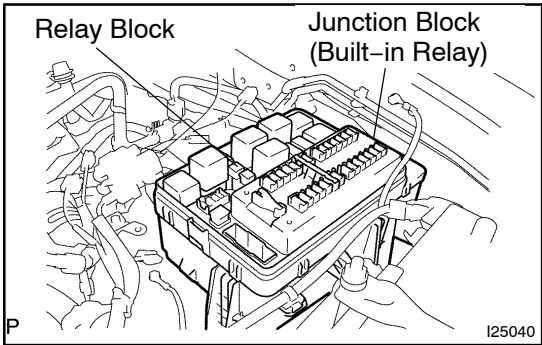
The rear heater relay is built in the engine room junction block. Since the relay is constructed with a relay block that is in the junction block as a unit, it is impossible to disconnect the wire harness connecting with the relay block.

1. REMOVE ENGINE ROOM J/B
2. INSPECT REAR HEATER RELAY CONTINUITY

| Condition | Tester connection | Specified condition |
| Constant | 29 - 31 | Continuity |
| Apply B+ between terminals 29 and 31. | 2 - 3 | Continuity |

If continuity is not as specified, replace the engine room J/B.
