## CIRCUIT INSPECTION

| <b>DTC</b> | <b>11</b> | <b>Front Room Temperature Sensor Circuit</b> |

This sensor detects the temperature inside the cabin (front side) and sends the appropriate signals to the A/C amplifier.

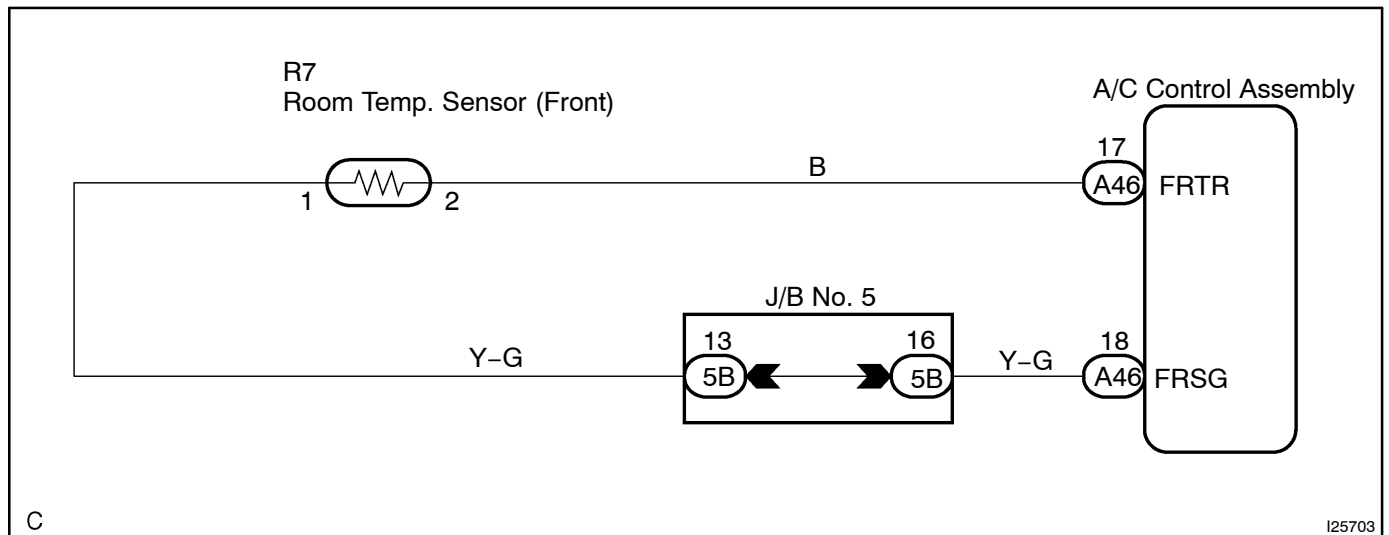
I25703

## WIRING DIAGRAM

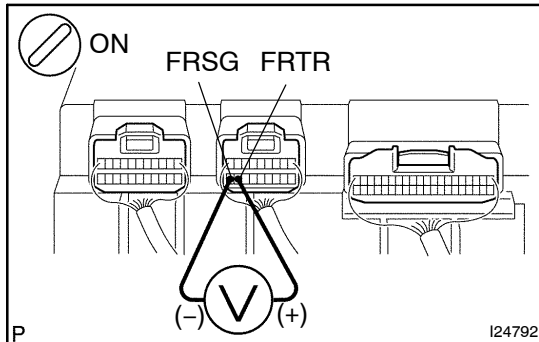
| 1 | <b>Check voltage between terminals FRTR and FRSG of A/C amplifier.</b> |

- (a) Turn ignition switch to ON.
- (b) Measure voltage between terminals FRTR and FRSG of A/C amplifier connector at each temperature.

**OK:****Voltage :**

at 25°C (77°F) : 1.8 – 2.2 V

at 40°C (104°F) : 1.2 – 1.6 V

As the temperature increases, the voltage decreases.

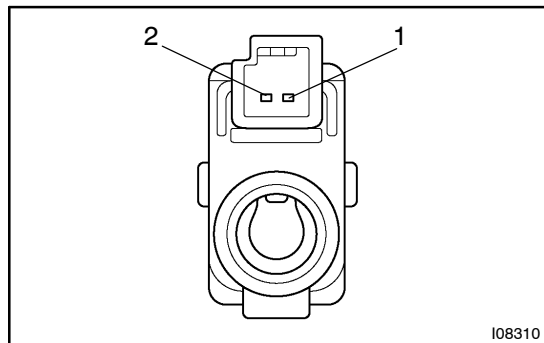
**2 Check front room temperature sensor.**

Measure resistance between terminals 1 and 2 of front room temperature sensor connector at each temperature.

**OK:****Resistance :**

at 25°C (77°F) : 1.65 – 1.75 kΩ

at 50°C (122°F) : 0.55 – 0.65 kΩ

As the temperature increases, the resistance decreases.

**NG****Replace front room temperature sensor.****OK****3 Check harness and connector between A/C amplifier and front room temperature sensor (See page IN-36).****NG****Repair or replace harness or connector.****OK****Check and replace A/C amplifier.**
