| <b>DTC</b> | <b>19</b> | <b>Rear Room Temperature Sensor Circuit</b> |

## CIRCUIT DESCRIPTION

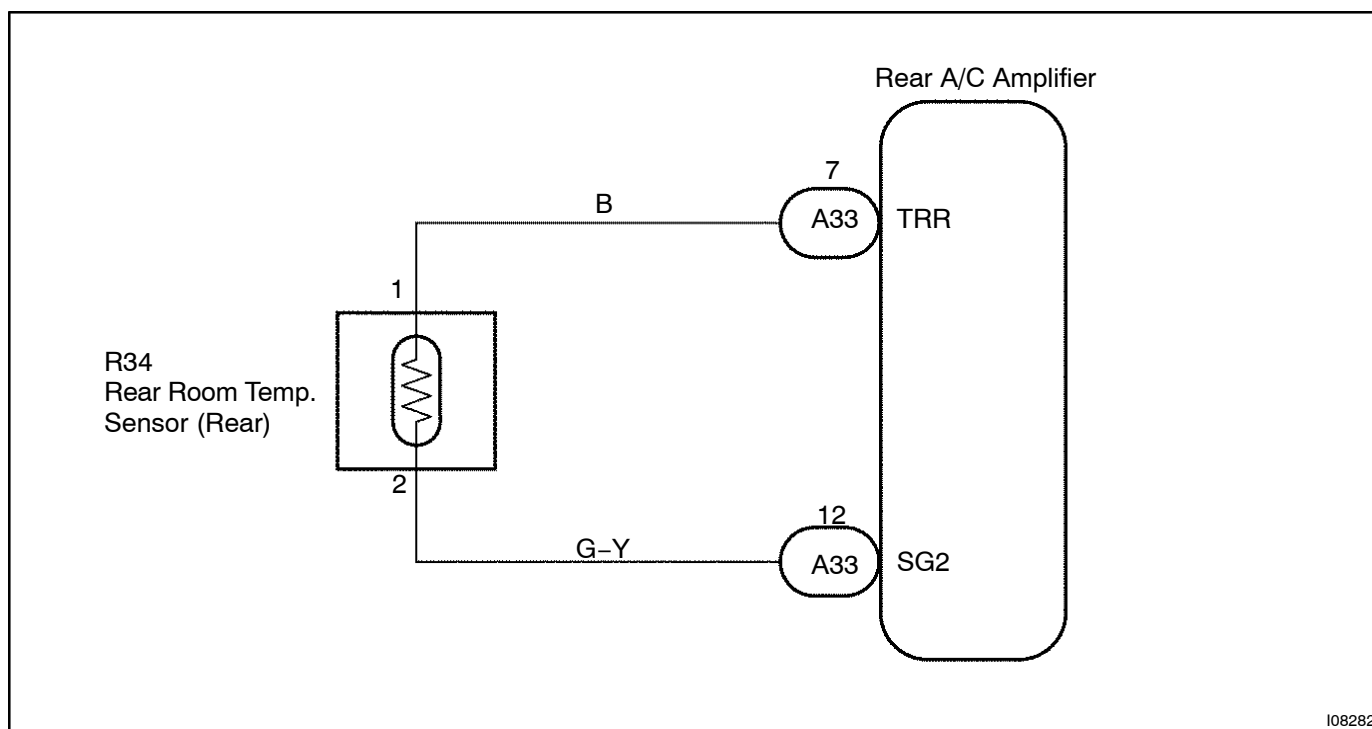
## WIRING DIAGRAM

This sensor detects the temperature inside the cabin (rear side) and sends the appropriate signals to the rear A/C amplifier.

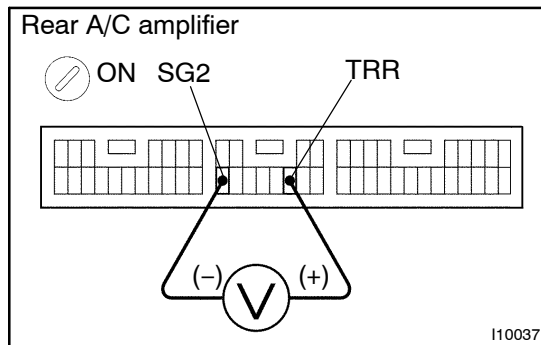
| <b>1</b> | <b>Check voltage between terminals TRR and SG2 of A/C amplifier.</b> |

Remove rear A/C amplifier with connectors still connected.

- (a) Turn ignition switch to ON.
- (b) Measure voltage between terminals TRR and SG2 of rear A/C amplifier connector at each temperature.

at 25°C (77°F) : 1.8 – 2.2 V

at 40°C (104°F) : 1.2 – 1.6 V

As the temperature increases, the voltage decreases.

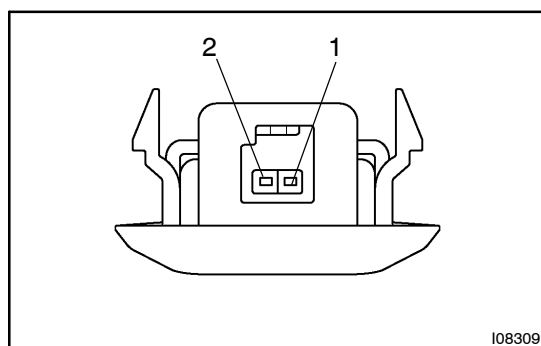
| <b>2</b> | <b>Check rear room temperature sensor.</b> |

Disconnect rear room temperature sensor connector.

Measure resistance between terminals 1 and 2 of room temperature sensor connector at each temperature.

at 25°C (77°F) : 1.65 – 1.75 kΩ

at 50°C (122°F) : 0.55 – 0.65 kΩ

As the temperature increases, the resistance decreases.

**Replace rear room temperature sensor.**
