| <b>DTC</b> | <b>B0135/73</b> | <b>Short in P/T Squib LH Circuit</b> |

## CIRCUIT DESCRIPTION

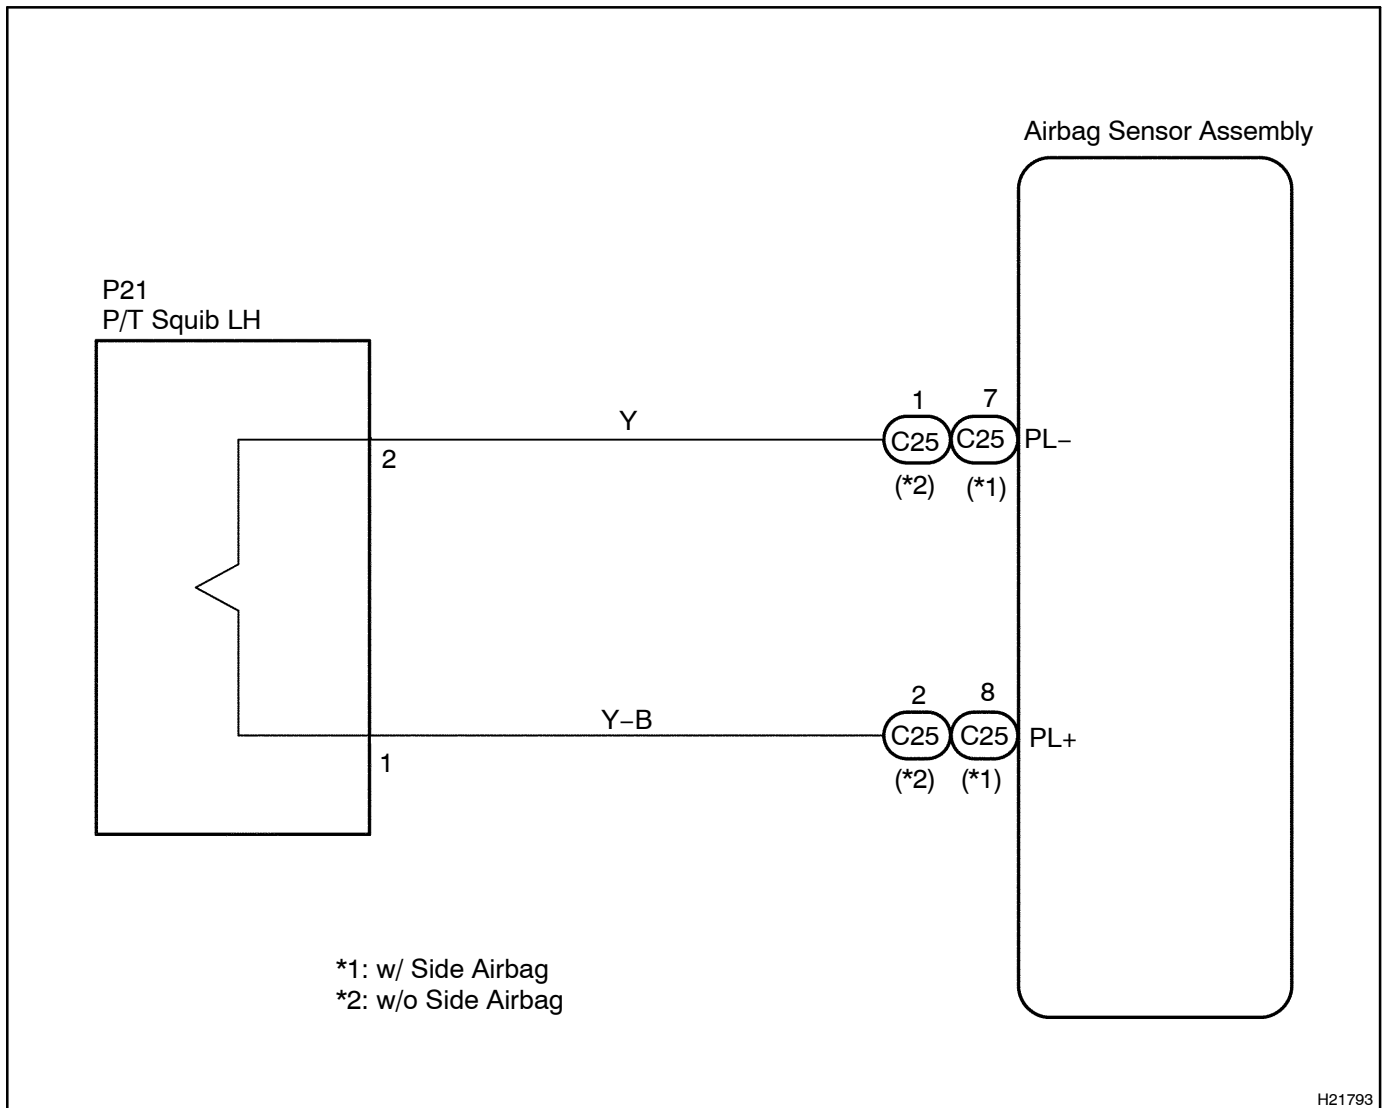
## WIRING DIAGRAM

The P/T squib LH circuit consists of the airbag sensor assembly and the seat belt pretensioner LH. It causes the SRS to deploy when the SRS deployment conditions are satisfied. For details of the function of each component, see OPERATION on page [RS-3](#). DTC B0135/73 is recorded when a short is detected in the P/T squib LH circuit.

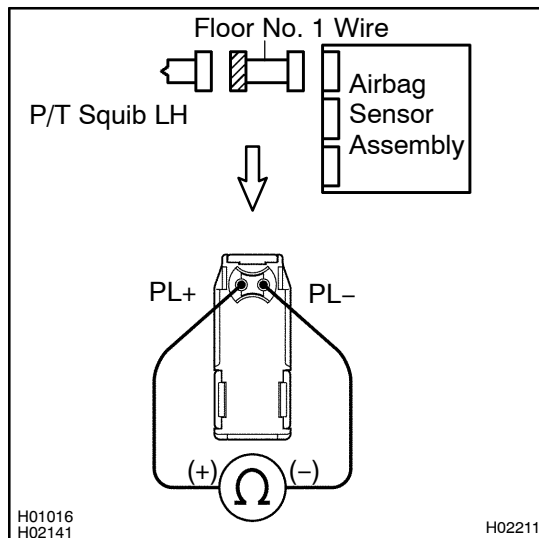
- 2 Check floor No. 1 wire (P/T squib LH circuit).

Release the airbag activation prevention mechanism built in the connector of the floor No. 1 wire on the airbag sensor assembly side (See page [DI-699](#)).

Measure the resistance between PL+ and PL- of the floor No. 1 wire connector on the seat belt pretensioner LH (P/T squib LH) side.

**Resistance: 1 MΩ or Higher**

**Replace floor No. 1 wire.**

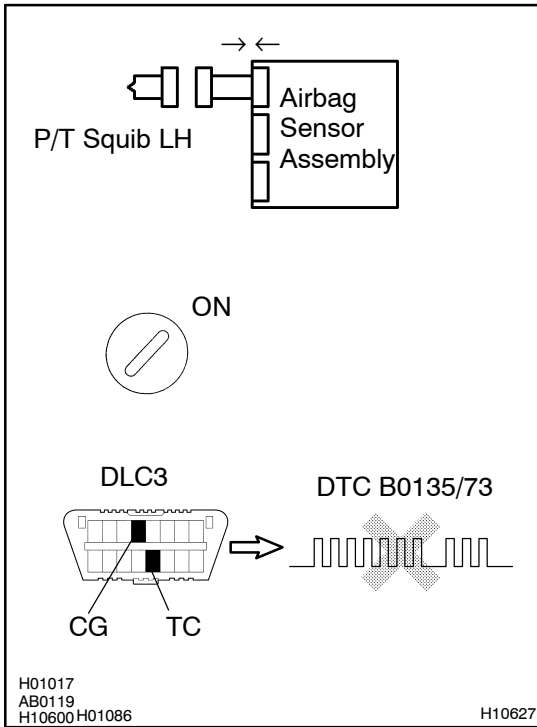
### 3 Check airbag sensor assembly.

- Connect the connector to the airbag sensor assembly.
- Connect the negative (-) terminal cable to the battery, and wait at least for 2 seconds.

- Turn the ignition switch to ON, and wait at least for 10 seconds.
- Clear the DTC stored in memory (See page [DI-699](#)).
- Turn the ignition switch to LOCK, and wait at least for 10 seconds.
- Turn the ignition switch to ON, and wait at least for 10 seconds.
- Check the DTC (See page [DI-699](#)).

**DTC B0135/73 is not output.**

**Replace airbag sensor assembly.**

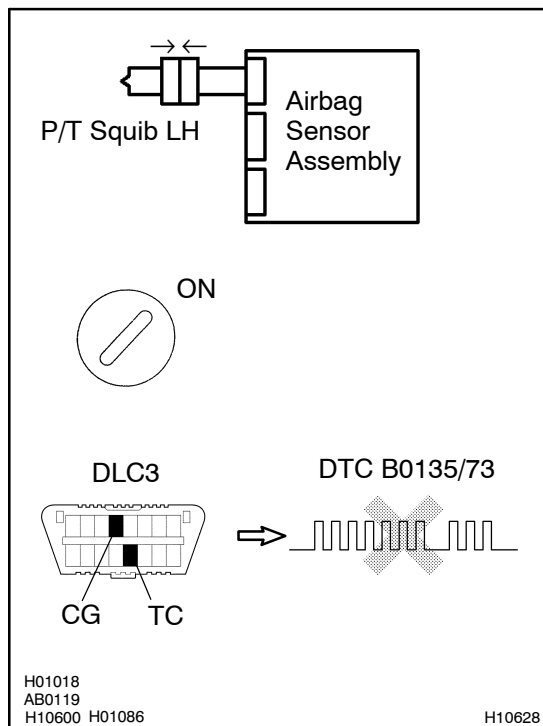
#### 4 Check P/T squib LH.

- Turn the ignition switch to LOCK.
- Disconnect the negative (-) terminal cable from the battery, and wait at least for 90 seconds.
- Connect the seat belt pretensioner LH (P/T squib LH) connector.
- Connect the negative (-) terminal cable to the battery, and wait at least for 2 seconds.

- Turn the ignition switch to ON, and wait at least for 10 seconds.
- Clear the DTC stored in memory (See page [DI-699](#)).
- Turn the ignition switch to LOCK, and wait at least for 10 seconds.
- Turn the ignition switch to ON, and wait at least for 10 seconds.
- Check the DTC (See page [DI-699](#)).

**DTC B0135/73 is not output.**

**Replace seat belt pretensioner LH (P/T squib LH).**
