SUBARU.

NUMBER 06-24-91

SERVICE BULLETIN

SUBJECT: SECONDARY SIDE BLEEDING OF A.B.S. HYDRAULIC CONTROL UNIT

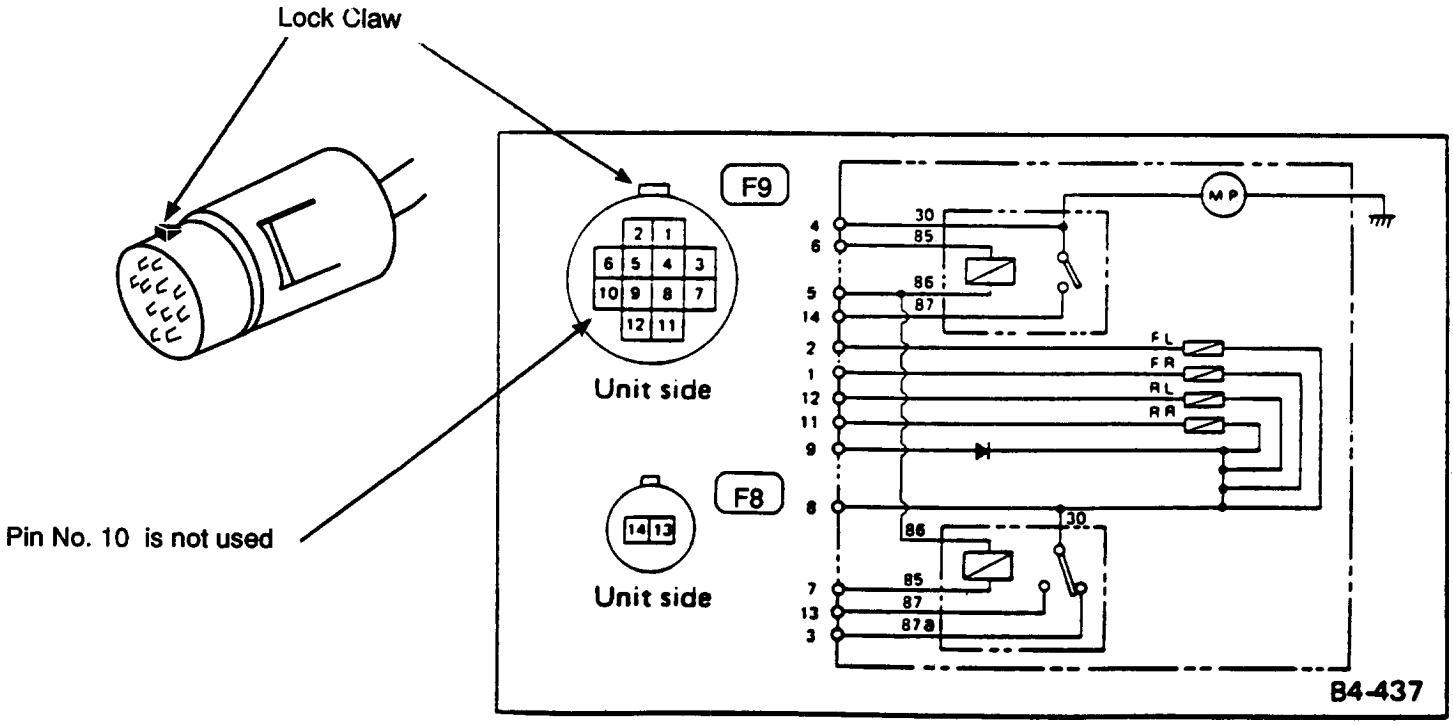
The locking claw at the forward part of the large connector should be at the top or 12 o'clock position. This will properly locate pins 1, 2, 11, and 12 which are used during the bleeding process. See diagram below. If connector F9 is not referenced correctly, pin 10, which is not used, may be mistaken for one of the pins used in the bleeding process.

When performing secondary side bleeding of the A.B.S. Hydraulic Control Unit, make certain you are referencing the connector (F9) at the control unit correctly.
