SERVICE BULLETIN

APPLICABILITY: All Models
SUBJECT: Tire Rotation Pattern

NUMBER: 05-37-07
DATE: 03/12/07

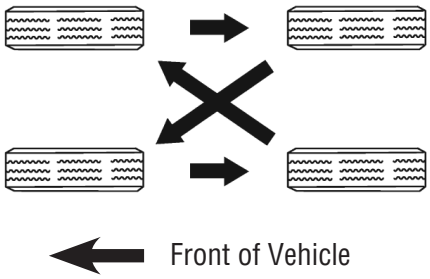
Tire Rotation Pattern for Non-Directional Tires

In an effort to further reduce uneven tire wear and prolong tire life, the tire rotation pattern has been changed for non-directional tires. To maximize the life of each tire and ensure that the tires wear uniformly, it is best to rotate the tires every 7,500 miles (12,000 km). Note: The tire rotation pattern for directional tires has not changed.
