PRECAUTIONS FOR REPAIRING BODY STRUCTURE PANELS

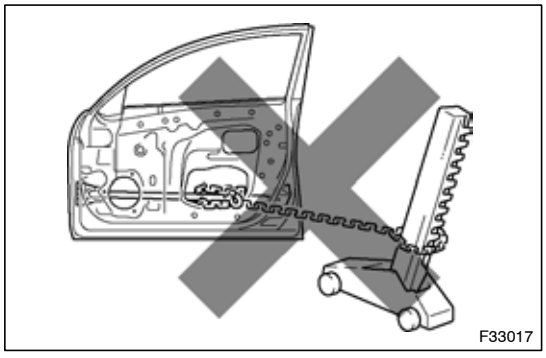
F33015

A sharp deformation angle on a panel that cannot be returned to its original shape by pulling or hammering is called a kink.

Structural parts are designed to perform in their original shape. If parts are deformed in an accident, or if the deformed parts are repaired and reused, the parts may be unable to perform as intended.

It is necessary to replace the part where the kink has occurred.
