PRECAUTIONS FOR REPAIRING BODY STRUCTURE PANELS

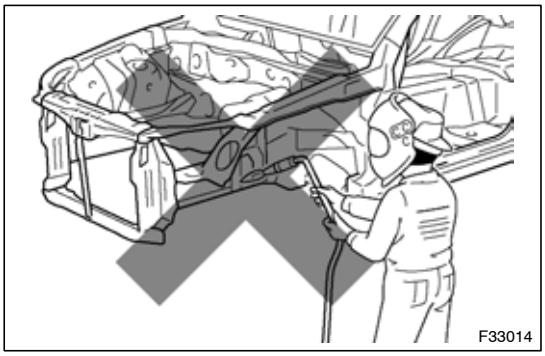
F33014

Toyota prohibits the use of the heat repair method on body structure panels when repairing a vehicle damaged in a collision.

If body structure parts are heat repaired with an acetylene torch or other heating source, the crystalline organization of the steel sheet will change and the strength of the steel sheet will be reduced. The ability of the body to resist rust is significantly lowered as well since the rust resistant zinc coating is destroyed by heat and the steel sheet surface is oxidized.
