DTC	C1336/39	Zero Point Calibration of Deceleration Sensor Undone

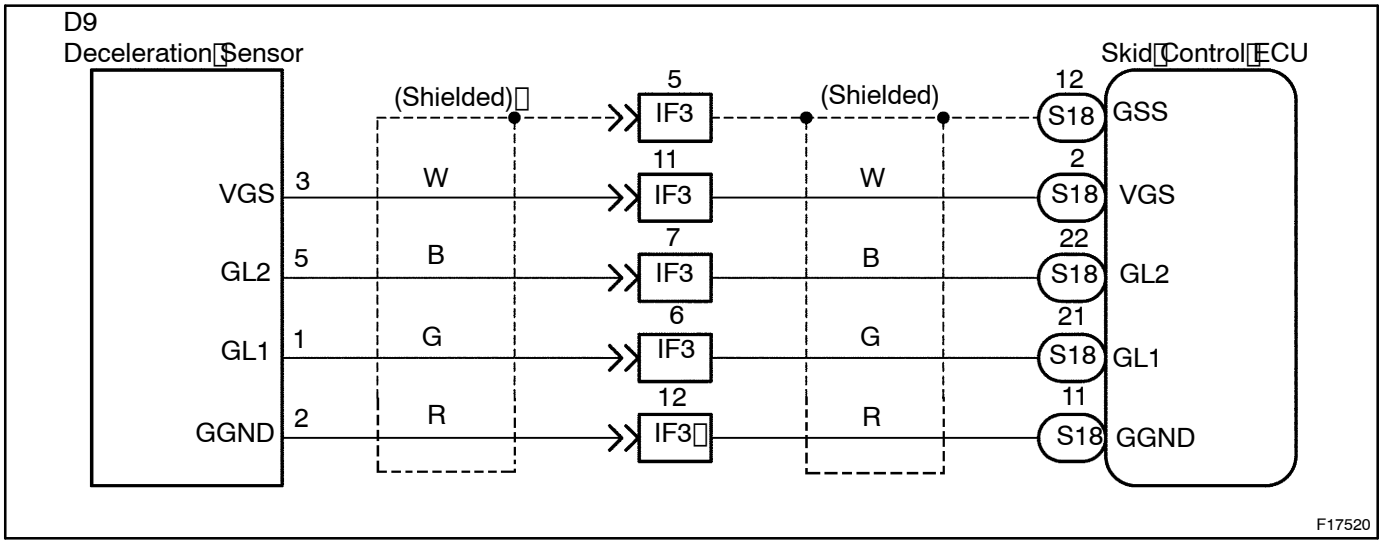
WIRING DIAGRAM

DTC No.	DTC Detecting Condition	Trouble Area
C1336/39	After battery terminal was connected, when the shift lever was moved other than to P position within 15 sec. soon after ECU terminal IG1 become ON for the first time.	• Deceleration sensor • Deceleration sensor circuit • P position switch circuit
