PRECAUTIONS FOR REPAIRING BODY STRUCTURE PANELS

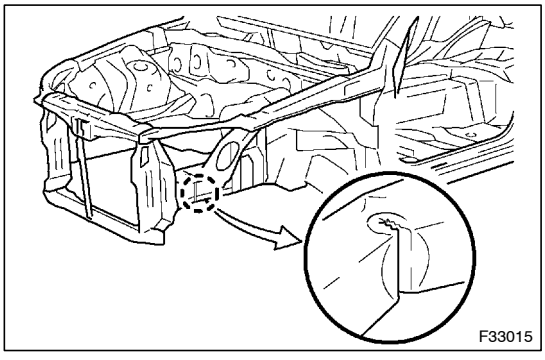
Toyota prohibits the use of the heat repair method on body structure panels when repairing a vehicle damaged in a collision.

If body structure parts are heat repaired with an acetylene torch or other heating source, the crystalline organization of the steel sheet will change and their strength of the steel sheet will be reduced. The ability of the body to resist rust is significantly lowered as well since the rust resistant zinc coating is destroyed by heat and the steel sheet surface is oxidized.

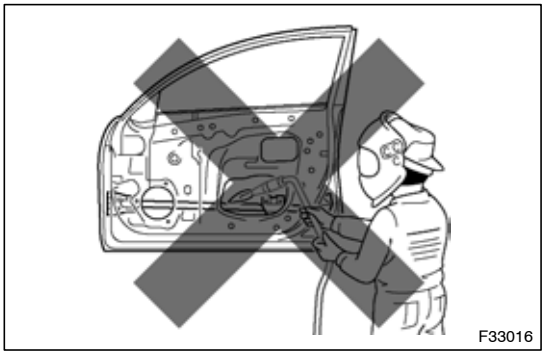
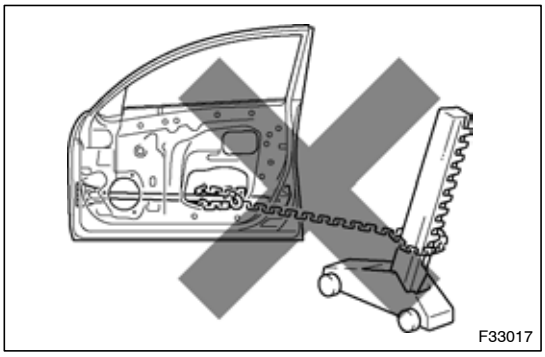
F33016

A sharp deformation angle on a panel that cannot be returned to its original shape by pulling or hammering is called a kink.

Structural parts are designed to perform in their original shape. If parts are deformed in an accident, or if the deformed parts are repaired and reused, the parts may be unable to perform as intended.

It is necessary to replace the part where the kink has occurred.
