PRECAUTIONS FOR REPAIRING BODY STRUCTURE PANELS

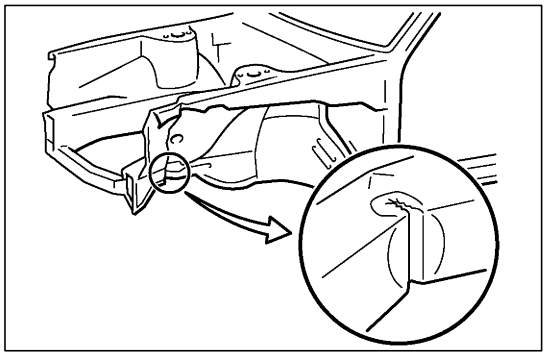
If a body structure parts are heat repaired with an acetylene torch or other heating source, the crystalline organization of the steel sheet will change and the strength of the steel sheet will be reduced.

The ability of the body to resist rust is significantly lowered as well since the rust resistant zinc coating is destroyed by heat and the steel sheet surface is oxidized.

Toyota prohibits the use of the heat repair method on body structure panels when repairing a vehicle damaged in a collision.
