TOYOTA SERVICE BULLETIN

Group: 09 No.: 08 Date: Oct, 18

## Model : Hiace

# Subject : Corrections to Repair Manual RM26T0E

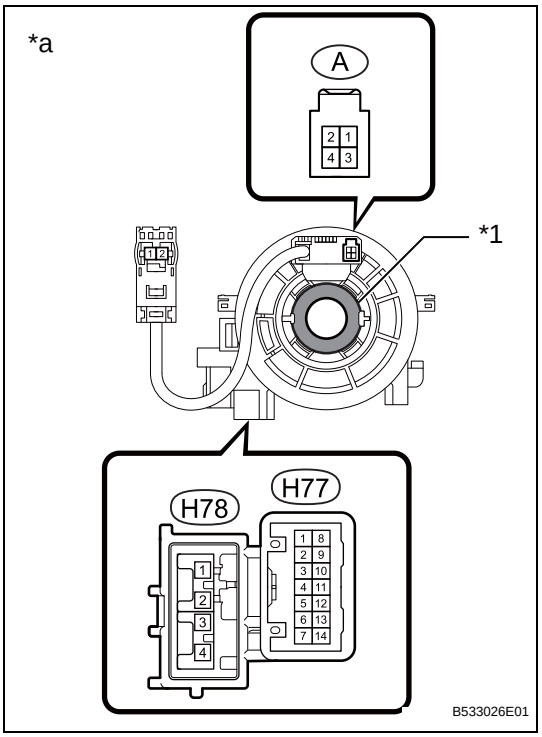
**When rotating the spiral cable sub-assembly, make sure to push on the interlock indicated in the illustration to release the interlock mechanism.**

[All Corrected]

If the result is not as specified, replace the spiral cable sub-assembly.

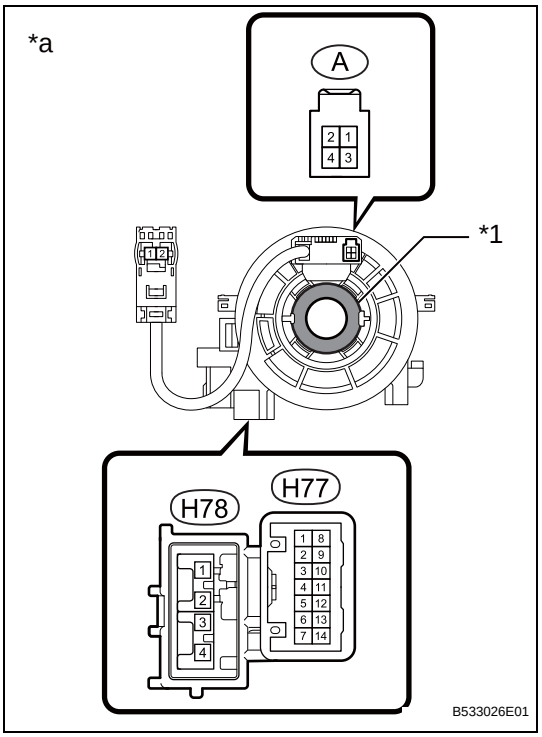
**When rotating the spiral cable sub-assembly, make sure to push on the interlock indicated in the illustration to release the interlock mechanism.**

[All Corrected]

If the result is not as specified, replace the spiral cable sub-assembly.

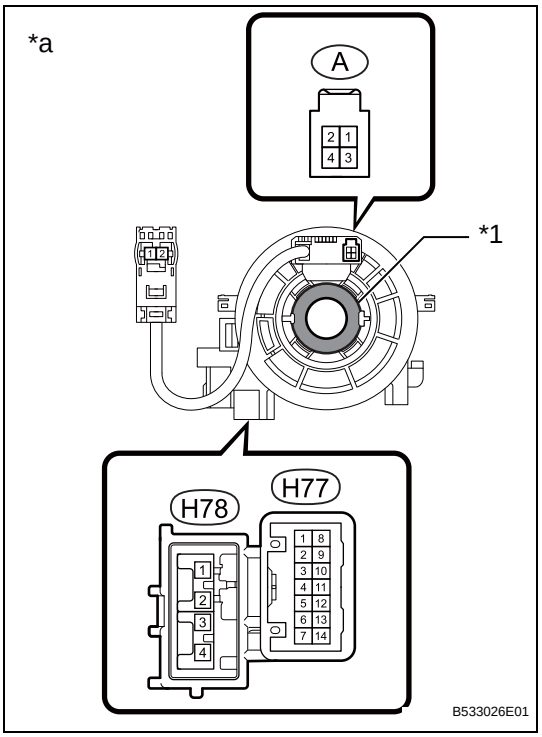
**When rotating the spiral cable sub-assembly, make sure to push on the interlock indicated in the illustration to release the interlock mechanism.**

[All Corrected]

If the result is not as specified, replace the spiral cable sub-assembly.

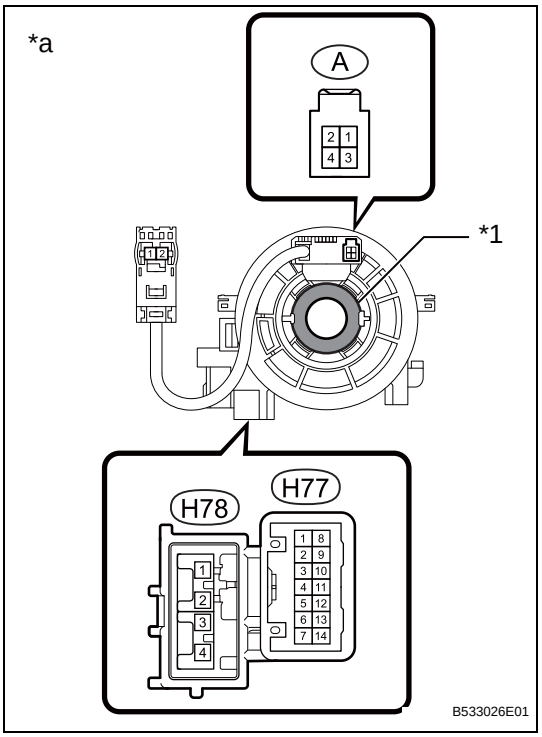
**When rotating the spiral cable sub-assembly, make sure to push on the interlock indicated in the illustration to release the interlock mechanism.**

[All Corrected]

If the result is not as specified, replace the spiral cable sub-assembly.
