PRECAUTIONS FOR REPAIRING BODY STRUCTURE PANELS

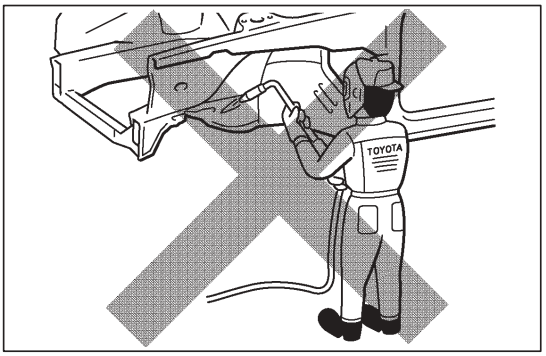
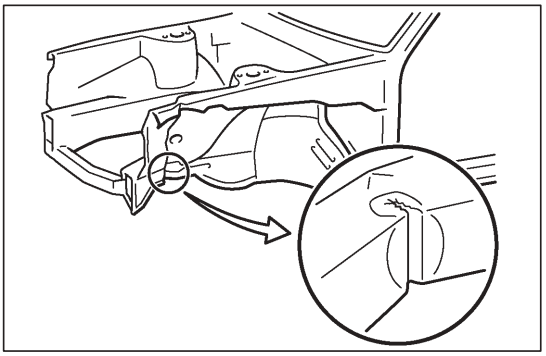
Toyota prohibits the use of the heat repair method on body structure panels when repairing a vehicle damaged in a collision.

If a body structure parts are heat repaired with an acetylene torch or other heating source, the crystalline organization of the steel sheet will change and the strength of the steel sheet will be reduced.

The ability of the body to resist rust is significantly lowered as well since the rust resistant zinc coating is destroyed by heat and the steel sheet surface is oxidized.

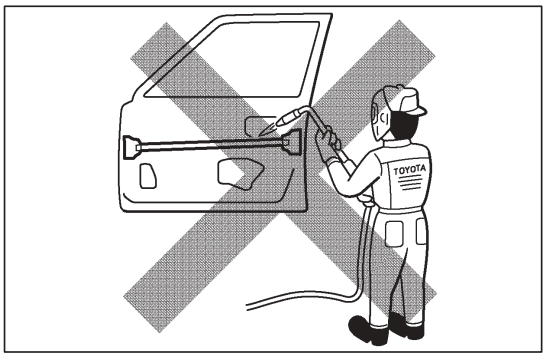
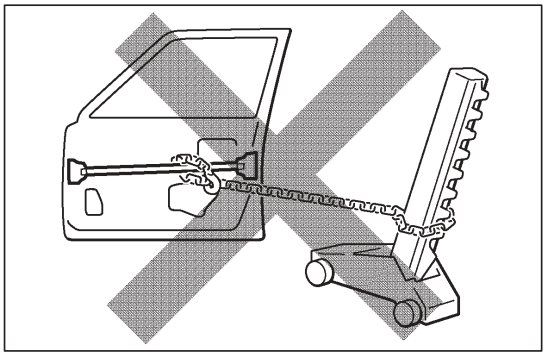
A sharp deformation angle on the panel that cannot be returned to its original shape by pulling or hammering is called a kink.

Since structure parts were designed to exhibit a 100% performance when they were in their original shape, if they are deformed in an accident, or if the deformed parts are repaired and reused, they become unable to exhibit the same performance as intended in the design.

It is necessary to replace the part where the kink has occurred.
