PRECAUTIONS FOR REPAIRING BODY STRUCTURE PANELS

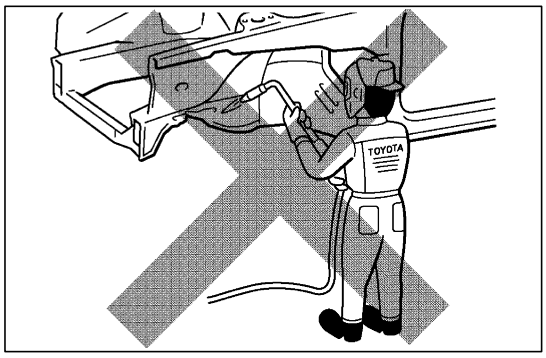
Toyota prohibits the use of the heat repair method on body structure panels when repairing a vehicle damaged in a collision.

If a body structure parts are heat repaired with an acetylene torch or other heating source, the crystalline organization of the steel sheet will change and the strength of the steel sheet will be reduced.

The ability of the body to resist rust is significantly lowered as well since the rust resistant zinc coating is destroyed by heat and the steel sheet surface is oxidized.

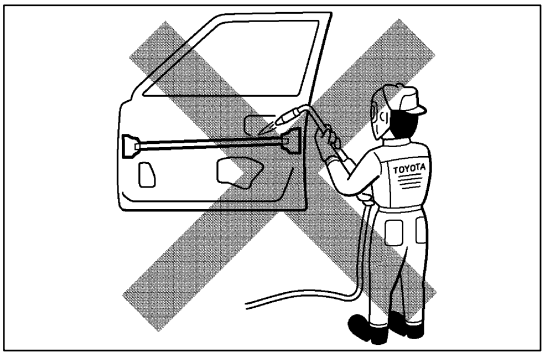
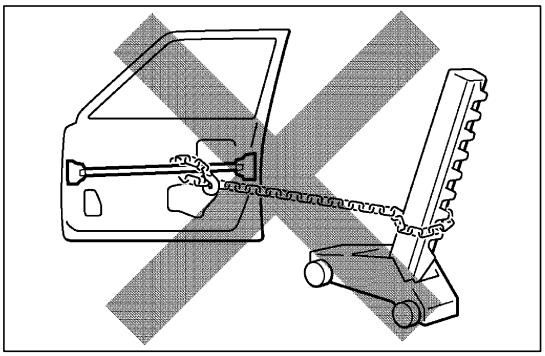
A sharp deformation angle on the panel that cannot be returned to its original shape by pulling or hammering is called a kink.

Since structure parts were designed to exhibit a 100% performance when they were in their original shape, if they are deformed in an accident, or if the deformed parts are repaired and reused, they become unable to exhibit the same performance as intended in the design.

It is necessary to replace the part where the kink has occurred.
