DTC B2797 COMMUNICATION MALFUNCTION NO.1

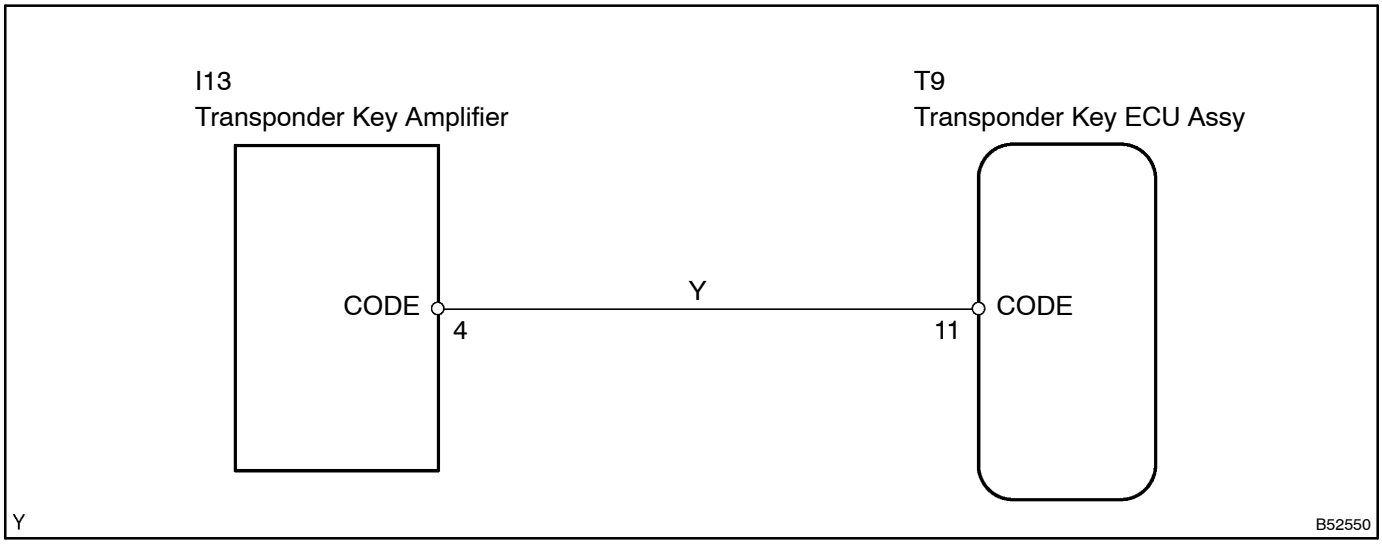
WIRING DIAGRAM

This DTC is output when an error occurs in the normal communication.
HINT:
Some noise exists in the communication line.

DTC No.	DTC Detection Condition	Trouble Area
B2797	Keys are positioned too close each other, or noise occurred in communication line	• Key • Wire harness • Transponder key amplifier (transponder key coil) • Transponder key ECU assy

(a) After exchanging the transponder key ECU, check that the engine starts.

OK → **NORMAL (TRANSPONDER KEY AMPLIFIER DEFECTIVE)**

REPLACE TRANSPONDER KEY ECU ASSY
