PRECAUTIONS FOR REPAIRING BODY STRUCTURE PANELS

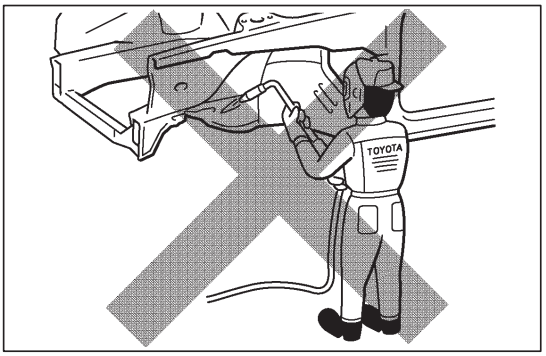
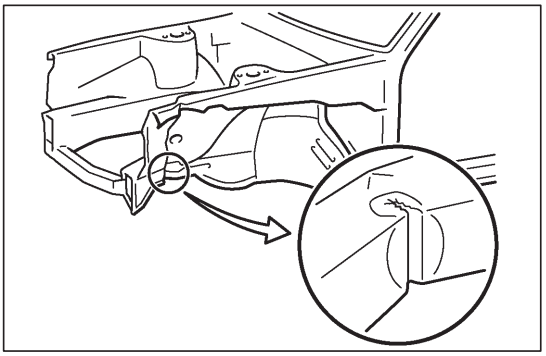
Toyota prohibits the use of the heat repair method on body structure panels when repairing a vehicle damaged in a collision.

If a body structure parts are heat repaired with an acetylene torch or other heating source, the crystalline organization of the steel sheet will change and the strength of the steel sheet will be reduced.

The ability of the body to resist rust is significantly lowered as well since the rust resistant zinc coating is destroyed by heat and the steel sheet surface is oxidized.
