PRECAUTIONS FOR REPAIRING BODY STRUCTURE PANELS

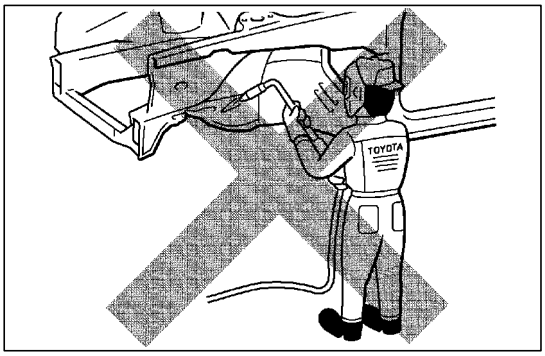
1. HEAT REPAIR FOR BODY STRUCTURE PANELS

Toyota prohibits the use of the heat repair method on body structure panels when repairing a vehicle damaged in a collision.

If a body structure parts are heat repaired with an acetylene torch or other heating source, the crystalline organization of the steel sheet will change and the strength of the steel sheet will be reduced.

The ability of the body to resist rust is significantly lowered as well since the rust resistant zinc coating is destroyed by heat and the steel sheet surface is oxidized.

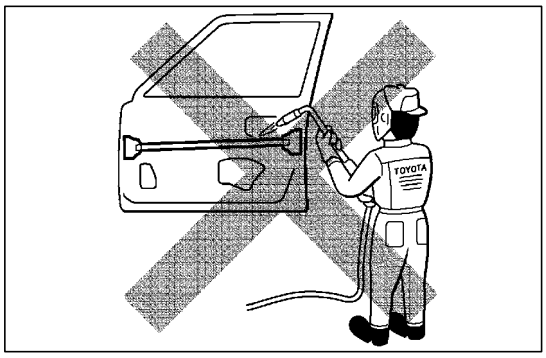
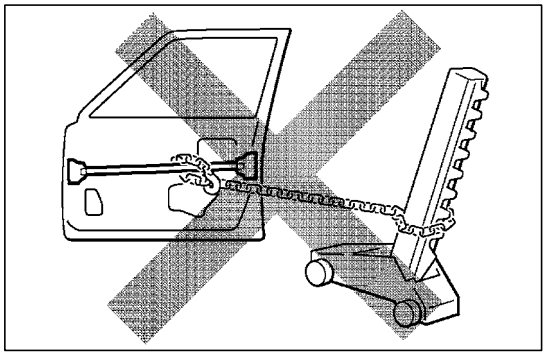
A sharp deformation angle on the panel that cannot be returned to its original shape by pulling or hammering is called a kink.

Since structure parts were designed to exhibit a 100% performance when they were in their original shape, if they are deformed in an accident, or if the deformed parts are repaired and reused, they become unable to exhibit the same performance as intended in the design.

It is necessary to replace the part where the kink has occurred.
