PRECAUTIONS FOR REPAIRING BODY STRUCTURE PANELS

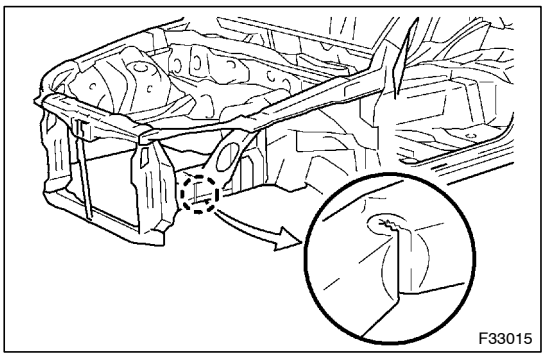
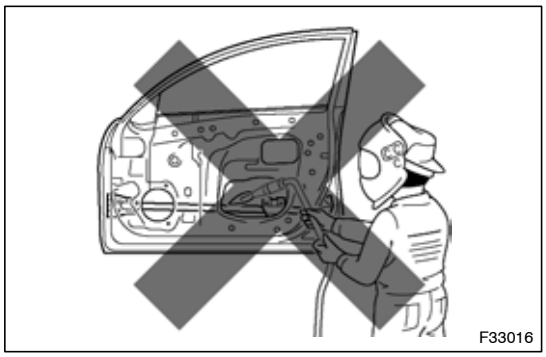
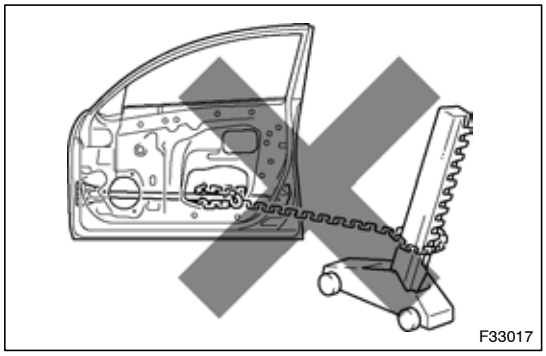
Toyota prohibits the use of the heat repair method on body structure panels when repairing a vehicle damaged in a collision.

If body structure parts are heat repaired with an acetylene torch or other heating source, the crystalline organization of the steel sheet will change and their strength of the steel sheet will be reduced. The ability of the body to resist rust is significantly lowered as well since the rust resistant zinc coating is destroyed by heat and the steel sheet surface is oxidized.
