PRECAUTIONS FOR REPAIRING BODY STRUCTURE PANELS

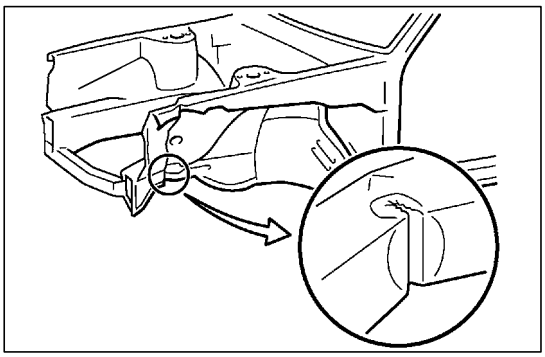
1. HEAT REPAIR FOR BODY STRUCTURE PANELS

Toyota prohibits the use of the heat repair method on body structure panels when repairing a vehicle damaged in a collision.

If body structure parts are heat repaired with an acetylene torch or other heating source, the crystalline organization of the steel sheet will change and the strength of the steel sheet will be reduced. The ability of the body to resist rust is significantly lowered as well since the rust resistant zinc coating is destroyed by heat and the steel sheet surface is oxidized.
