# insider info.

## Clutch Pedal Sticking

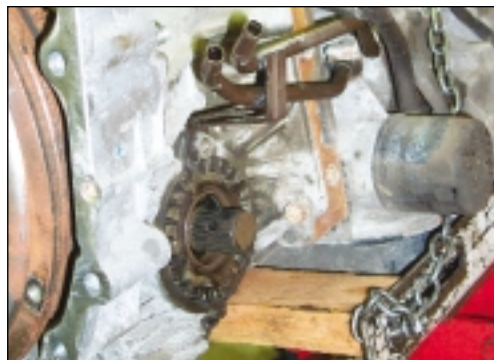
Phase II 4EAT Transmission

There are seven different shift schedules/maps in the TCM logic control of the 1999 Second Generation 4EAT. They are Normal, Power, Slope, Hold 2nd, Cruise, Hot ATF, Cold ATF. The shift schedule/map will determine how and when the transmission shifts. For example, in the slope mode, when driving up a hill under certain engine load conditions, the TCM will shift the transmission back down to 3rd gear.

This is done to keep the transmission from upshifting/downshifting in and out of 4th gear needlessly. On the uphill control, the slope angle is estimated from the throttle opening angle and vehicle speed change. When the TCU detects that the vehicle is moving uphill, upshifting is restrained by selecting a special shift map, which prevents needless upshifting/downshifting.
