SERVICE BULLETIN

92MY SIA BUILT LEGACY STATION WAGON
WITH MANUAL TRANSMISSION

SUBJECT: COMBINATION METER WIRING

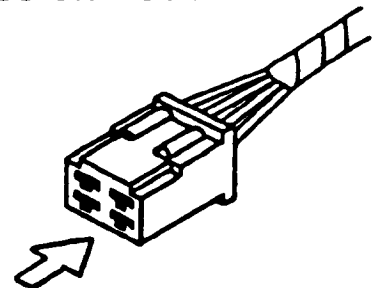
Note: I-14 is not used on manual transmission Models

Viewed from this direction

Relocate the pins in connectors I-14 and I-15 as shown
