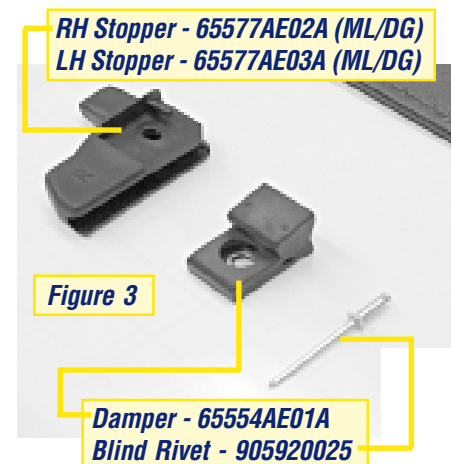
Please be advised of specific part ordering, pertaining to the Legacy’s tonneau cover (00MY-03MY). If a customer complains about the hook ends loose or missing, it is not necessary to order a complete tonneau

NOTE: 2000 model Legacy’s only have the screw. 2001 may be either a blind rivet or screw. 2002 and up Legacy’s uses a blind rivet.

cover assembly. Simply order the hook ends, damper and rivet (see figure 3 for part number applicability).

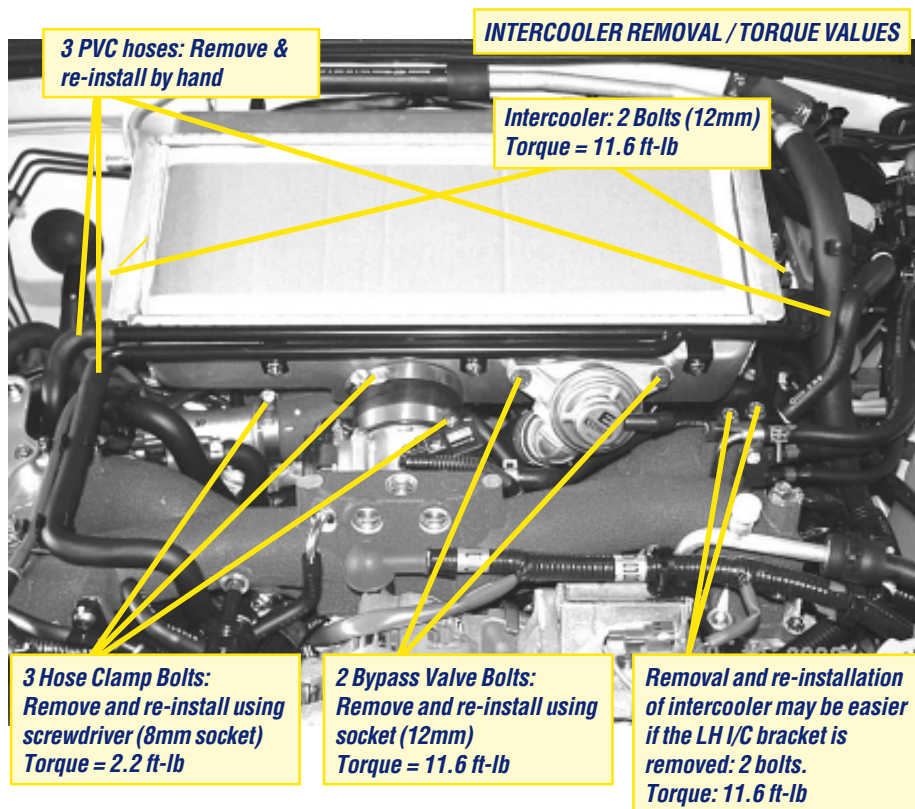
- 1) Use care when handling the intercooler. Failure to do so may result in damage to the top surface (e.g. fins). See figure 2 for one method of handling the intercooler when removing from the vehicle.
- 2) Be sure to cover all open holes (e.g. hoses, inlet and outlet pipes of intercooler and turbocharger) to prevent objects from falling inside.
- 3) After the vacuum hose is routed properly and the intercooler is ready to go back in the vehicle, ensure that the rubber intake air duct to the intercooler is secured all the way around the metal inlet pipe (see figure 2).
