16 PHASE II 4EAT STUD LEAK REPAIR (REVISED)

This is revised information concerning the article published in the **November 2003 TechTIPS Newsletter**.

Articles in This Issue

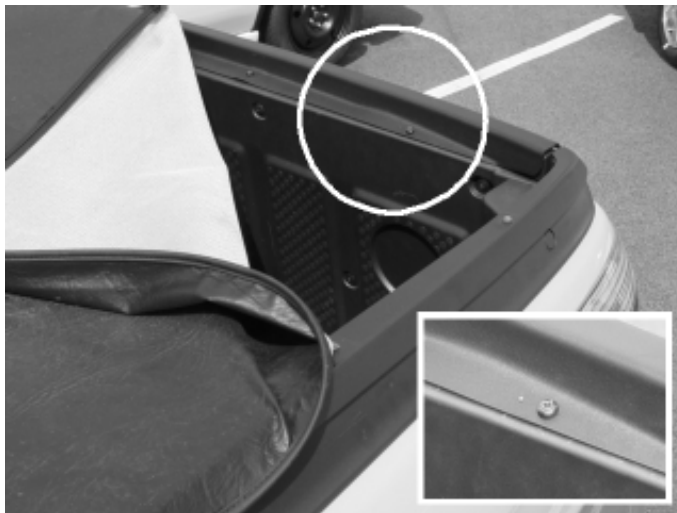
L0010LS030 -- Soft cover replacement part includes two latches.

L0010LS080 -- Support bow. If the customer wants a bow, you will need to order it separately.

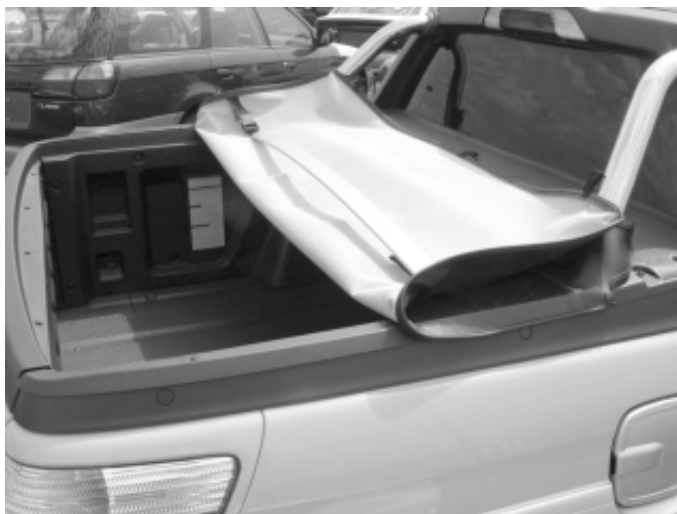
New Style

L0010LS031 -- Soft cover replacement part (the support bow is included in the original kit).

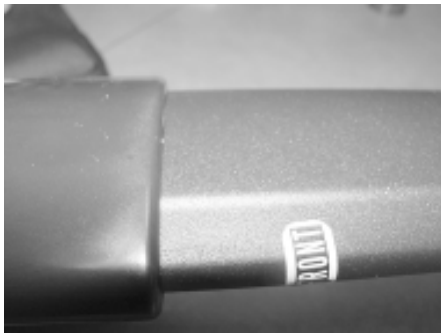
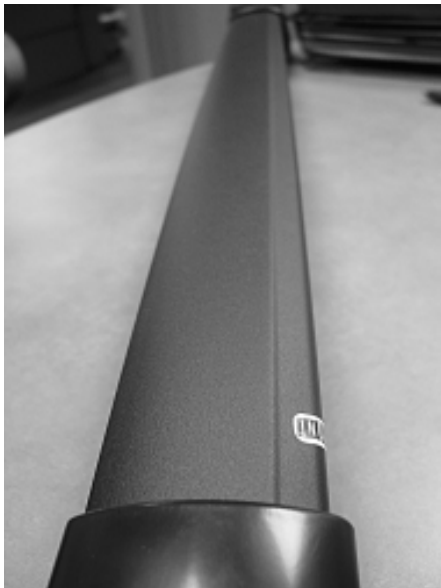
The design of the Forester crossbar has been revised. The crossbar previously contained black textured tape on the top of the bar surface. The tape has been removed and is replaced with black textured paint. This redesigned crossbar is applicable to 2003 and the upcoming 2004 Forester.

- **P/N E361SSA011**
2004 Forester Front X-Bar Assembly with black textured paint
- **P/N E361SSA012 -**
2004 Forester Rear X-Bar Assembly with black textured paint
