TECHNICAL SERVICE BULLETINS

APPLICABILITY: STi Vehicles, All Model Years
SUBJECT: Towing Recommendations

NUMBER: 01-162-05
DATE: 06/28/05

APPLICABILITY: All Models
SUBJECT: Cylinder Head Gasket (residual carbon deposits and rubber coating removal)
NUMBER: 02-100-06R
DATE: 10/31/06

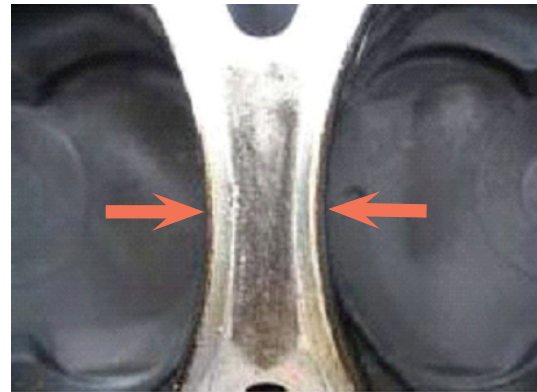
Carbon deposit on cylinder block bore sealing portion

Using a gasket scraper, carefully clean any carbon deposits and rubber coating found on the surface of cylinder block and cylinder head.

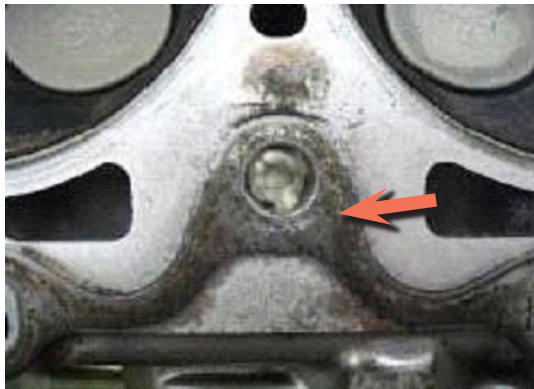
Rubber coating residue on coolant sealing portion

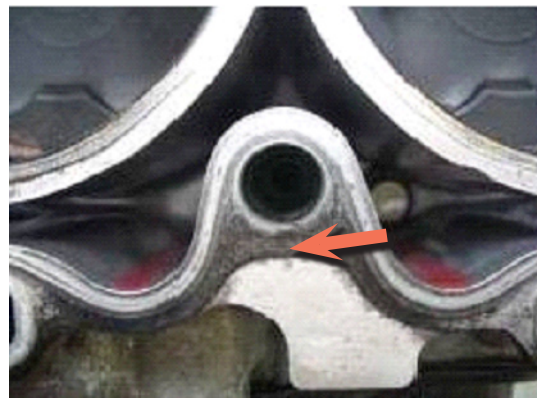
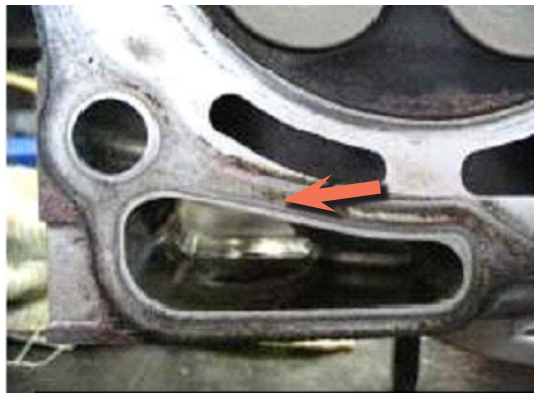
Rubber coating residue on oil sealing portion

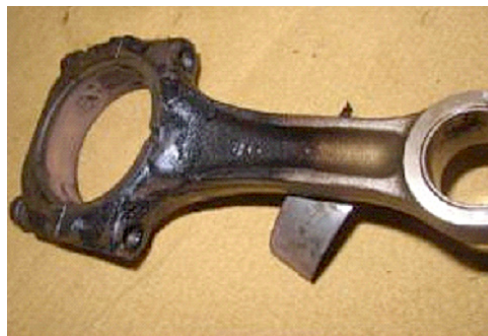
- Some brands of oil which are available in the aftermarket may not have enough lubrication ability and durability, regardless the price. (Poor performance oil causes damage on the crankshaft bearing, camshaft bearing, piston ring, cylinder liner, or turbo charger.)
- If the oil complies with the American Petroleum Institute (API) classification of SM (or SL minimum), and is within the recommended viscosity, it will not cause engine problems.
- A lack of oil may cause damage to the crankshaft bearing, camshaft bearing, piston ring, cylinder liner, or turbo charger.
- When the vehicle is used under severe driving conditions, moderate to hard acceleration on a somewhat regular basis, the engine oil and filter should be changed every 3,750 miles (6,000 km) or 3.75 months. For additional examples of severe driving conditions, refer to the Warranty & Maintenance Booklet.

- The use of a Genuine Subaru oil filter is strongly recommended. Many aftermarket oil filters have different filtration capacity and relief valve opening pressure. Those filters may not meet Subaru's requirements and may cause engine problems.

Rod Bearing Spun from Lack of Oil

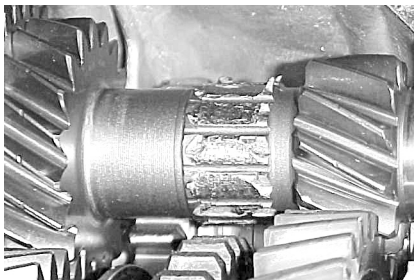
Some examples of abusive driving are exceeding maximum recommended RPMs, excessive torque transferred to the transmission during acceleration from a complete stop (dumping the clutch), downshifting at high RPMs and missing shifts.

Reverse Gear Teeth Stripped

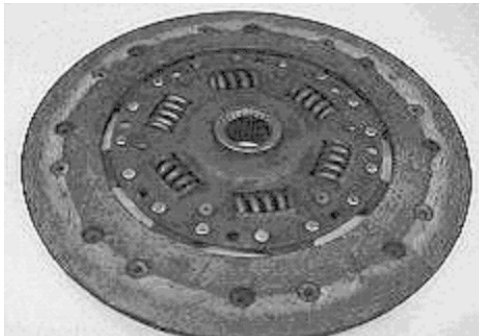
Over Heated Clutch Disc

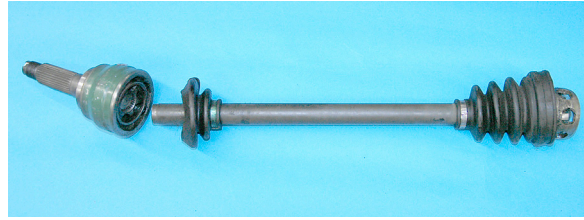
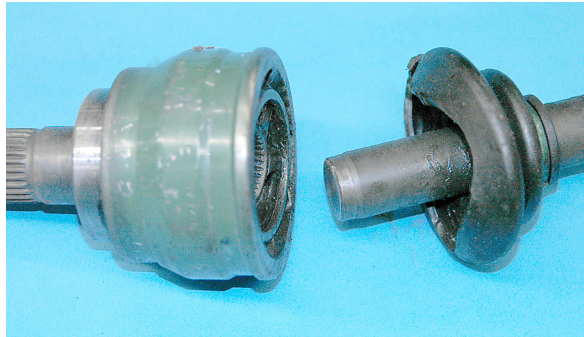
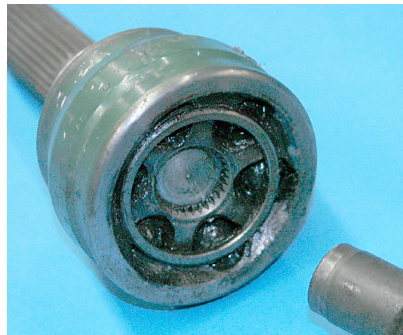
The following 3 photos show an axle shaft that was sheared off at the “Bell Joint” (BJ) as the result of abuse.

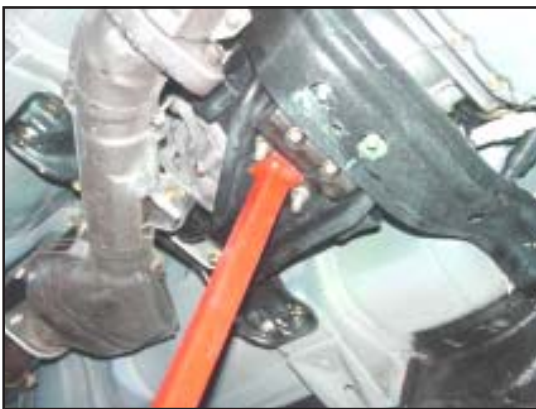
Figure 1

When performing service work or installing SOA's accessory short throw shifter, it is extremely important that the transmission is supported properly when removing or reinstalling the cross member. If not, damage to the bolts and/or threads will occur. Support the transmission using a transmission jack, regardless if the vehicle is supported by a lift or car ramps (**Figure 1**). It is recommended that hand tools be used for the removal and installation of the bolts. Inspect for bolt thread damage and replace as necessary. Be sure to clean any protective wax from the mating surfaces and be sure to start all bolts several threads by hand before using tightening tools. **Note: If severe damage is evident to the threads, the use of a Heli-coil® type kit is an approved repair method.**

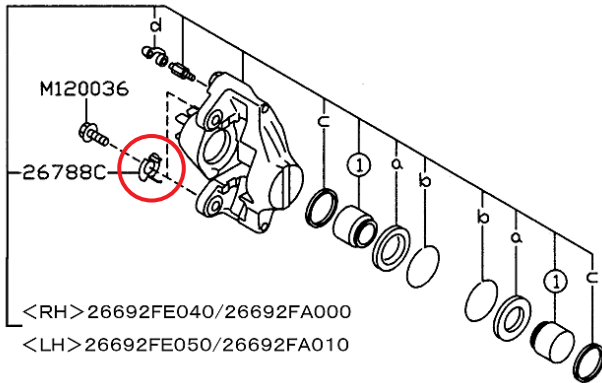
New Disk Brake Kit: 26692FE040/050 (LH/RH)

Note: Though there were design changes made to this part, the part numbers remain the same.

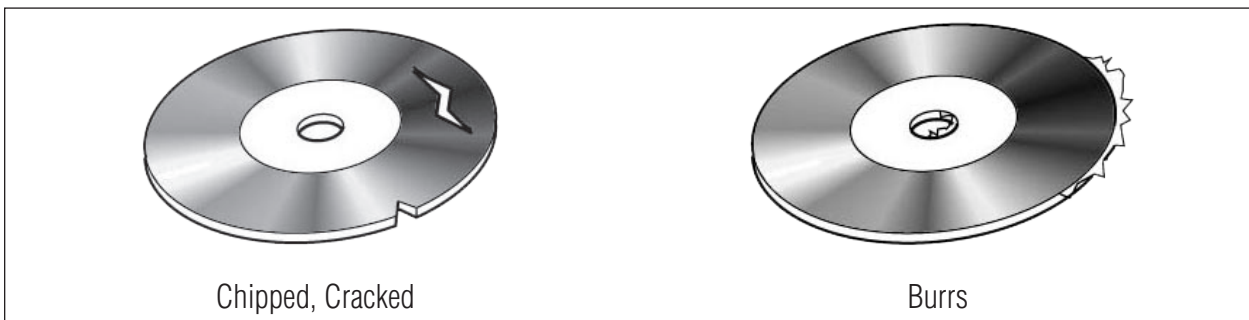
3. Damaged Discs

4. Poor quality discs.

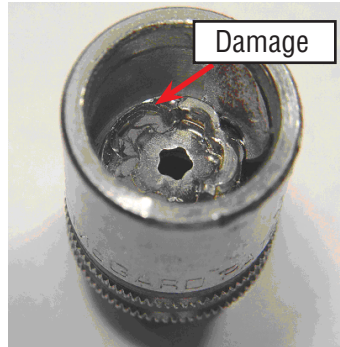
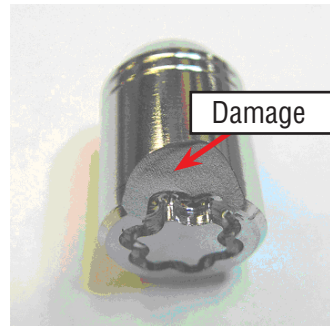
WARNING: Use of an impact wrench may cause permanent damage to the wheel lock and key.

NOTE: For ease of installation and removal, the wheel lock should always be the last lug nut tightened on each wheel and should always be the first one removed.

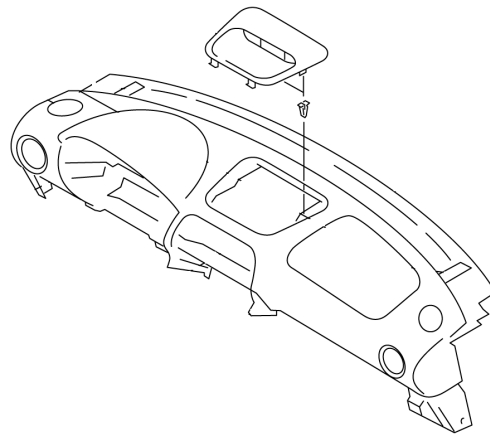
Check the part number of the clock currently installed in the vehicle. If equipped with the old style, replace it with the new style.

- 1) Record radio stations.
- 2) Disconnect negative battery cable
- 3) Remove the clock by carefully lifting up on the clock cover and disengage the 2 front clips.
