# SERVICE BULLETIN

| <b>SERVICE BULLETIN</b> | | No.: MSB-99E13-501 | |
| <b>Subject:</b> CORRECTION OF CONNECTOR NOS. | | <b>&lt;M/Y&gt;</b><br>99-10 | |

| <b>Subject:</b> CORRECTION TO SHAPE OF LSPV AND TO<br>SPRING SUPPORT INSTALLATION | | <b>&lt;M/Y&gt;</b><br>99-10 | |

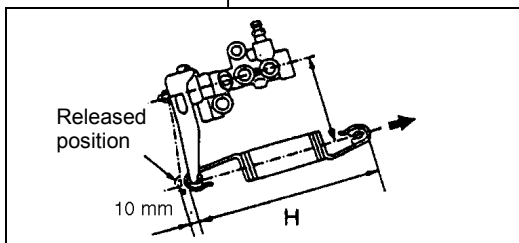
&lt;Correct&gt;

3. Disconnect the spring at the support side.
4. Place the spring so that it is in parallel with the load sensing proportioning valve, and pull in the direction indicated by the arrow so that its length H shown in the figure (the length between its ends) is as noted below.
