## Technical Service BULLETIN

### A/C COMPRESSOR MAINTENANCE FOR STORED VEHICLES

All Models

AC002-00

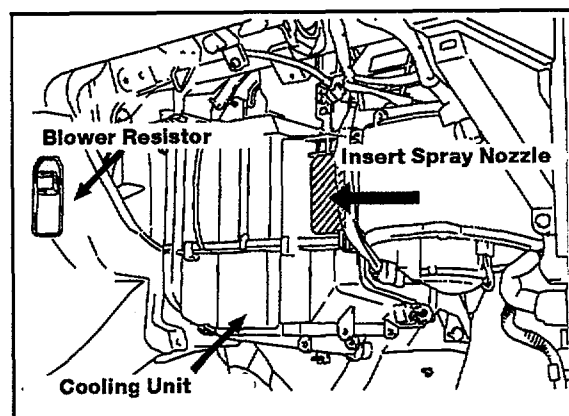
(f) Remove the blower resistor to allow access for the spray nozzle (insert at red arrow).

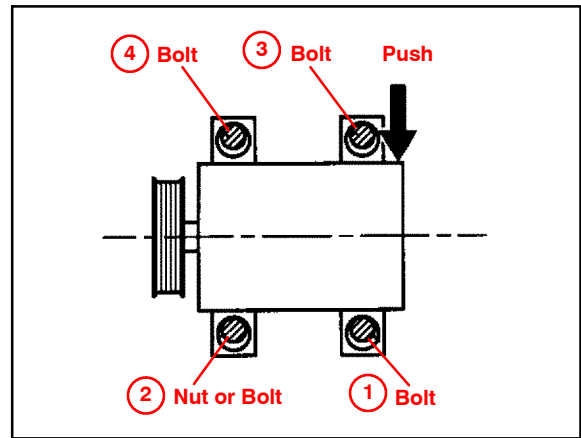
**Installation  
Procedure**  
(Continued)**1. AZ Series Engine:  
Install A/C Compressor**

**Introduction** Use the following tip when installing an A/C compressor on the AZ or ZZ series engine to ensure proper belt alignment. Improper installation of the A/C compressor may result in abnormal belt noise or wear.

- A. Loosely install the compressor  
(with the 3 bolts and nut or  
4 bolts.)

Push down on the rear side of the  
compressor and tighten the  
bolts/nut in the order shown.

**Torque: 24.5 N•m (250 kgf•cm, 18 ft•lbf)**

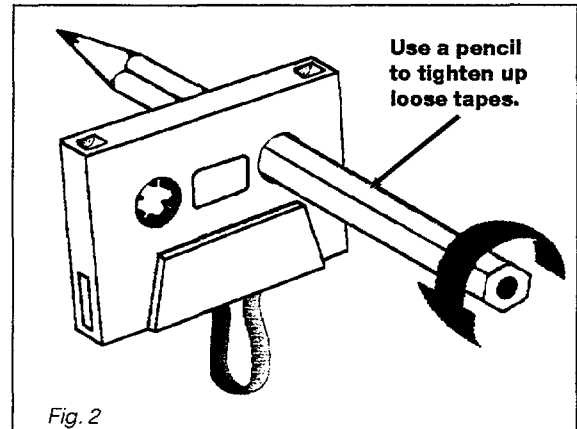
1. Remove the cassette from the player when the cassette is not in use.
2. Store the cassette in its case.
3. Store the cassette in a cool, dry area away from direct sunlight and magnetic components such as speakers.
4. Avoid touching the tape itself. This could result in poor sound quality or sound drop out.
5. Keep the tape tightly wound as shown in figure 2. Tape speed can be affected by loosely wound tape.

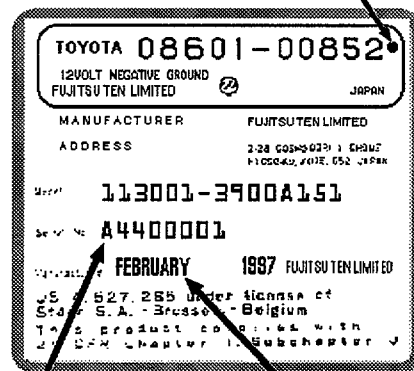
**Countermeasured units have this black dot**

**Introduction** The PIO/DIO 34224 Fujitsu Ten CD Player's (P/N 08601-00852) circuitry was changed to eliminate "does not eject/accept CD" conditions.

- Fujitsu Ten began shipping the countermeasured exchange units starting December 1996.
- Countermeasured CD players have a black dot after the Toyota Parts Number.

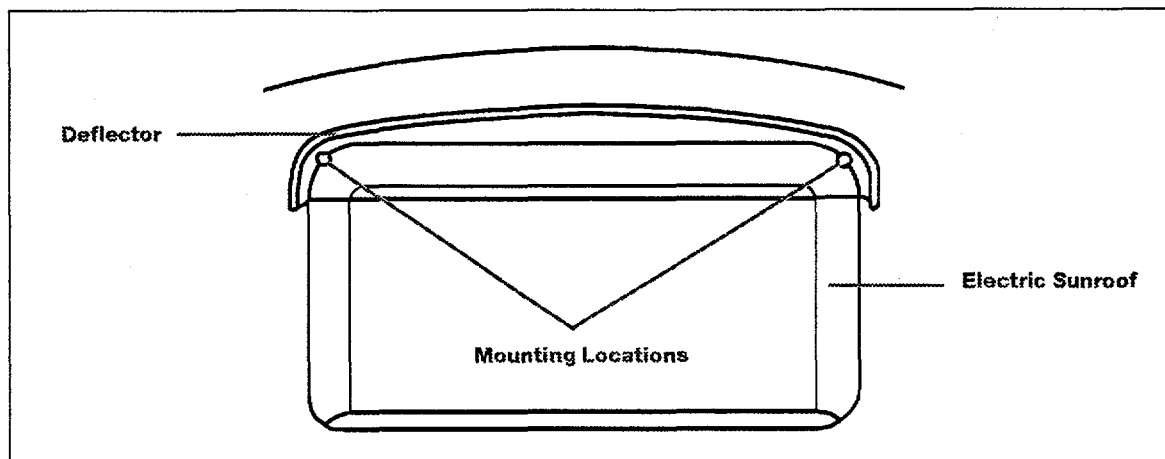
**Introduction** The accessory Sunroof Wind Deflector (Part Number 00531-42970) available for the RAV4 is applicable only to 4 door vehicles equipped with electric sliding sunroof.

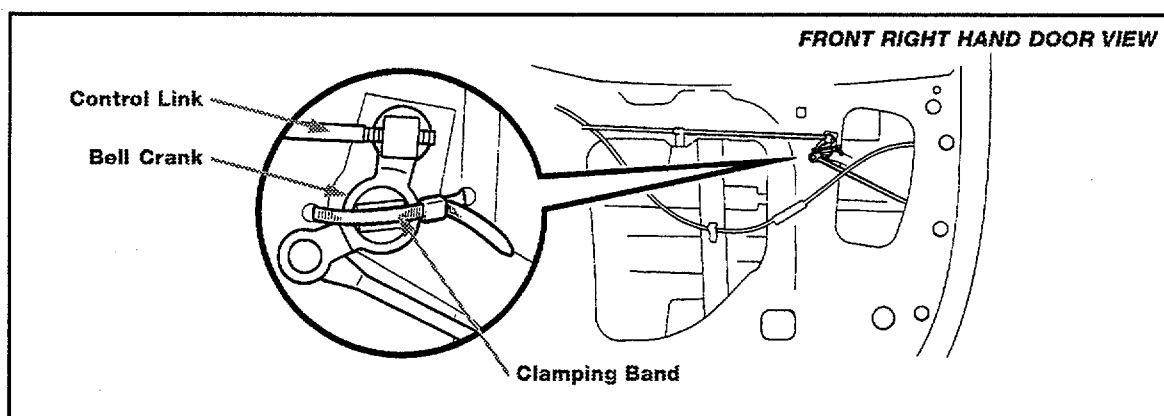
The bell crank pivot pin is identified in the parts microfiche as a "Front Door Lock Link Clamp".

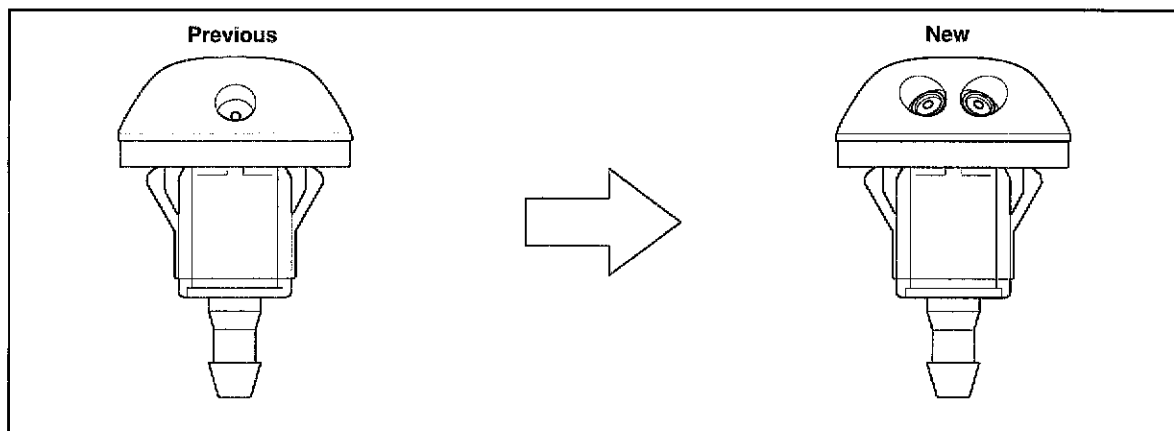
**Introduction** The rear wiper washer nozzle has been changed from a one-hole type to a two-hole type for improved washing performance.

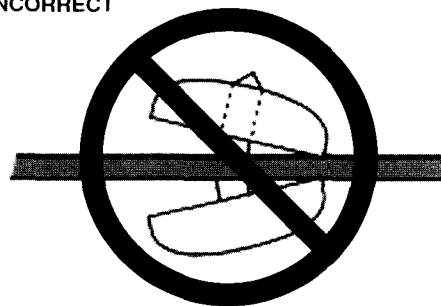
**INCORRECT**

- D. Check to be sure that the male pin of the Tongue Plate Stopper has become deformed evenly in the hole of the female part and is firmly held to the belt webbing. (See illustrations.)

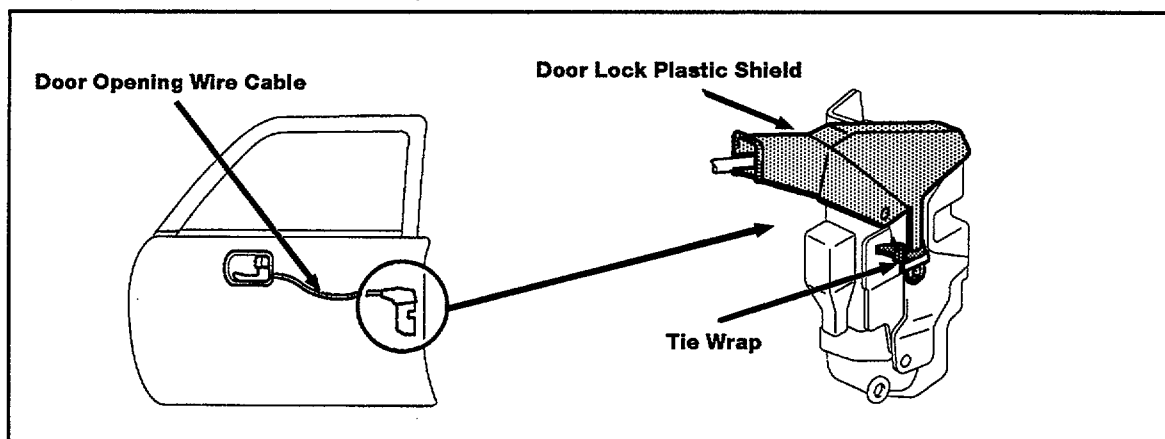
**Introduction** To enhance front door lock operation and promote water proofing of 1996 and 1997 MY RAV4 door locks, Toyota has added a wire cable door lock plastic shield. The new door lock plastic shield covers the top of the latch mechanism.

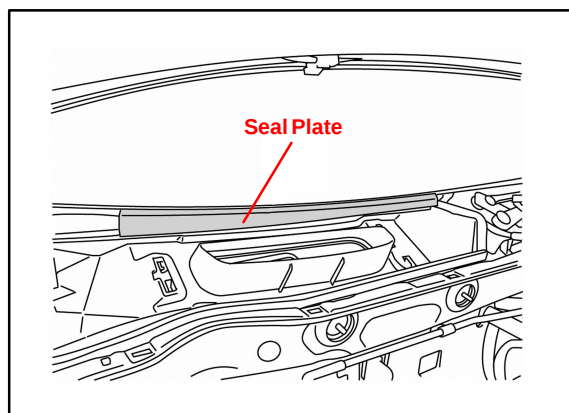
**Introduction** Some RAV4 customers may complain of water on the passenger's side floorboard after a heavy rainstorm or when going through a carwash. Water may be traveling underneath the outer cowl panel and entering the passenger compartment through the fresh air inlet of the heater box. The following repair procedure has been made available to correct this concern.

8. Install the seal plate on the cowl top outer panel as follows.

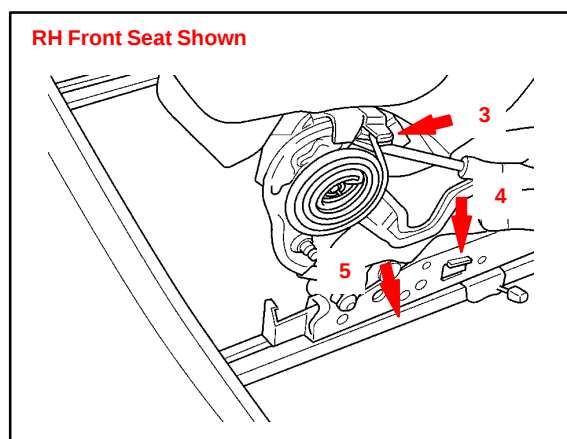
**Introduction** Some customers may complain that the seat back may be difficult to return from the recline position if it is tilted beyond 30 degrees. Improved seat springs are available for driver and passenger's seats. The following repair information has been provided to correct this concern.

3. Remove the outside spiral spring.
  - A. Insert a screwdriver between the spiral spring and the side frame (refer to “3” in the illustration).
  - B. Using the screwdriver, push against the spiral spring, just below the frame stopper and against the side frame lip behind the spring (refer to “4” in the illustration).
  - C. Remove the spiral spring. Use caution when removing the spring (refer to “5” in the illustration).

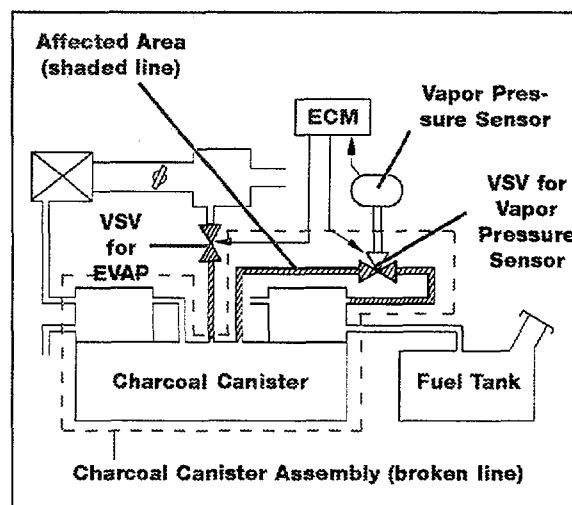
When performing diagnostics for an occurrence of a MIL "ON" condition, Diagnostic Trouble Code (DTC) P0441 may be result of debris in Evaporative Emission Control System. This may cause blockage of a vapor line, or a stuck VSV, as described in troubleshooting area of Repair Manual.

- A. Diagnostics for P0441:
1. Remove Vacuum Hoses between EVAP VSV and Charcoal Canister and discard.
  2. If there is a metal vapor pipe between EVAP VSV and Charcoal Canister, clean inside of vapor pipe.
  3. Replace EVAP VSV and Charcoal Canister assembly with new parts.
  4. Install new vacuum hoses between EVAP VSV and Charcoal Canister.
- B. Diagnostics for P0446:
1. Inspect vacuum hoses and pipes between EVAP (Purge) VSV and Charcoal Canister for leaks.
  2. Replace Vapor Pressure VSV and Canister.

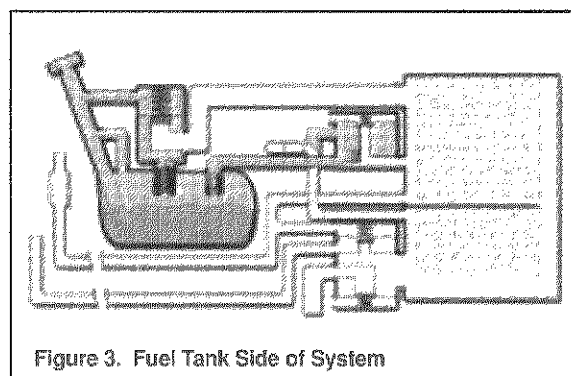
The ECM tests for leaks by measuring EVAP system pressure in the lines, charcoal canister, and fuel tank. When the EVAP pressure is higher or lower than atmospheric pressure, the ECM concludes that no leaks are present. EVAP pressure is measured by the vapor pressure sensor. If either the tank or canister purge side is at atmospheric pressure under specific conditions, the ECM determines there is a leak.

If DTC P0440 is present, the leak is on the fuel tank side of the EVAP system. This also includes the lines between the fuel tank and part of the canister. When the Vapor Pressure sensor is measuring tank pressure, the ECM is observing changes in pressure and comparing tank pressure to atmospheric pressure. No difference in pressure indicates a leak. The ECM may take 20 minutes or more to complete testing the fuel tank side (see Figure 3).

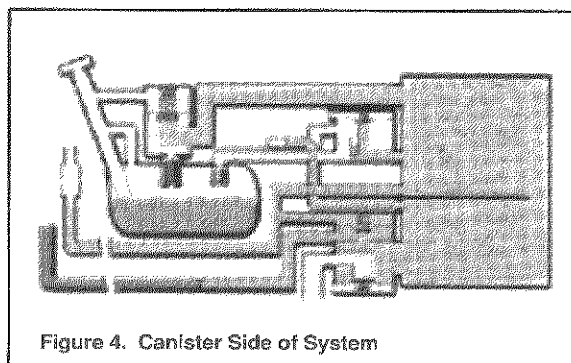
When the ECM switches the vapor pressure VSV to canister side, the ECM measures canister pressure. A leak on the canister side can set multiple DTCs (see Figure 4).

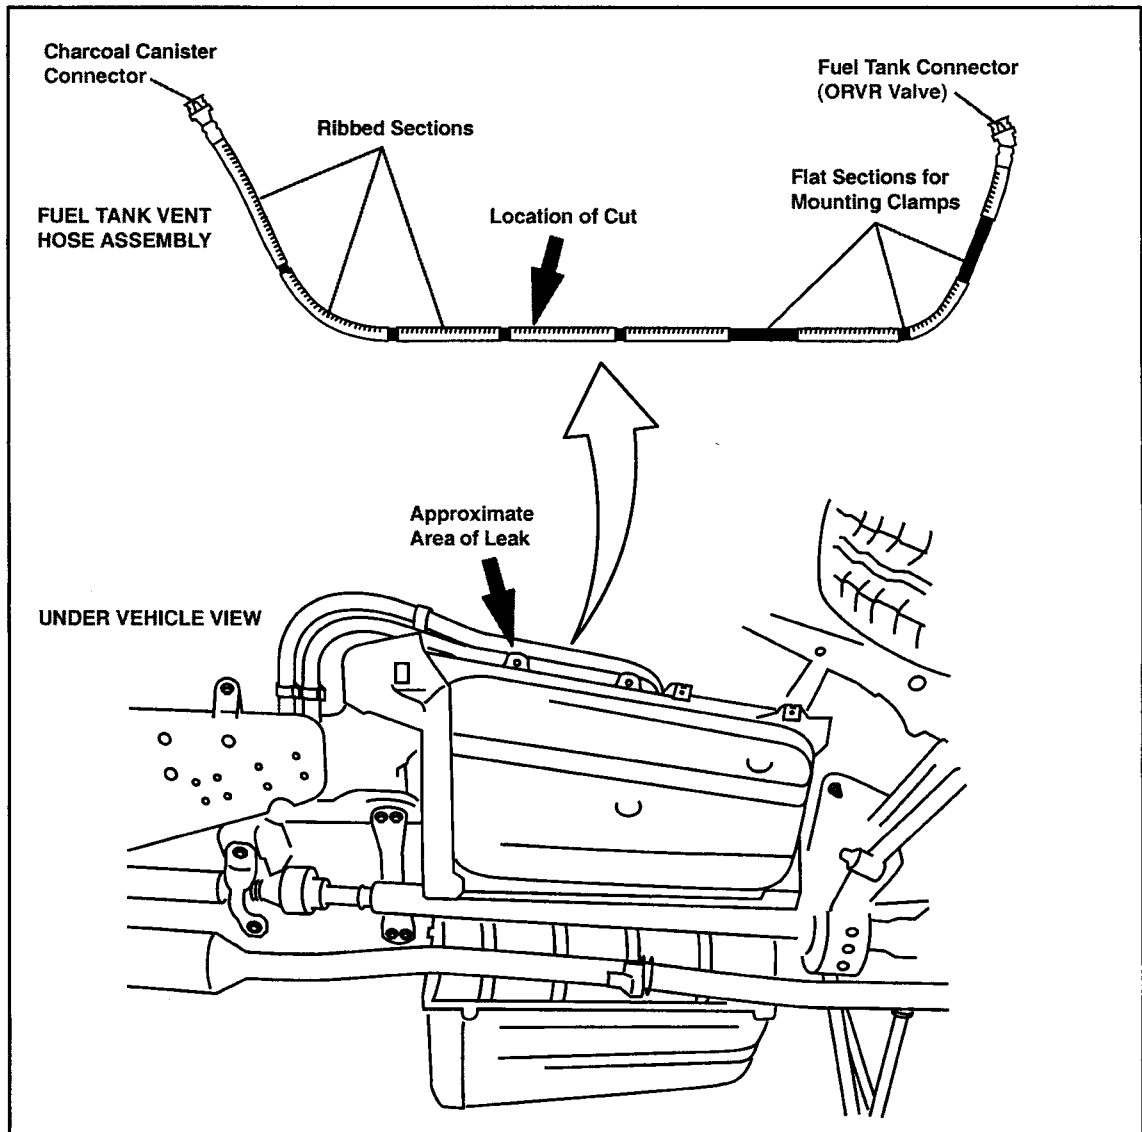
**Introduction** Some 2002 model year RAV4 vehicles may exhibit a M.I.L. "ON" with DTC P0442 (Evaporative Emission Control System Malfunction [Small Leak]) and/or DTC P0440 (Evaporative Emission Control System Malfunction). This may be due to slight damage to the Fuel Tank Vent Hose during the assembly process.

1. Pressure test the EVAP system to confirm leak from system using the EVAP Pressure Tester (P/N 00002–6872A). (Follow instructions on EVAP Pressure Tester.)
2. Examine the Fuel Tank Vent Hose Assembly **very closely** for a small cut in the 4th ribbed section from the charcoal canister (see illustration).

3. If cut is present, replace the Fuel Tank Vent Hose Assembly (P/N 77404–42010).
4. If no damage is found, perform EVAP system diagnostics for P0440 in the 2002 RAV4 Repair Manual, Volume 1, page DI–74.

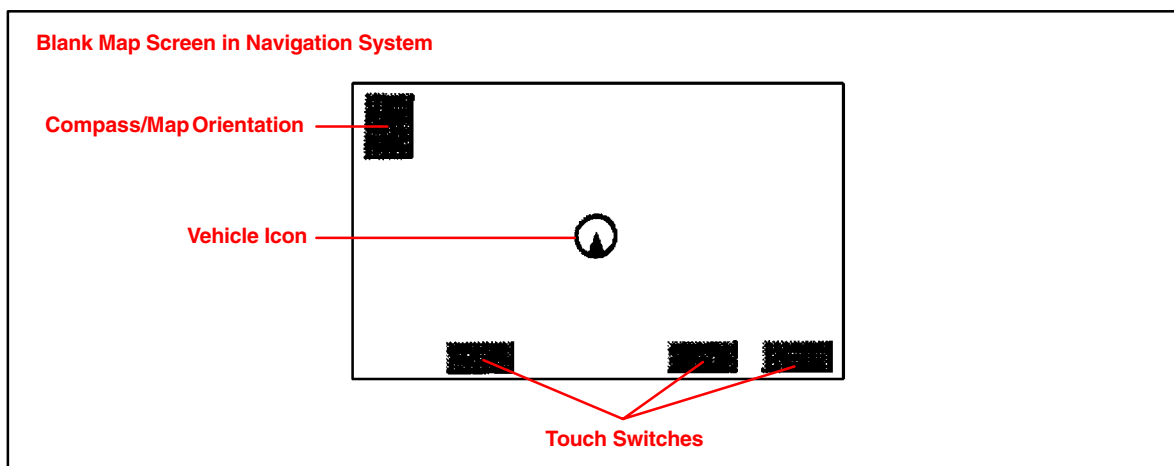
**Introduction** In some cases, when a vehicle arrives at a U.S. or Canadian port, and/or is in new inventory at the dealer, a blank map screen may occur, as shown below, just after turning the ignition switch ON and then touching the "I agree" switch. The only items that can be seen are the touch switches, compass, and the vehicle icon.

This condition is not a system failure. This is due to the system position memory originally identifying a set location near the manufacturing plant in Japan when the vehicle is brand-new. To re-initialize the navigation system memory location, follow the instructions on page 2.

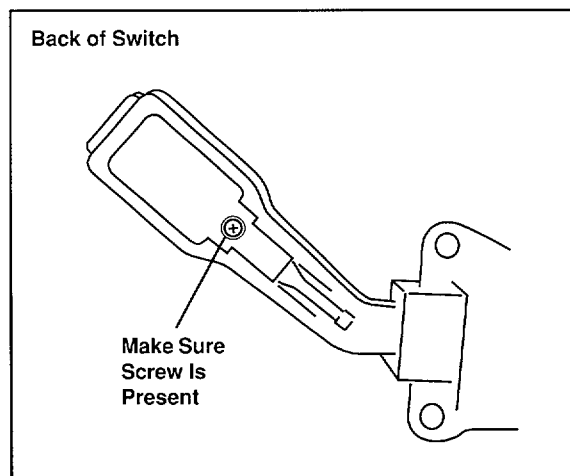
**Inspection Procedure** When replacing the Cruise Control Main Switch verify that the new part is equipped with a screw on the back of the switch. The screw can be seen from outside the part.

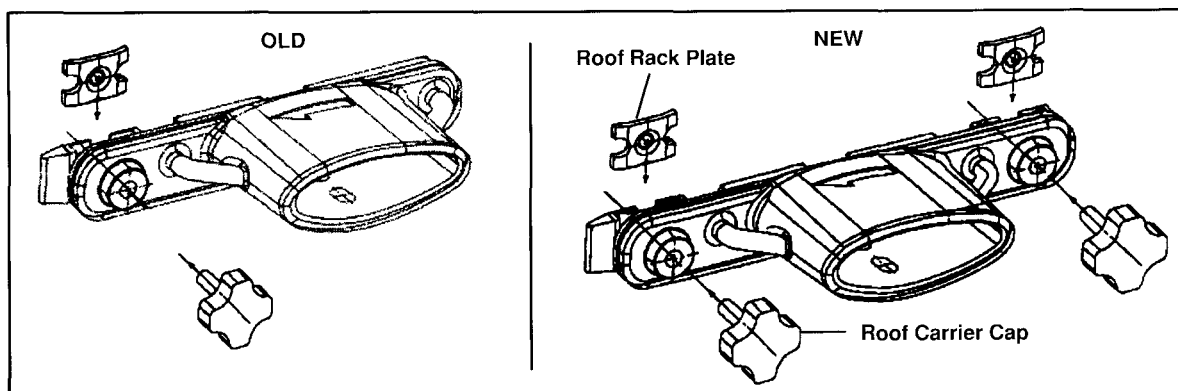
**Introduction** Some customers may complain of a rattle or buzz sound from the roof rack assembly when traveling over rough roads. The roof rack cross bar joints have been improved by adding an additional thumbscrew to provide a more secure attachment to the roof rack assembly.

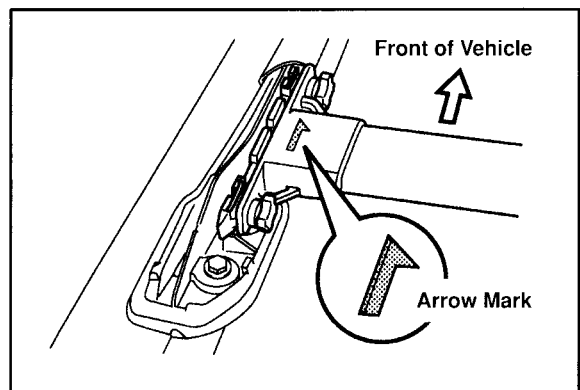
**If the cross bars are reinstalled backwards, they will create wind noise at highway speeds.**

4. Reinstall the cross bars, making sure that the directional arrows stamped on the joints are facing forward on the vehicle.

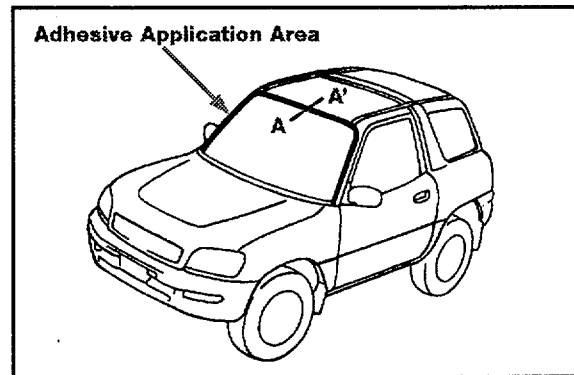
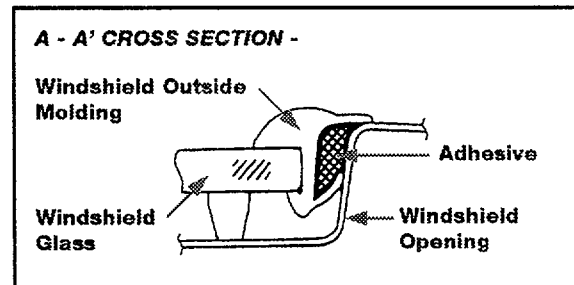
"Wind Whistle" is a high pitch sound generated when airflow speeds up as it passes through a narrow passage. In the windshield area, air enters at the bottom of the windshield molding and exits near the top of the molding.

1. Test drive the vehicle to confirm wind whistle is coming from the windshield molding area.
2. If wind whistle is present, use Urethane adhesive to fill any gap between the rubber portion of the windshield molding and the painted portion of the body windshield opening.

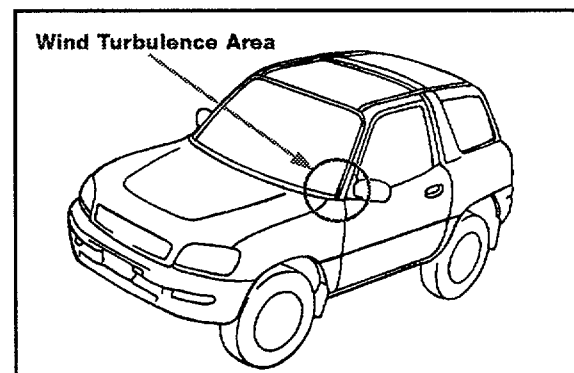
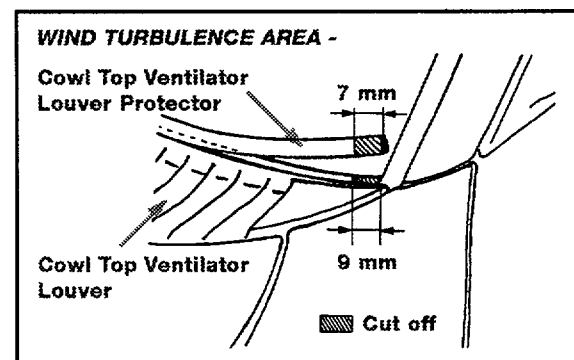
"Wind Turbulence" is a vibration sound caused by accelerated air flow as it travels around and past the windshield "A" Pillar and moldings.

**NOTE:**  
Use fine sand paper to smooth edge of Cowl Top Ventilator Louver.

3. Remove and replace the windshield outside molding with P/N 75533-42030.

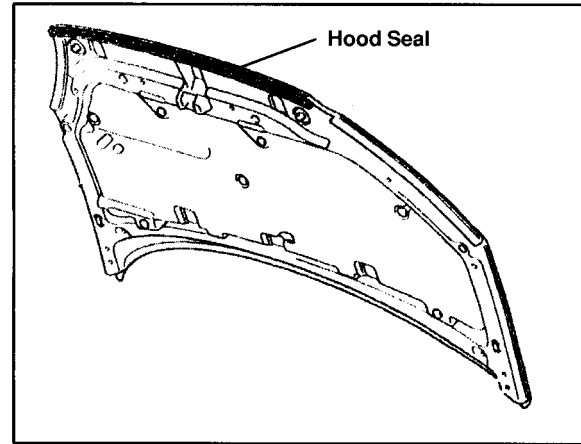
**Introduction** Some customers may experience a high-pitched wind whistle from the leading edge of the hood at highway speeds. The following field fix procedure is recommended to improve this condition.

1. Remove the hood to radiator grille seal from the hood.
